Legally Privileged Multidisciplinary Expert Report

McCrae Landslip Project

5 May 2025

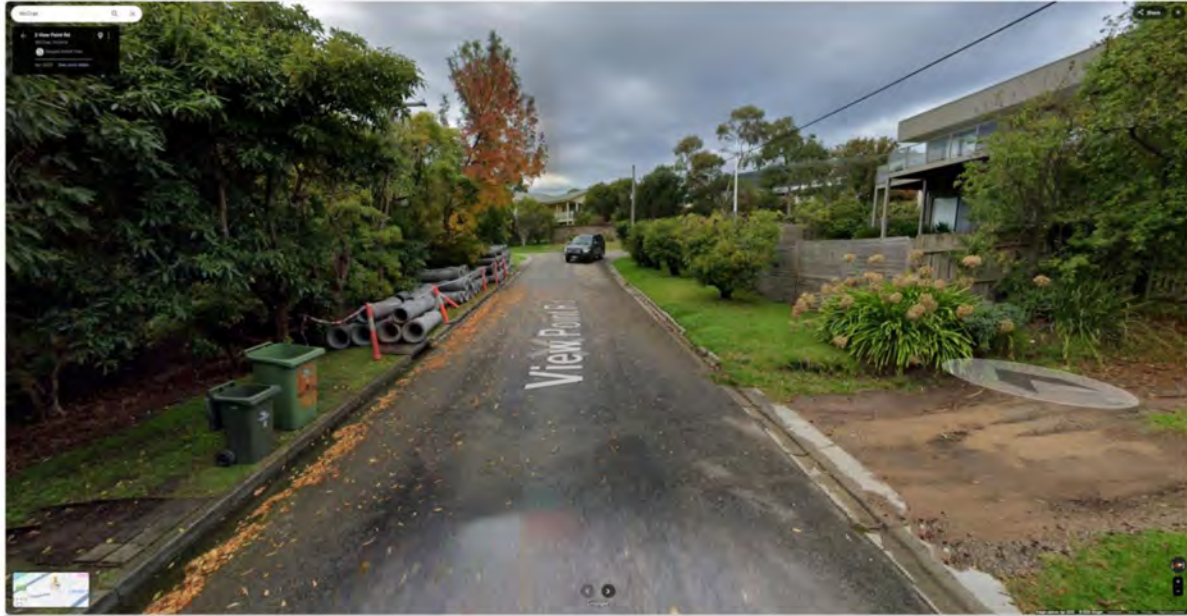
Figure 4: Google Streetview image from April 2023 looking east from outside No. 3 View Point Road. Note the stored pipes on the verge.

Publicly available photographs suggest stormwater upgrade works took place during Autumn 2023 (that is, after the November 2022 landslide) (see Figure 4).

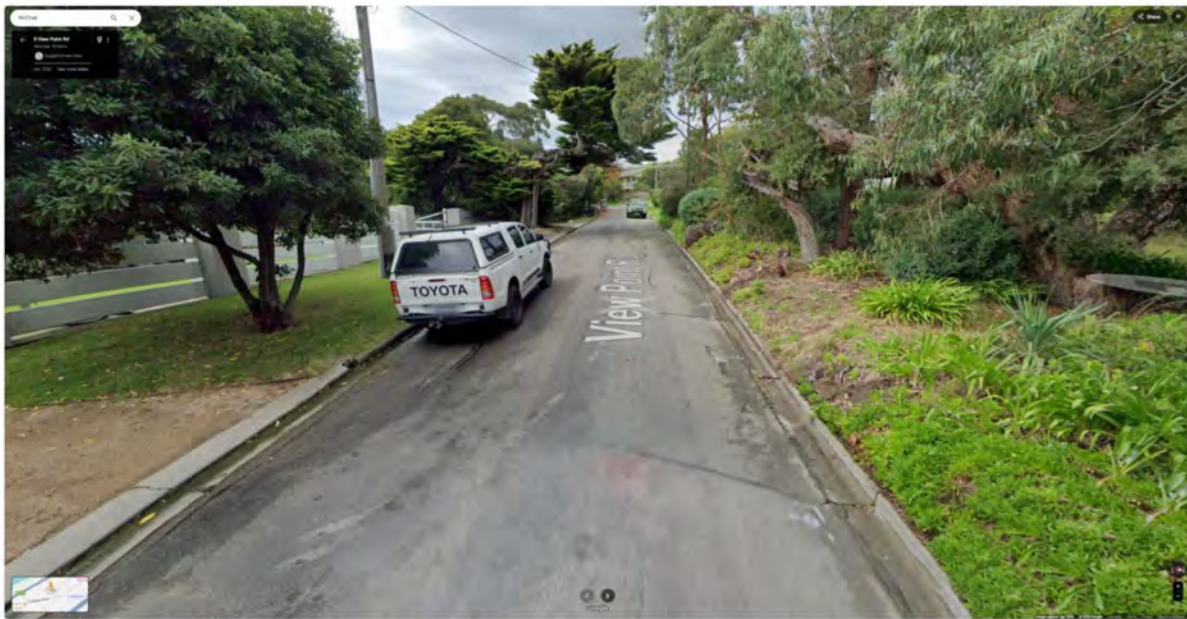
Figure 7: Google Streetview image from April 2023 looking east from outside No. 10-12 View Point Road.

Figure 5, Figure 6 and Figure 7 provide an indication of the condition of View Point Road. The condition of the pavement is characterised by numerous longitudinal cracks (Figure 5) and areas of crocodile cracking and spalling. Such evidence can indicate pavement fatigue or aging, or weak subgrade. Water is noted to be flowing down the eastbound kerb within the photographs. The precise date of the photographs is not known. But we note the greenish tinge of the kerb and channel, compared to the south side, which could indicate vegetation build up due to high levels of moisture content.

Note that Figure 5, Figure 6 and Figure 7 indicate that continuous flow along the kerb, which may confirm this statement.

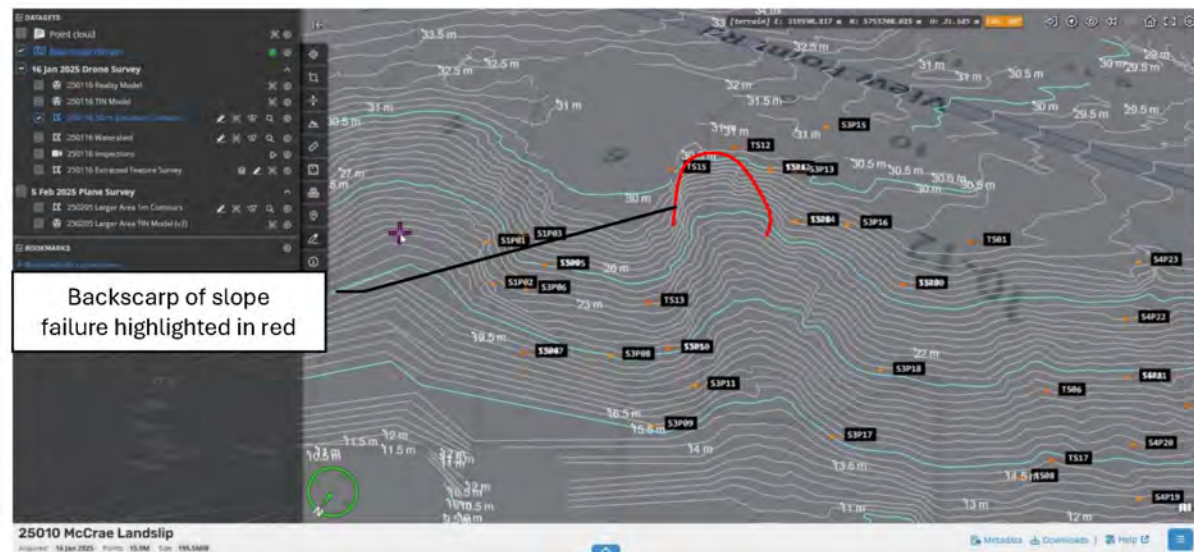
Figure 9: Oblique image showing approximate contours of the site.

Figure 9 provides imagery showing the height of the slope around the subject site. From this image, SMEC has been able to estimate the elevation of springs noted during drone footage.

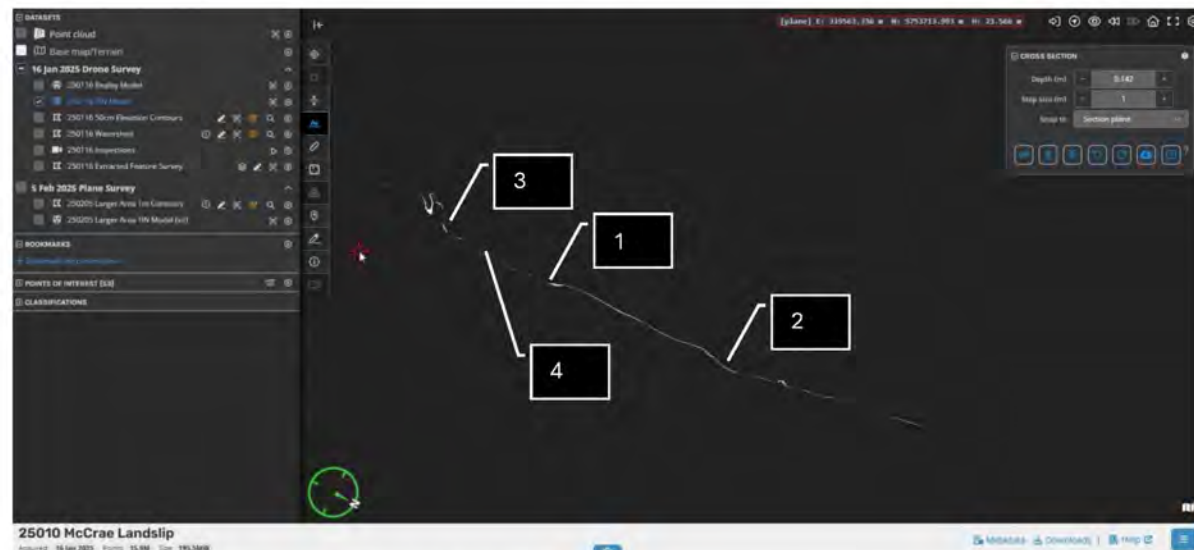
Figure 13: Cross section based on information from drone footage

Although Figure 13 is not scaled, the variation of the slope gradient is clear. Note that between points 1 and 2, the cross-section cuts through undisturbed slope. Point 3 shows the location of the backscarp of the failure, with point 4 the slip surface. The geometry of the topography shown in Figure 8, Figure 10 and Figure 11, suggest that the slip surface of the failure daylighted at an elevation similar to point 1. The toe debris has funnelled down a narrow gully throat before spilling out as illustrated in Figure 8 and Figure 11.

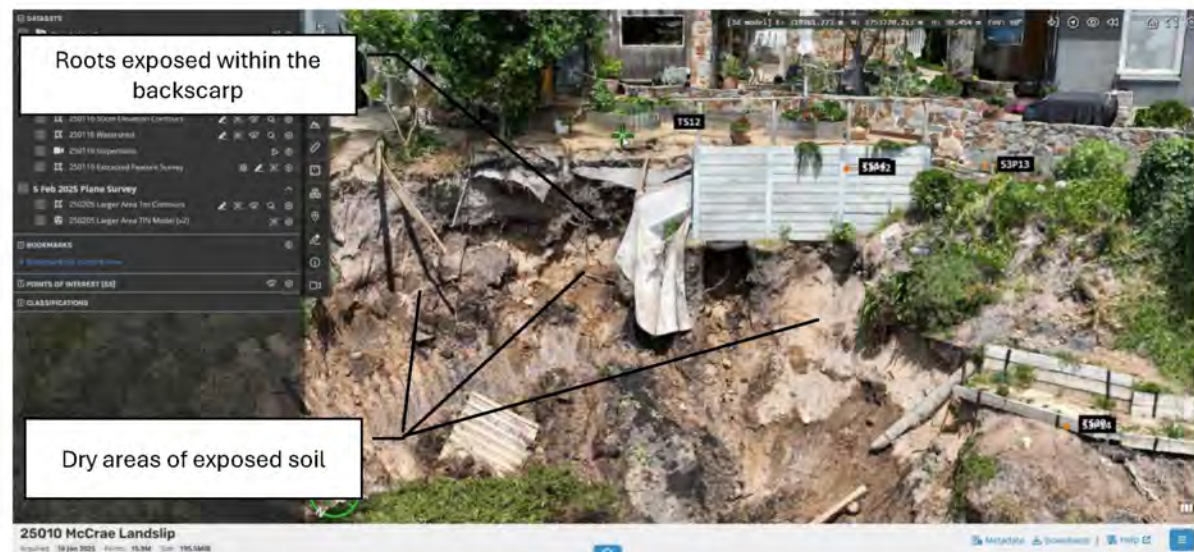
Figure 17: Drone footage looking directly at retaining wall

Figure 17 shows the condition of the retaining wall. The remaining posts have soil still surrounding them, with 'unretained' soil having slipped through the gaps. The dry nature of the remaining backscarp material is of interest. Considering the 30 m distance between SEW asset and the backscarp, the highly localised nature of the inferred wetter material does not indicate that the source of water is the SEW assets.

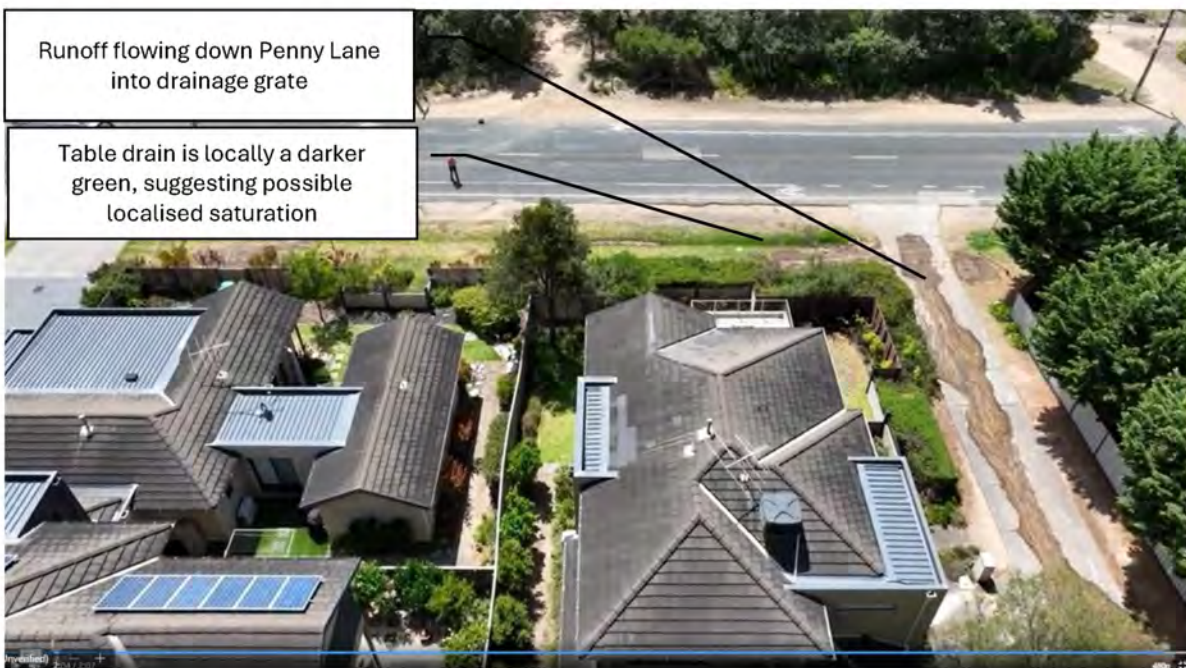
Figure 19: Drone footage from near the toe of the failure, looking towards Point Nepean Road.

Figure 19 shows water flowing down Penny Lane, and into a drainage grate, then flowing into a table drain. The surface area near the grate, is greener than the remaining length of drain.

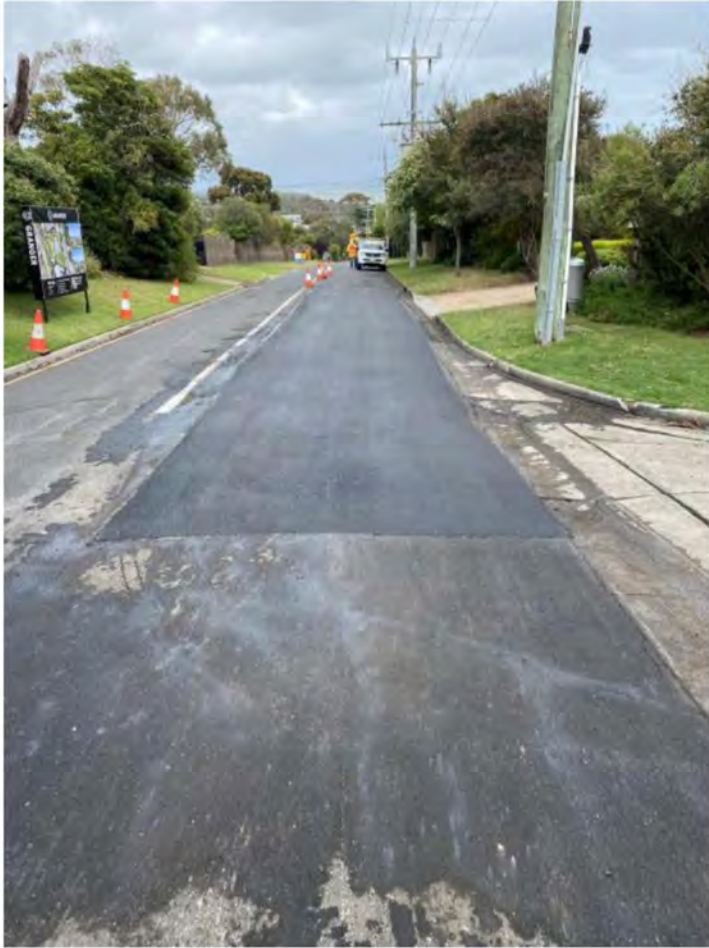
Figure 29: Photograph from SEW taken on 29 November 2023 (approximately), looking west along Coburn Avenue from junction with Prospect Hill Road showing asphalt pavement repair works.

We understand that additional asphalt and concrete works to the pavement were carried out in November and December 2023, as illustrated below. It does not appear that significant deterioration of the site took place in the time between the immediate works and more permanent works.

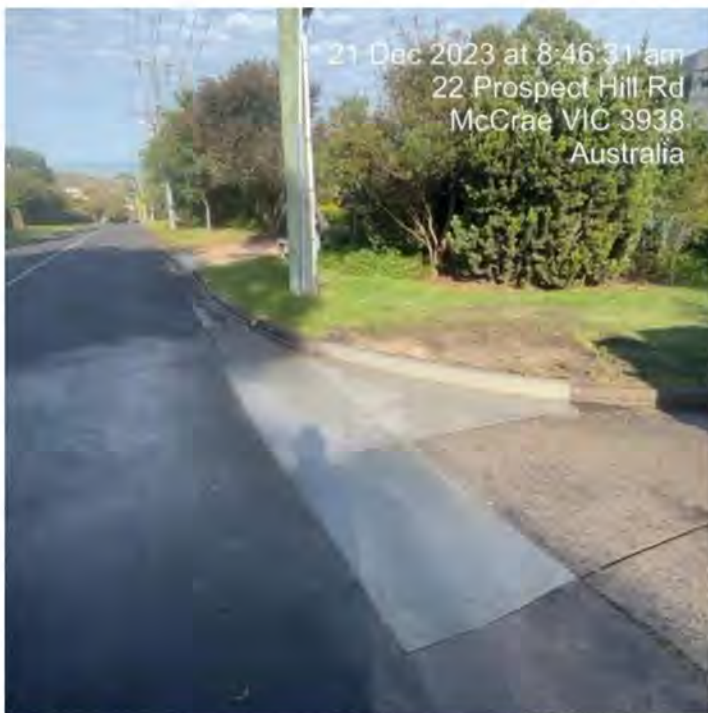
Figure 30: Photograph from SEW taken on 21 December 2023, looking west along Coburn Avenue from junction with Prospect Hill Road showing concrete pavement repair works.

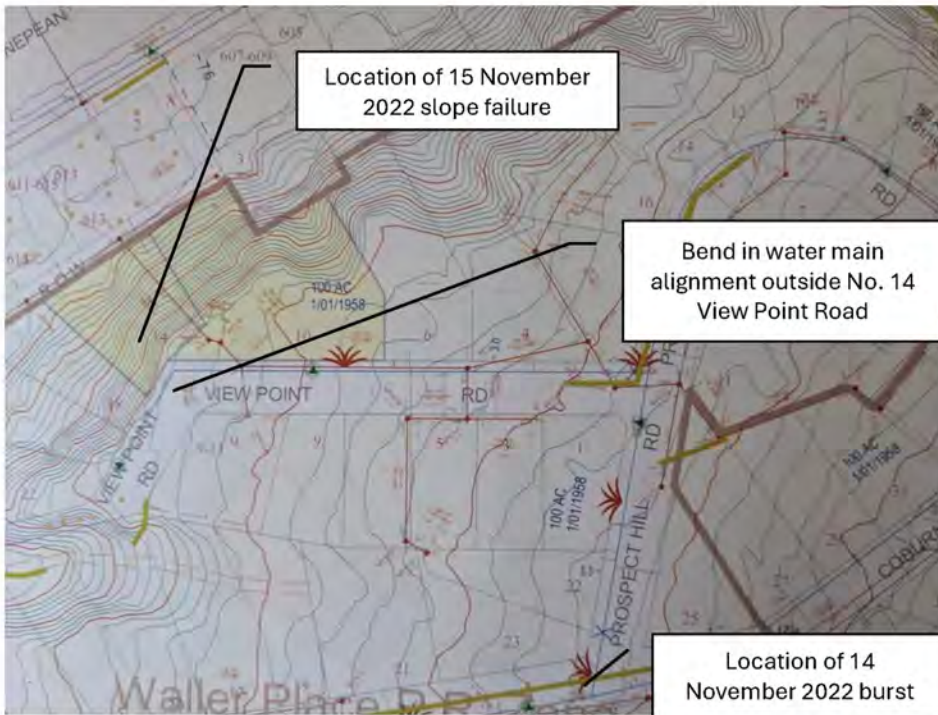
Figure 31: Excerpt of SEW map showing location of 23 Coburn Avenue, and the location of the 15 November 2022 slope failure, with annotations.

We understand that the 15 November 2022 slope failure is under current proceedings. It is not within the scope of the report to consider causes of this failure. However, Figure 31 illustrates that:

- the mains water for View Point Road, is linked to the mains water outside 23 Coburn Avenue. Leaked water could feasibly flow within the embedment material of the mains water.
- there is a bend in the mains water alignment at 14 View Point Road. This may have allowed water within the embedment material to seep out at that location and into 14 View Point Road. However, SMEC notes that there is no record of surface deformation between the mains trench and the slope failure.
- That the mains water system also links the site of the mains burst with a mains alignment down Coburn Avenue.
- Records suggest that the burst was repaired on the same date as it was observed, the volume of water lost is likely to be considerably less than the volume of water estimated for the Bayview Road leak located on 30 December 2024 and repaired on 1 January 2025.

In conclusion, the evidence of 15 November 2022 suggests that pipe burst can cause defects which are most likely to occur within the proximity of the burst. It is considered not feasible that water can transport down buried service trenches and leave the trench without resulting in defects being observed close to (i.e. within 5m) of the burst.

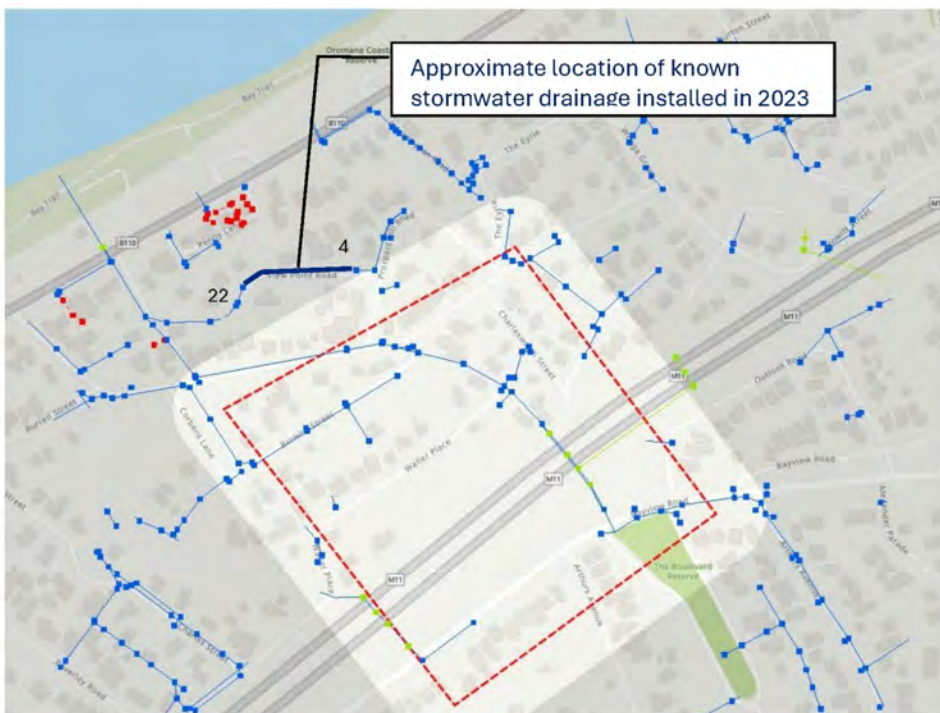
Figure 33: Map (not scaled) showing stormwater drainage network in the locality of the subject site.

Figure 33 indicates that stormwater drainage along View Point Road is incomplete (refer to annotation). SEW has advised SMEC, based on verbal conversations with Mornington Peninsular Shire Council, that the stormwater drainage flows from the front of No. 4 to No. 22 View Point Road. The works were completed in 2023. No as-built drawings or site records were available to SMEC at the time of writing.

SMEC has annotated Figure 33, to update it with the approximate locations of known buried stormwater drainage. The figure is derived from Before You Dig Australia maps, acknowledged to be incorrect by Mornington Peninsular Shire Council.

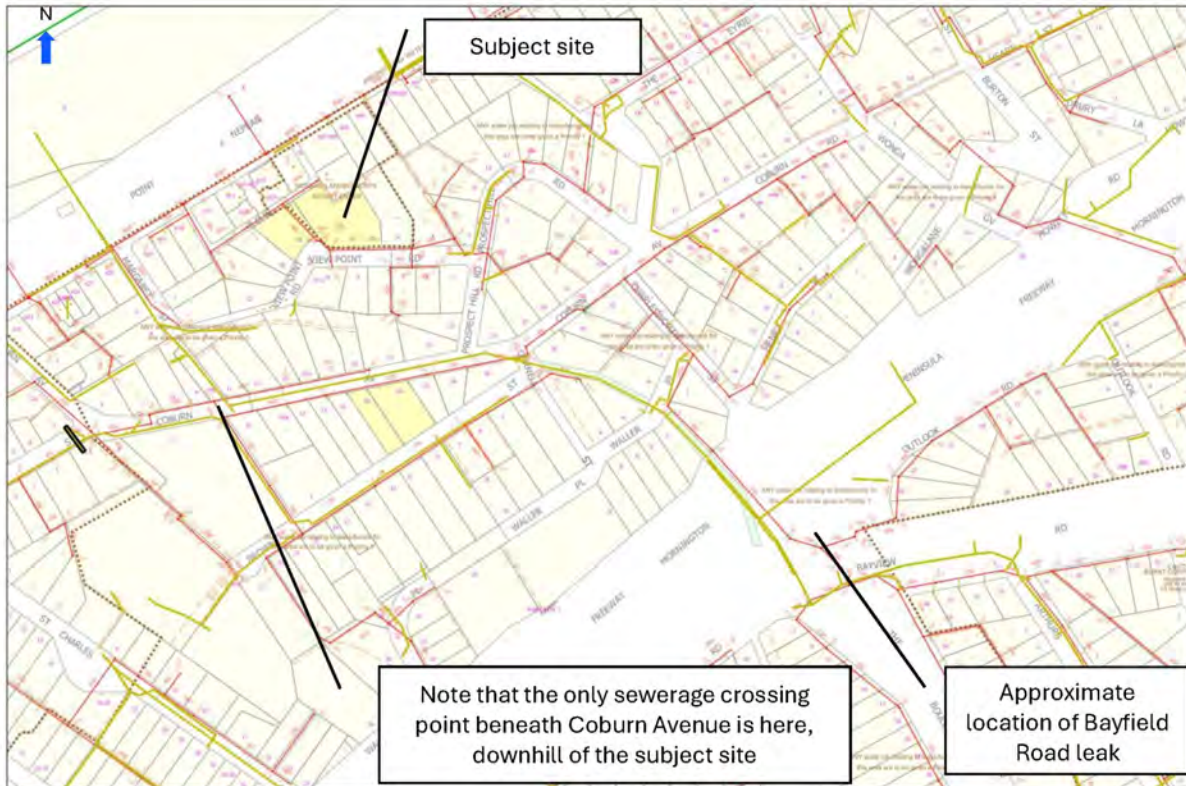
Figure 35: Plan showing sewerage network around locality of View Point Road. Note that the leak near Bayview Road is the south side of Mornington Freeway.

Figure 35 shows the location of buried sewer assets in the locality of View Point Road. It should be noted that the ground level tends to dip towards the northwest. There is no link between the sewer network of Prospect Hill Road and View Point Road, and the network south, or uphill from Coburn Avenue, as illustrated in Figure 58.

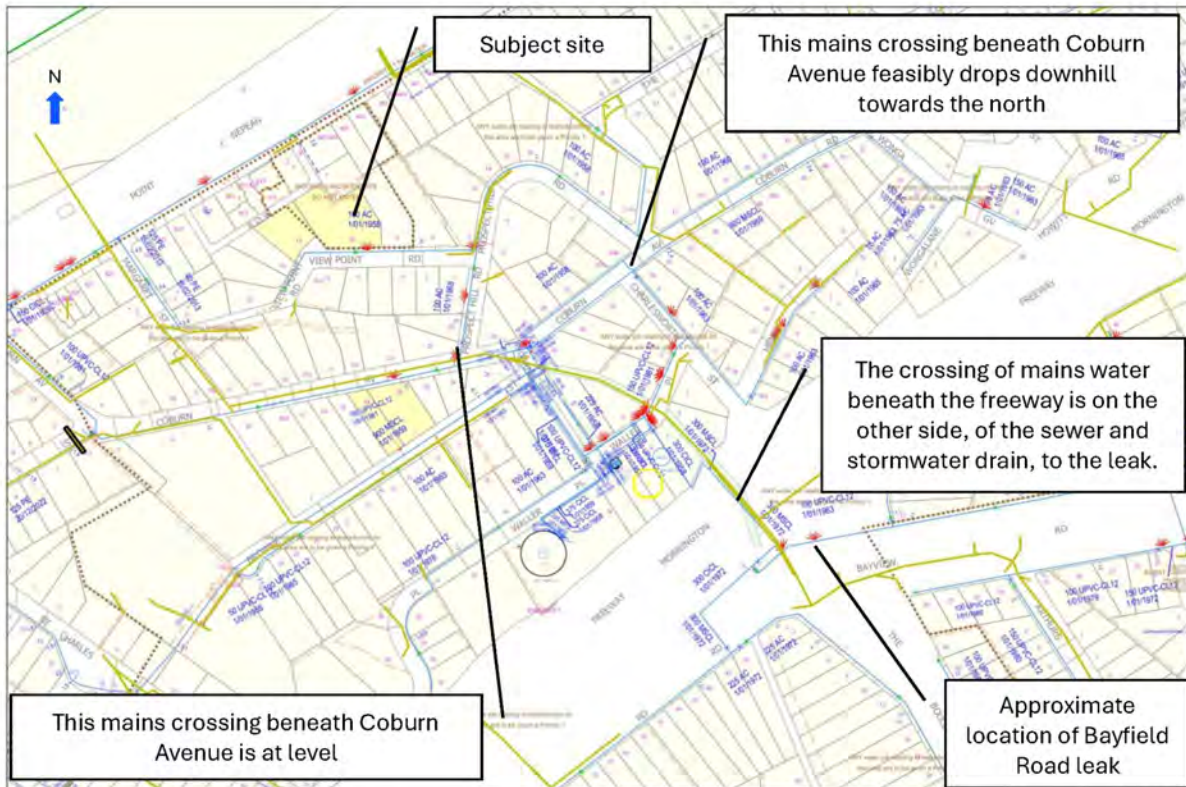
Figure 36: Plan showing water mains network around the locality of View Point Road.

Figure 36 illustrates that the link within the mains network at the T-junction of Prospect Hill and Coburn Avenue is level. This is not a concern for pumped water flow, but it indicates that the embedment material surrounding the mains, grades upwards towards Prospect Hill Road.

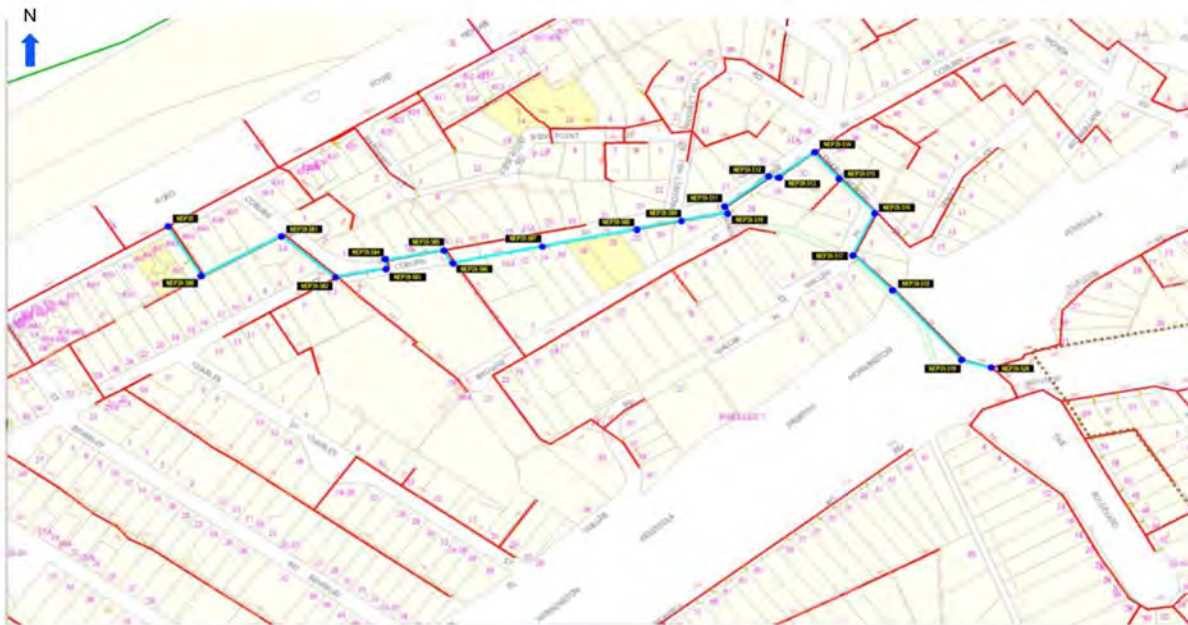
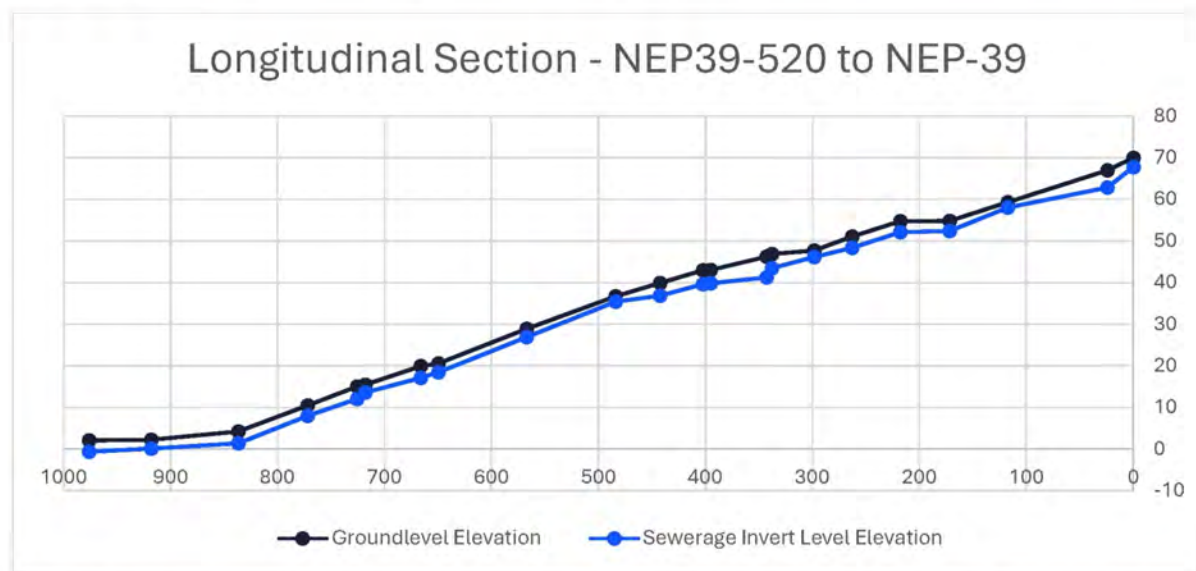
Figure 37 and Figure 38 illustrate the gradient through Bayview Hill Road into Point Nepean Road. Chainages 217.75 m to 298.25 m are located along Charlesworth Street, where upwelling was noted (Section 7.6.3.2). The depth to invert along Charlesworth Street varies from 2.69 m to 1.56 m. It is noted that the invert depths along Charlesworth Street are not the shallowest inverts along the alignment. It is therefore not certain that the depth to invert is solely related to the likelihood of upwelling.

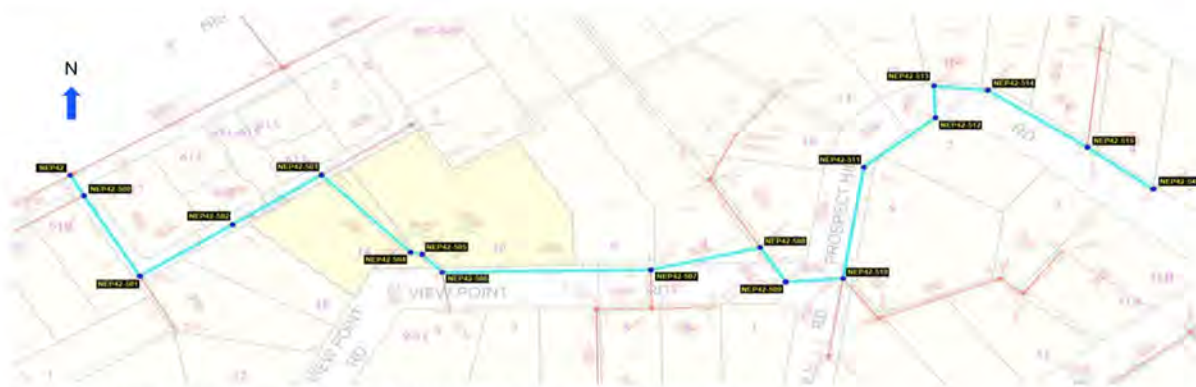
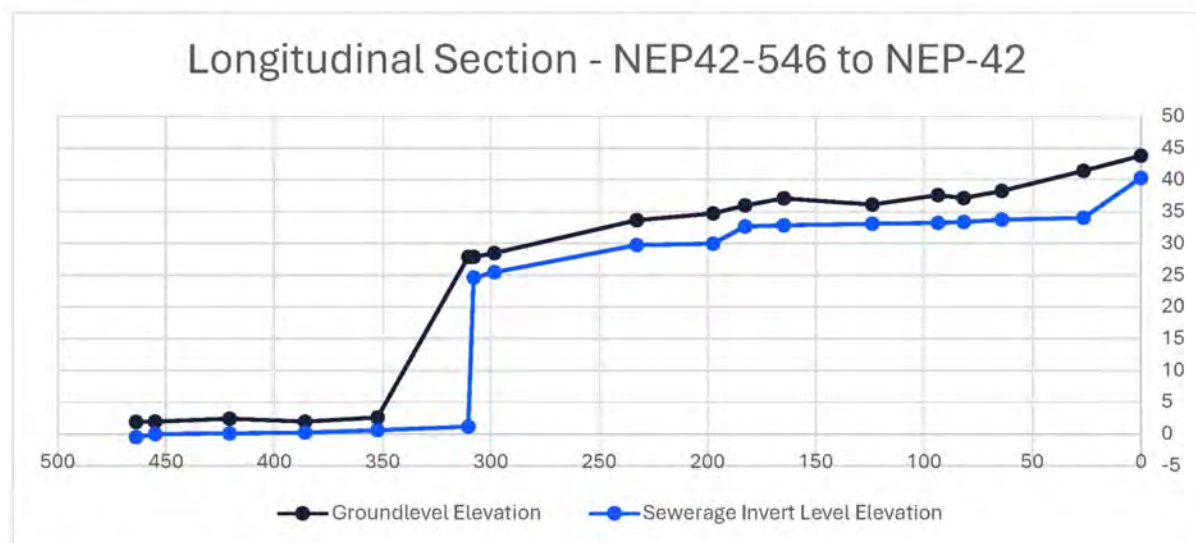
Figure 39 and Figure 40 illustrate the gradient through Prospect Hill Road into View Point Road. Note that the scales differ from Figure 37 and Figure 38. Note that 10 View Point Road is at chainage 298.4 m. The figures show a fall in invert level along the chainage, irrespective of the ground level. Note that Chainage 83.9m to 93.7m, is outside 10 Prospect Hill Place.

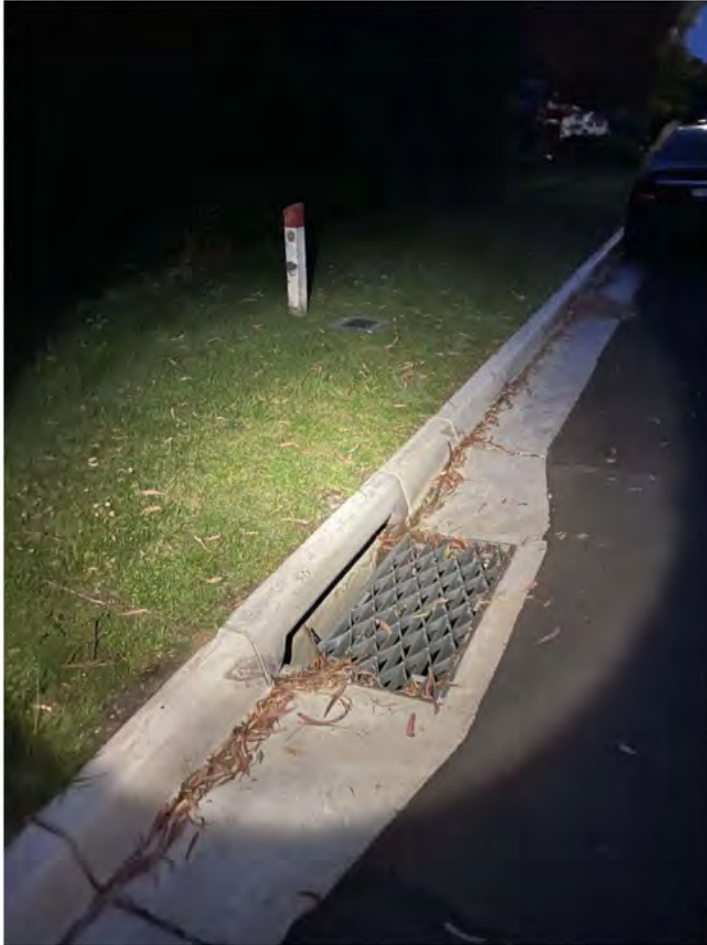
Figure 49: Photograph taken on the night of 5-6 January 2025, of a stormwater drainage pit outside what is thought to be No. 10 View Point Road

Figure 49 shows a storm water pit with a grate. The accompanying records from SEW personnel do not explicitly say where this pit is. However, based on locations of fire hydrants and recognisable fences, SMEC believe it is outside No. 10 (see Figure 6).

SEW has advised SMEC that in January 2025, SEW advised the owner of 5 Prospect Hill Road that they had identified a leak in the property from leak detection activities. In April 2025, the owner found the leak and repaired it. The flow of water within the stormwater drain (Figure 49) is considered to be at least in part due to the pumping of groundwater from the basement.

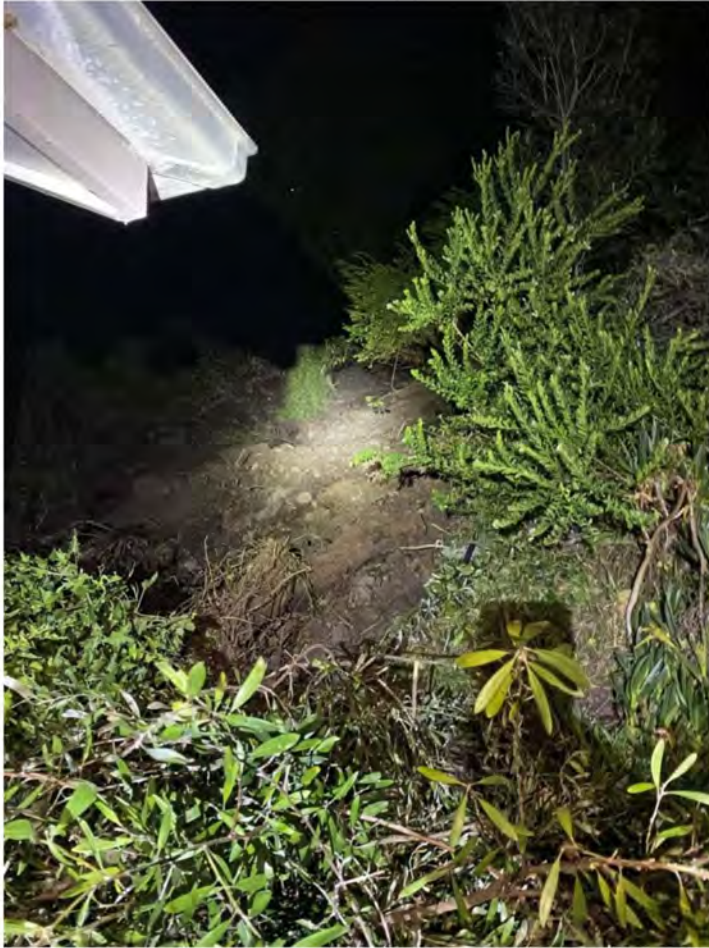
Figure 51: Photograph taken on the night of 5-6 January 2025, looking south from behind 3 Penny Lane

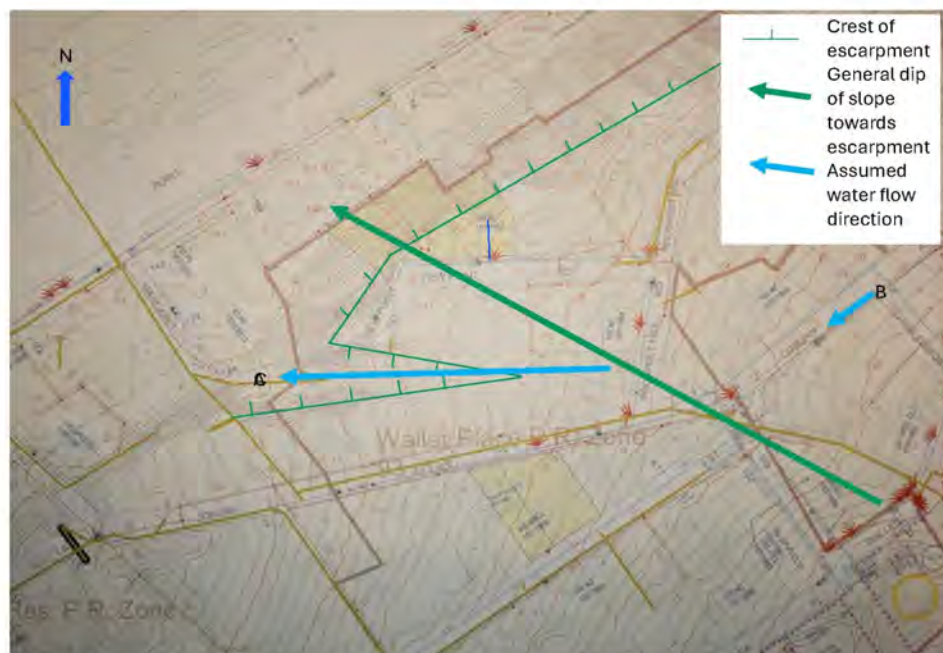
Figure 57: Map illustrating the evidence needed to confirm the hypothesis that the McCrea Landslide was impacted by a leak within SEW assets in the vicinity of the subject site

Figure 16 and Figure 32 illustrate the distance between the landslide and the location of the water main (located within the verge of View Point Road) is approximately 30 m. The ground level tends to drop across the alignment of View Point Road (see the green arrow, Figure 57).

- View Point Road runs along the centre line of a minor spur formed between the escarpment and the valley outfalling at Margaret Street (refer to the green lines indicating crest of escarpment, Figure 57),
- The alignment of the spur (the promontory between the two slopes highlighted in the figure above) is at an angle to the overall dip of the escarpment,
- The general dip of the slope towards the escarpment is oblique to the direction of the buried services along View Point Road.

It is considered more likely water flows down via Margaret Street (point A and blue arrow, Figure 57). Water from leaks at Charlesworth Street (point B and blue arrow, Figure 57), would flow downhill, westwards. The topography east of Cornells Street would suggest a fanning out of water, as opposed to a concentrated flow of water.

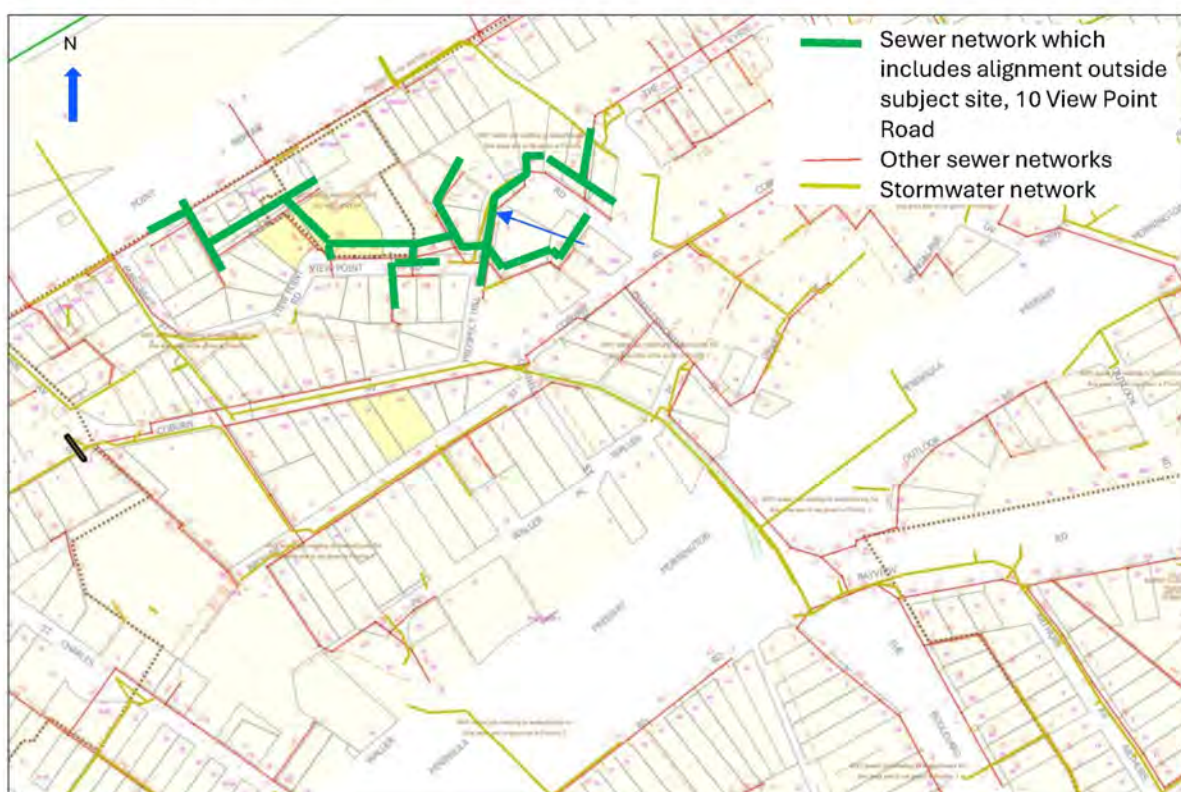
Figure 58: Map illustrating the evidence needed to confirm the hypothesis that the McCrea Landslide was impacted by a leak within SEW assets in the vicinity of the subject site

This means that there is no contiguous trenched network associated with the sewerage that could allow water from significantly uphill of the subject site to reach the site.

The network that connects View Point Road, taking account of gravity, is limited to the green annotated network in Figure 58.

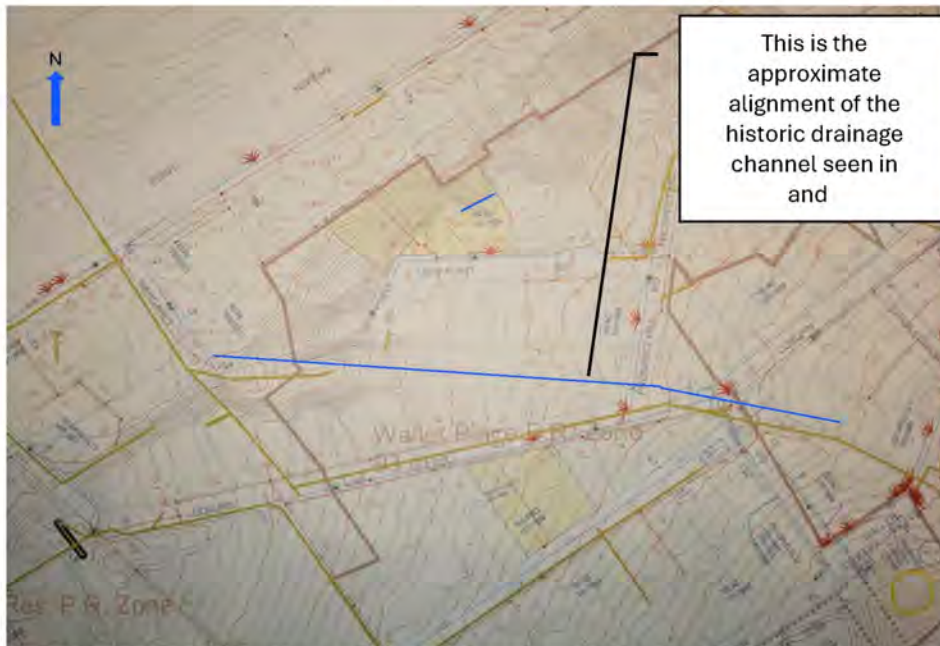
- A single leak 465 m uphill from the landslide,
 - Creating water flow across a historic surface water channel that outfalled at Margaret Road (Figure 59),
 - but also, across a modern cut that takes the Mornington Peninsula Freeway past McCrae (Drawing 003), and

Figure 59: Map illustrating the historical drainage channel in the locality of the subject site, in the context of current development

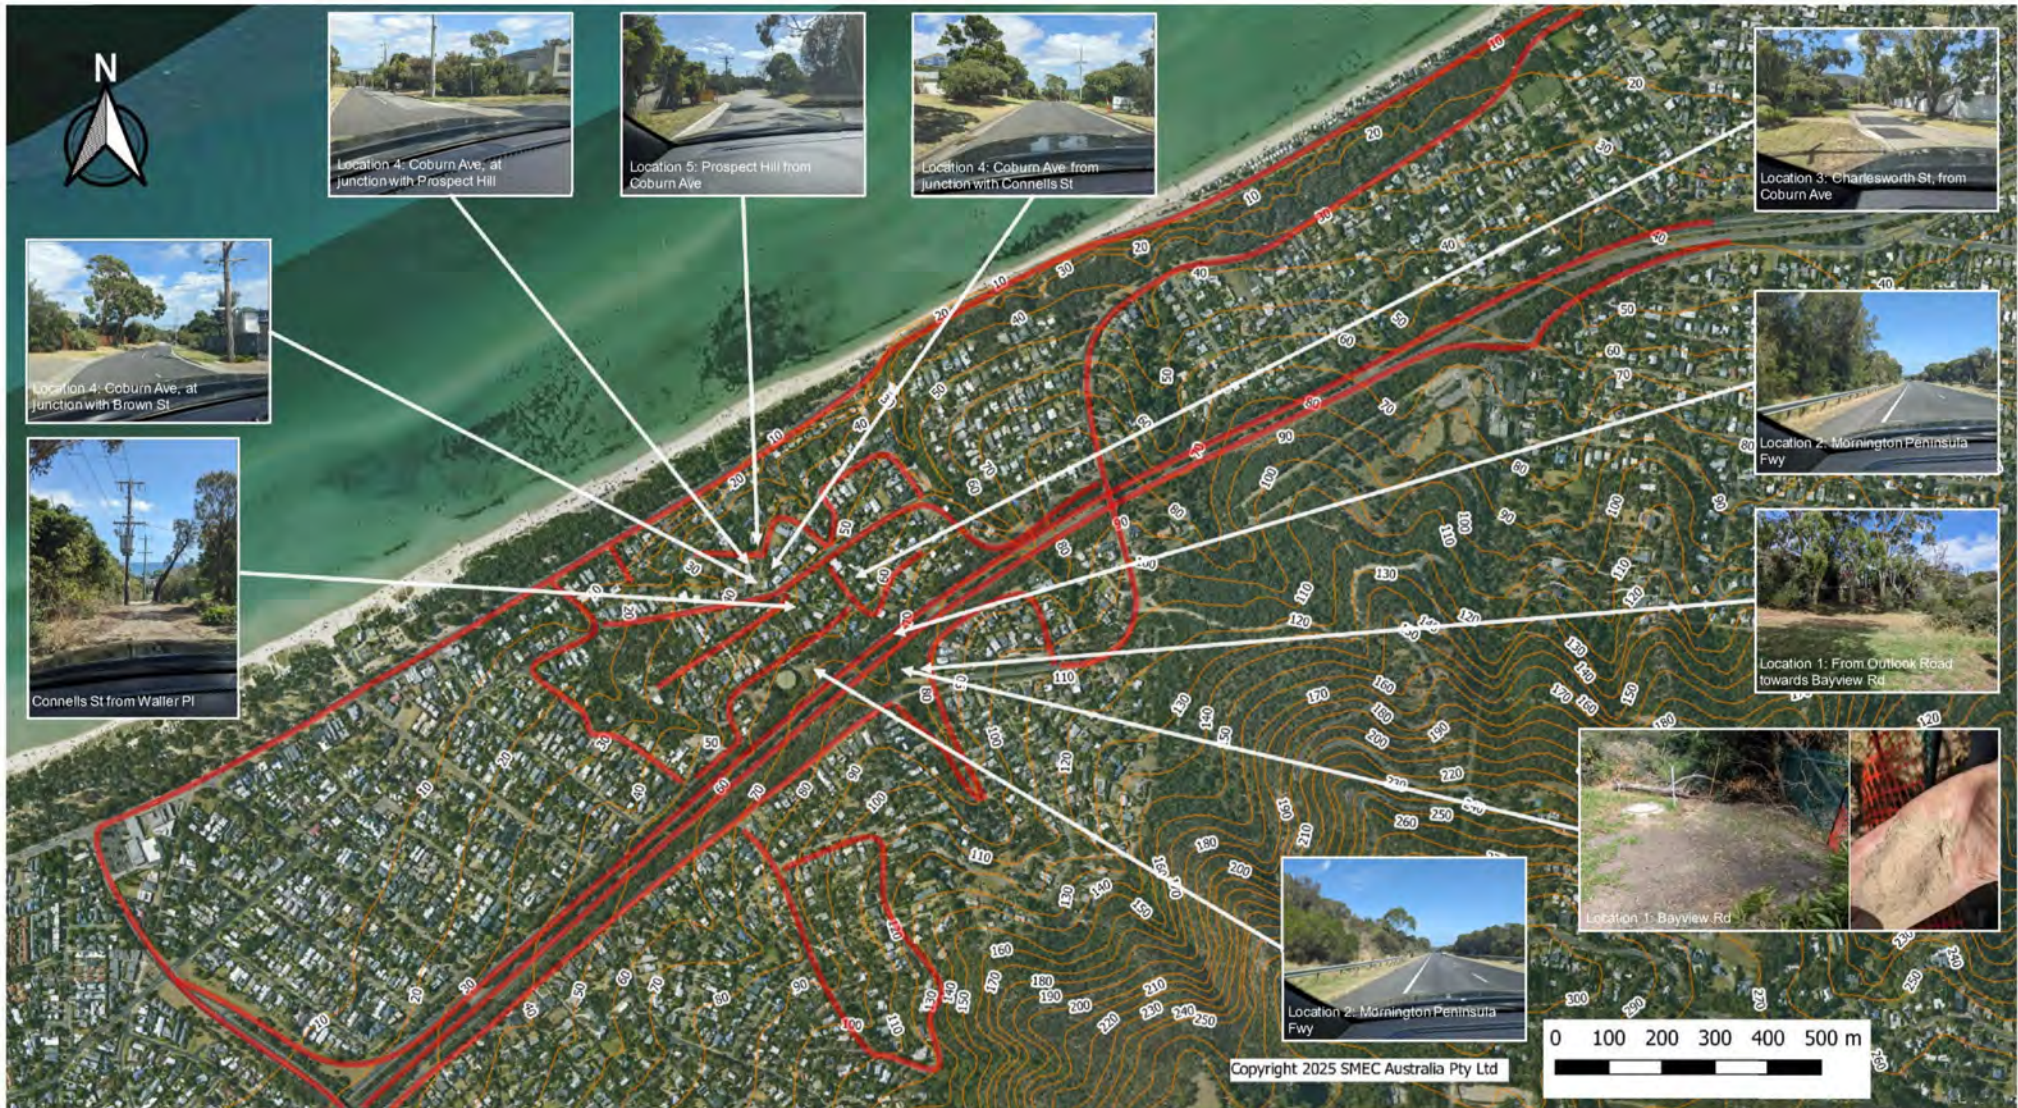
FIGURE TITLE: Drawing 001 - Aerial photograph of the locality of the subject site, showing roads driven during the site visit of 3 March 2025, and select photos taken during the site visit

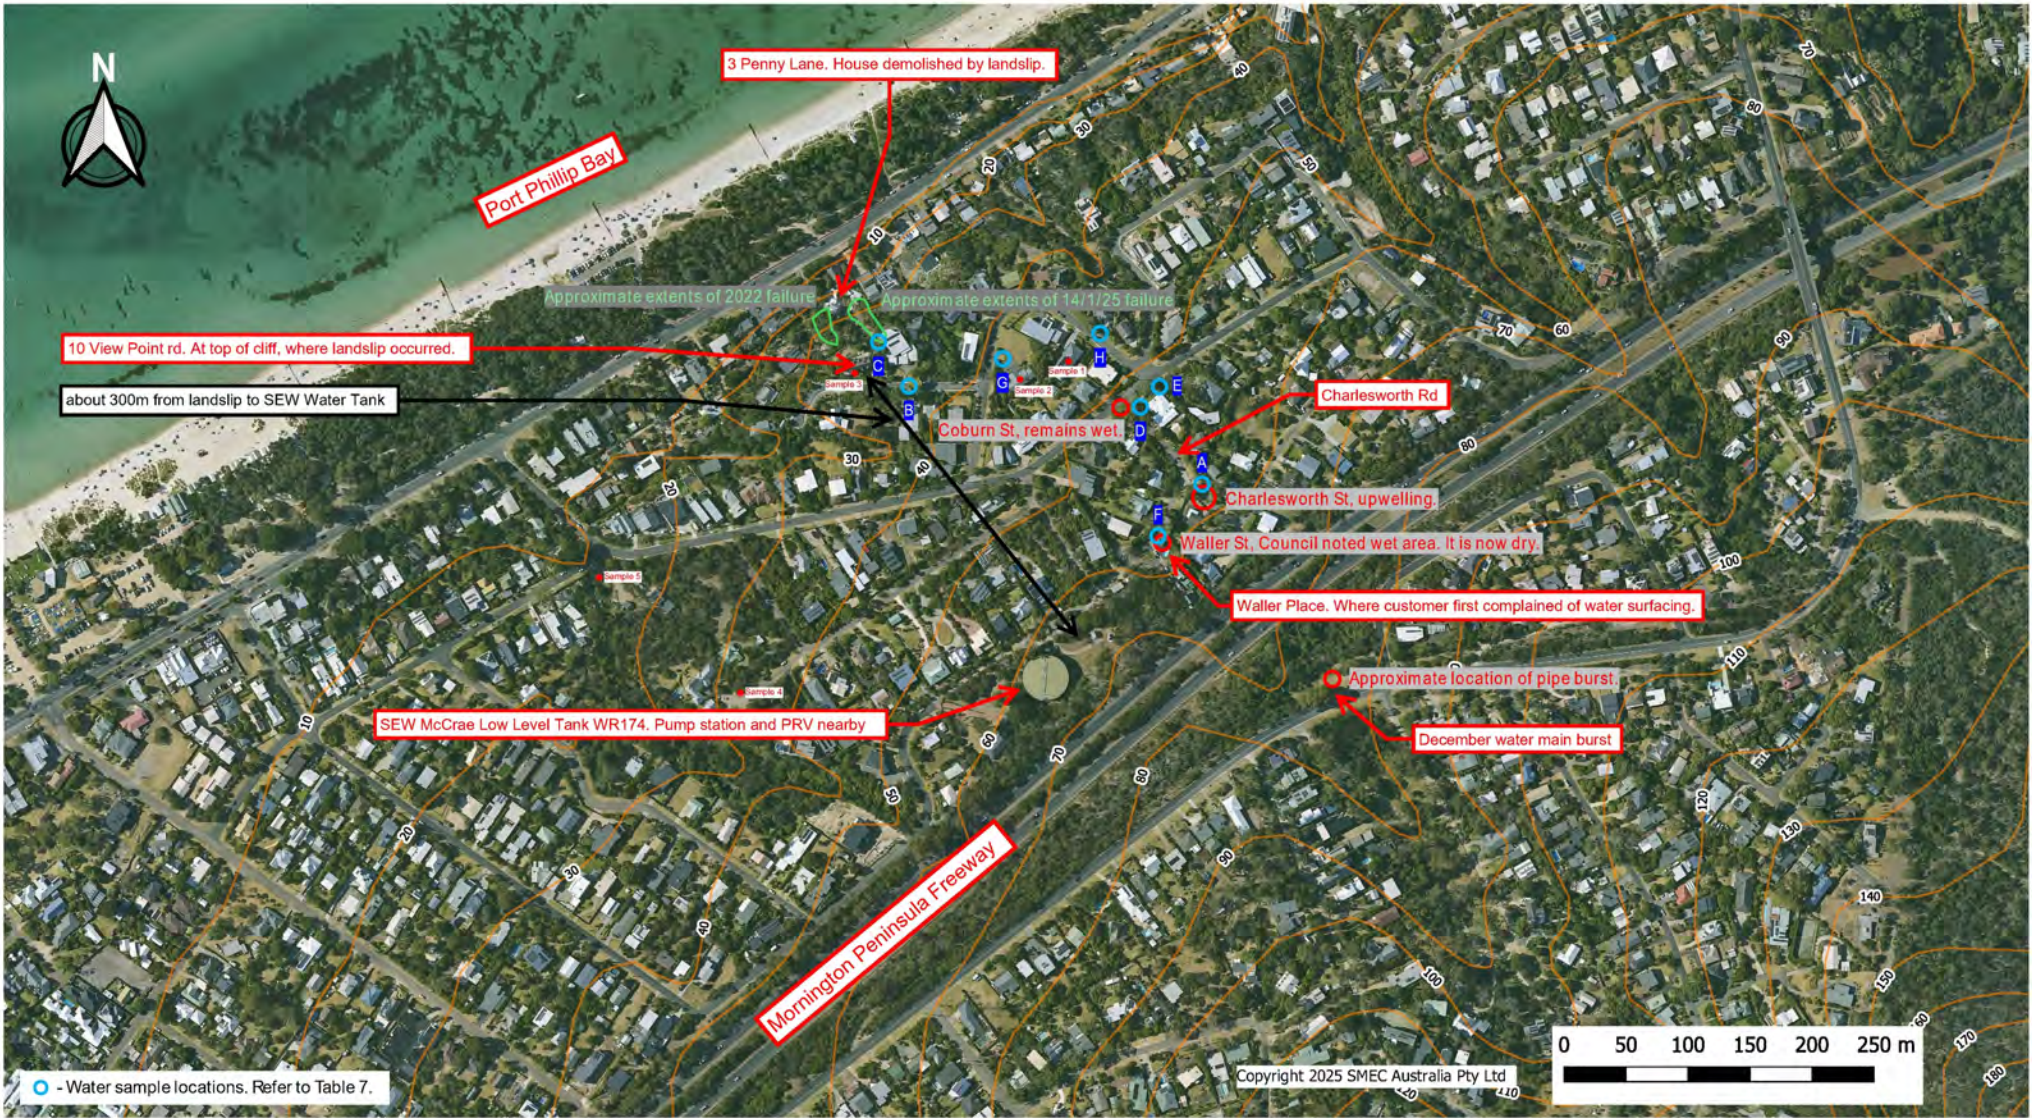
- raised the groundwater locally to a site some 20 m wide.
- Seepage, distortion, settlement or failure or other ground movement has not been observed at any location in between the leak and the site. There are observations of welling of water at locations which anecdotally appear to have occurred since May 2024, but with more frequency between 24 November 2024 and 13 January 2025 (Waller Place and Charlesworth Road, Drawing 003).

FIGURE TITLE Drawing 002 - Aerial photograph of the locality of the subject site, showing locations of note
