Legally Privileged Multidisciplinary Expert Report

# McCrae Landslip Project

Prepared for: Thomson Geer

5 May 2025

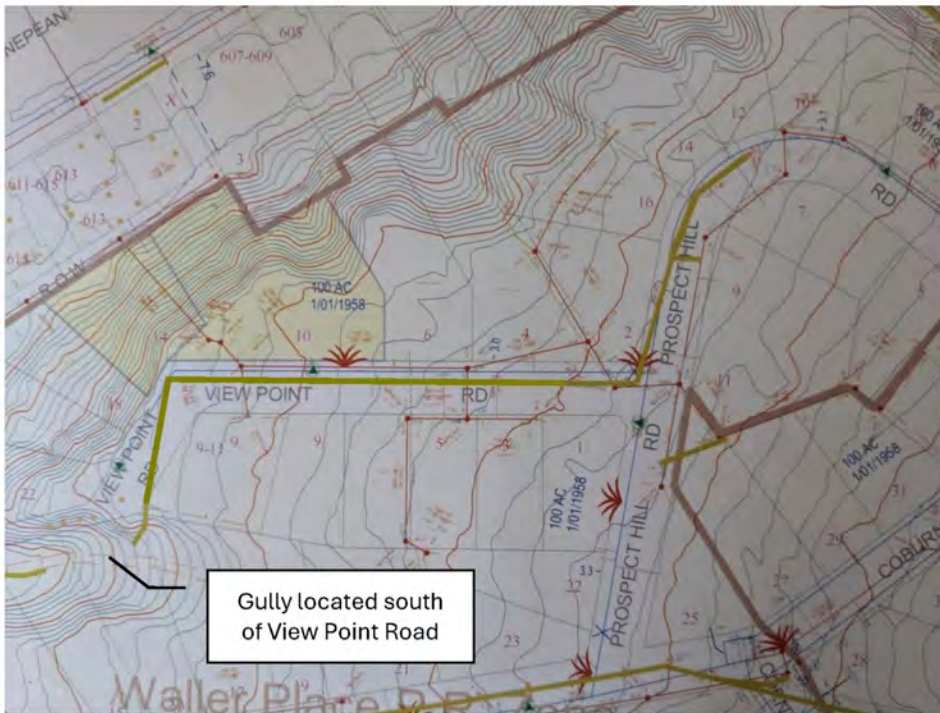
Figure 32: Excerpt of SEW map showing location of View Point Road and Prospect Hill Road.

Figure 32 also shows the topography of the locality. Note a gully that falls westwards, south of the turning circle of View Point Road. This is away from the subject site.

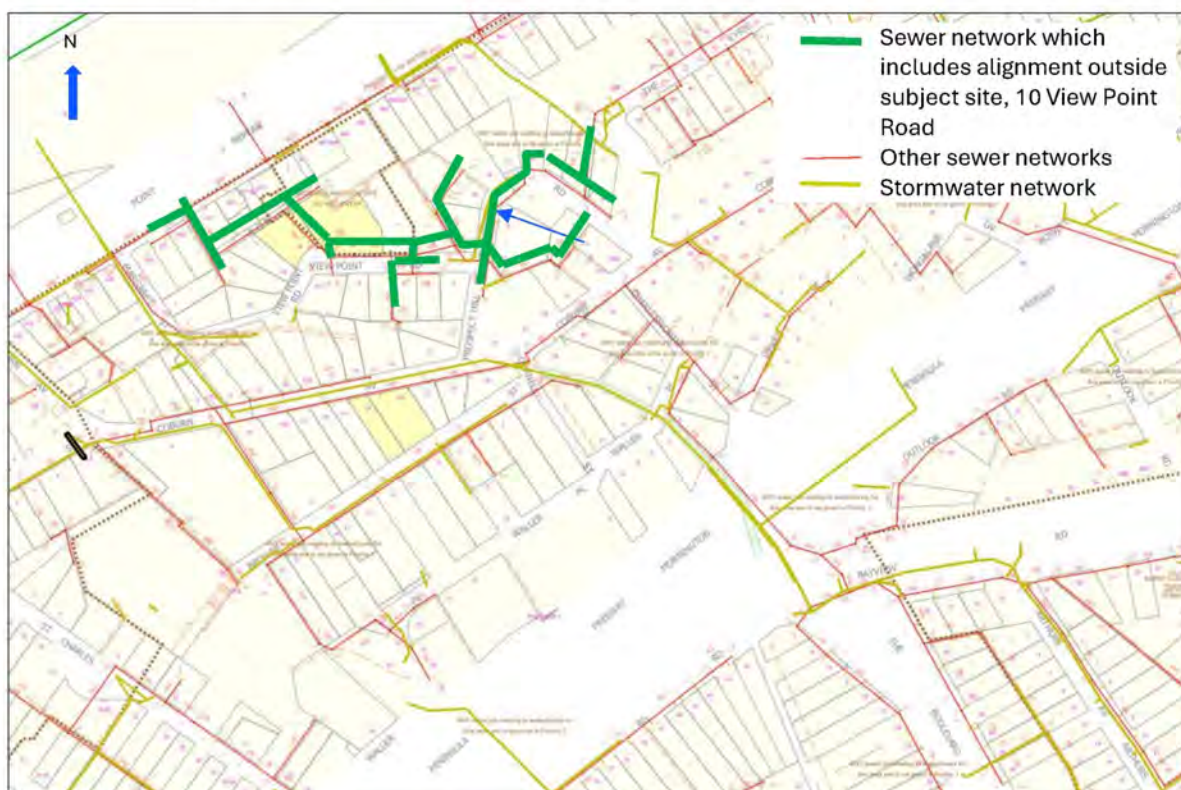
Figure 58: Map illustrating the evidence needed to confirm the hypothesis that the McCrea Landslide was impacted by a leak within SEW assets in the vicinity of the subject site

Analysis of Figure 35, Figure 36, Figure 39 and Figure 40, and show that the sewerage networks north and south of Coburn Avenue are not connected.

This means that there is no contiguous trenched network associated with the sewerage that could allow water from significantly uphill of the subject site to reach the site.
