**Task Number:**1295094/001**Task Address:**4 WALLER PLACE, MCCRAE VIC 3938 MapRef : 159B10**Program Name:****Task Work Type:**Planned Maintenance - Repair**Source Of Work:****Facility:****Permit Not Required:**No**Permit Pre Approved:**No**Permit Reason:**Other**Permit Other Reason:**

# Leak Report

**Task Number:**1295094/006

**Request Details:**Burst on the 150UPVC main opp 2 the boulevard. water Ops located leak

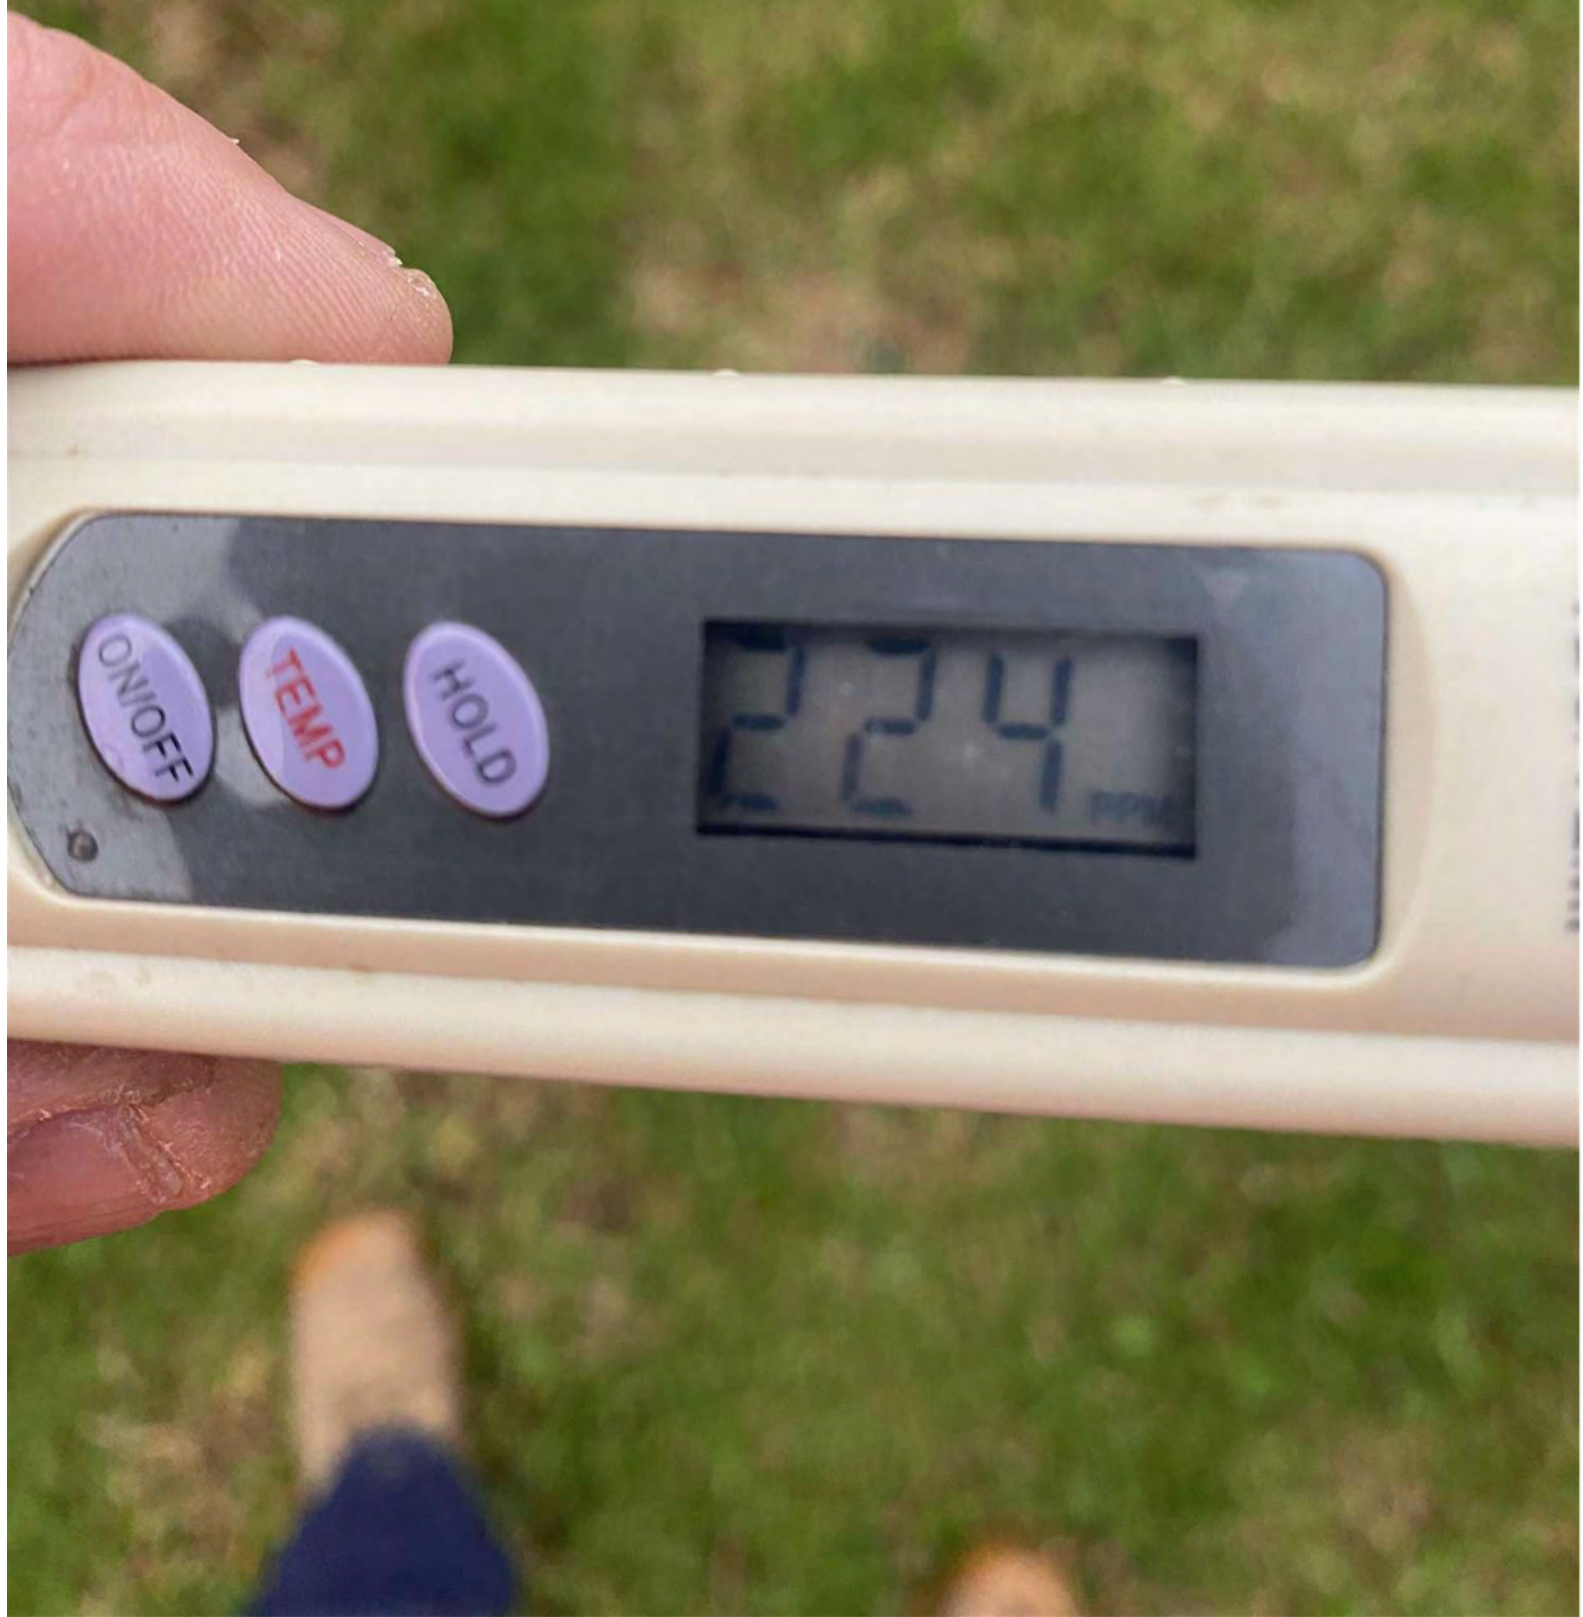
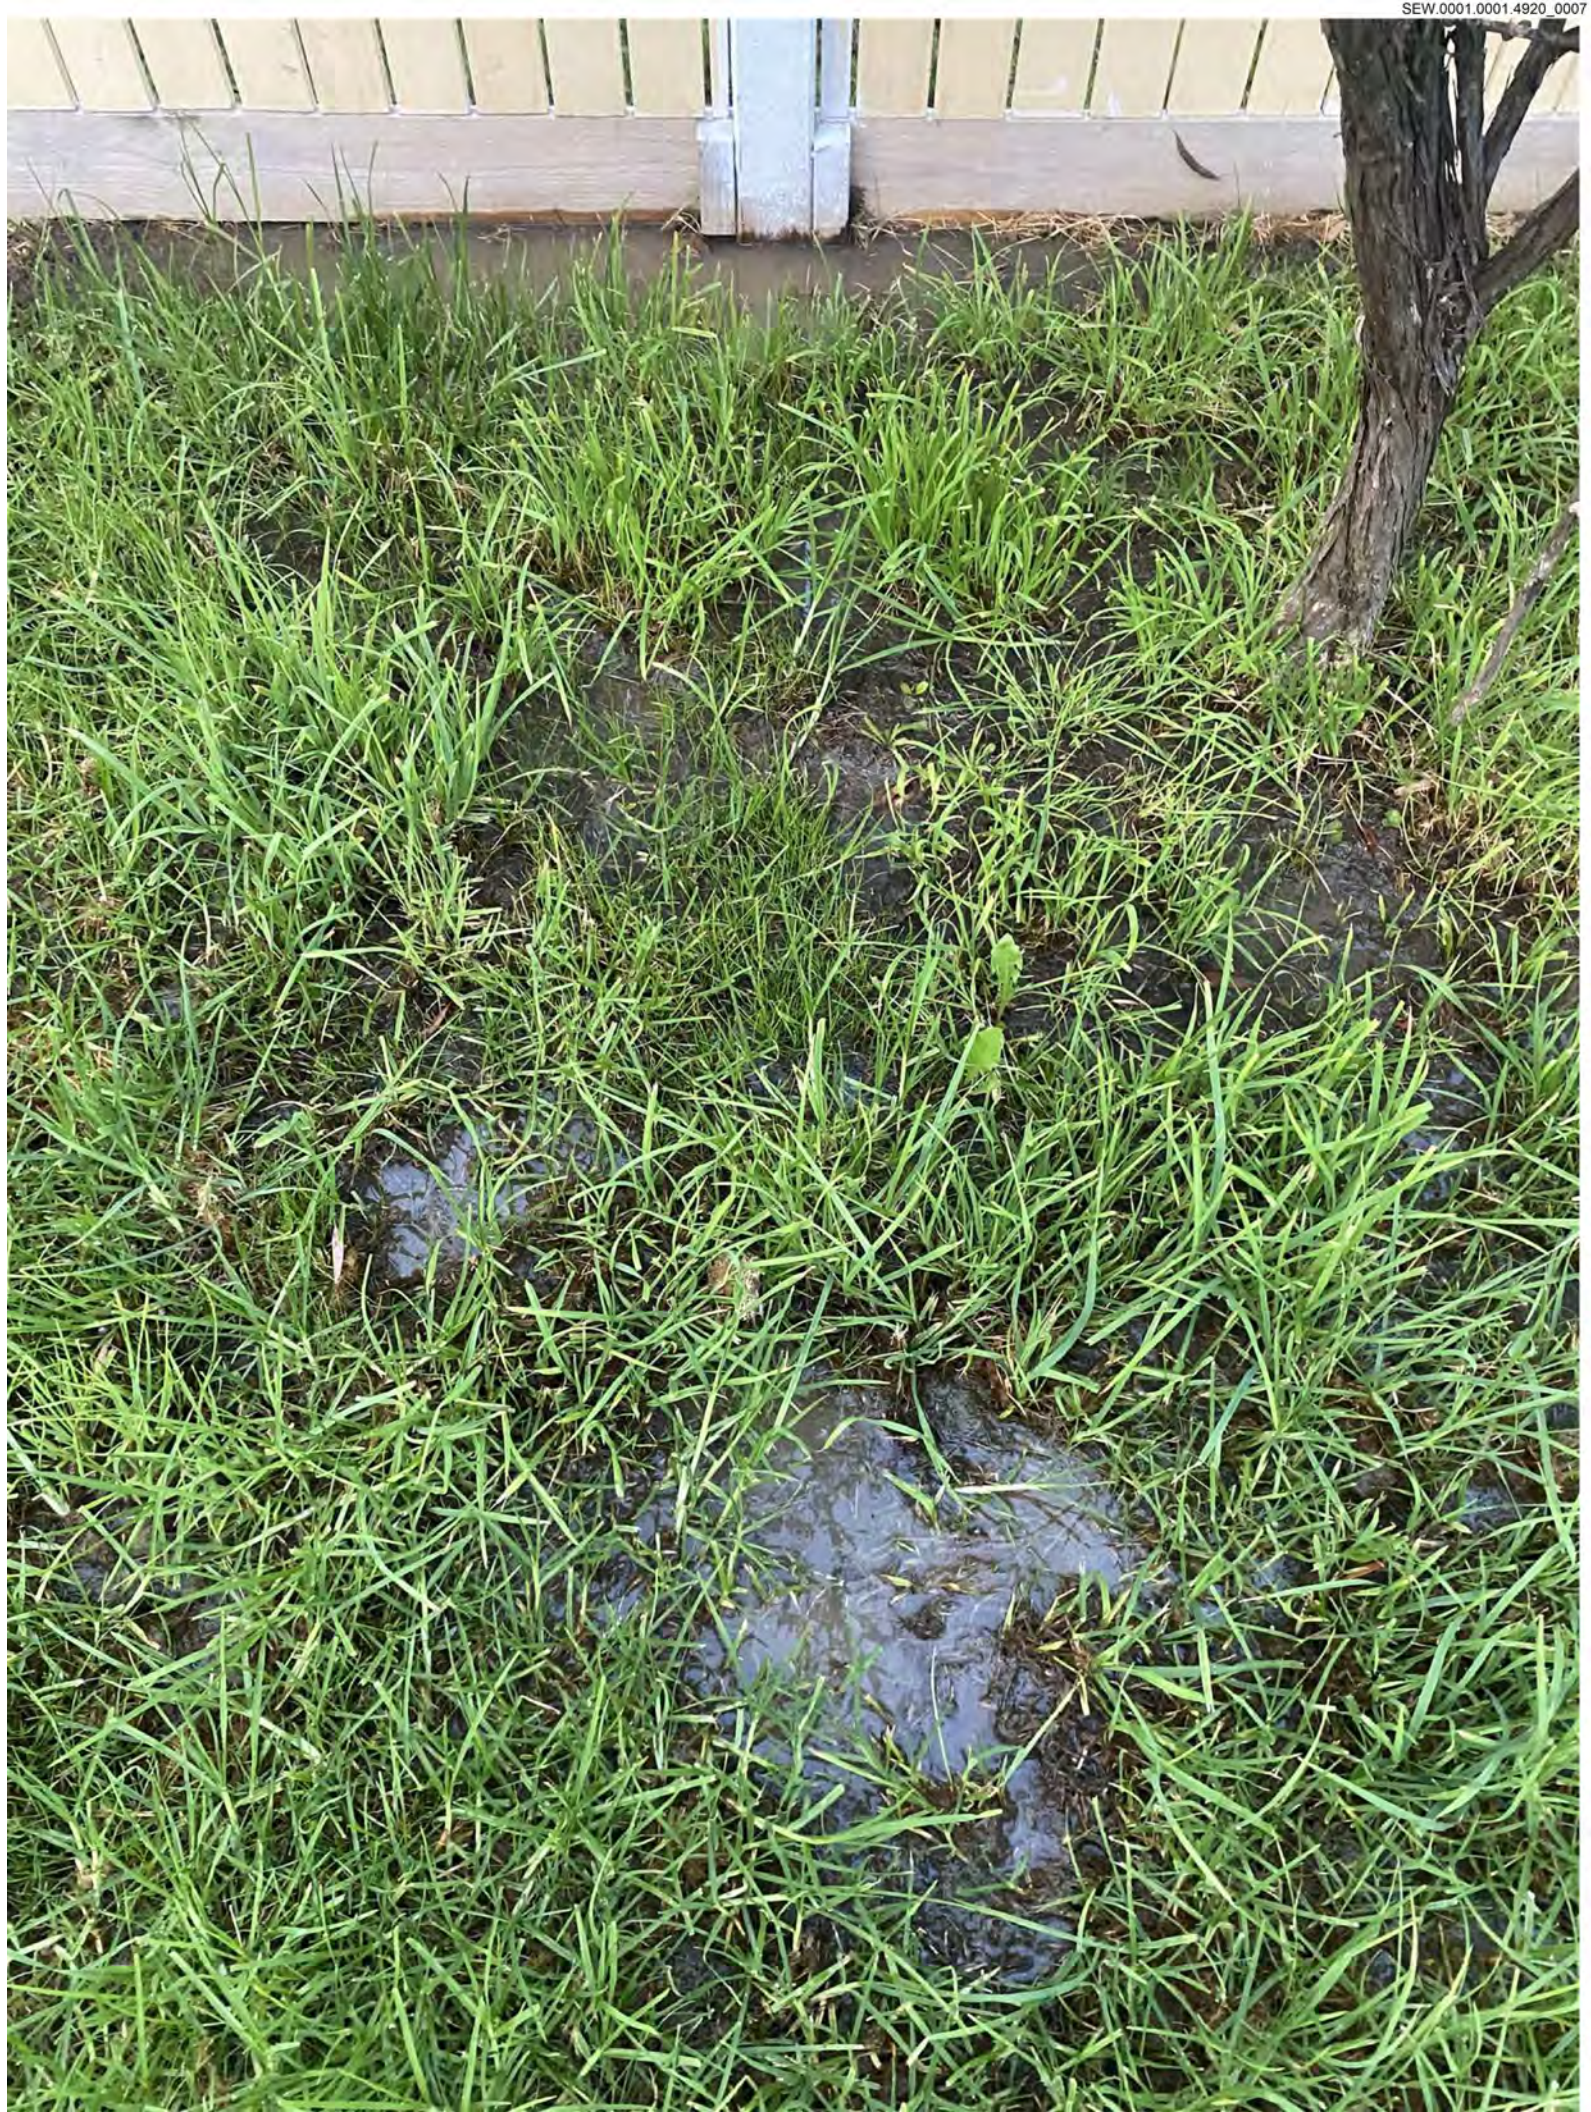
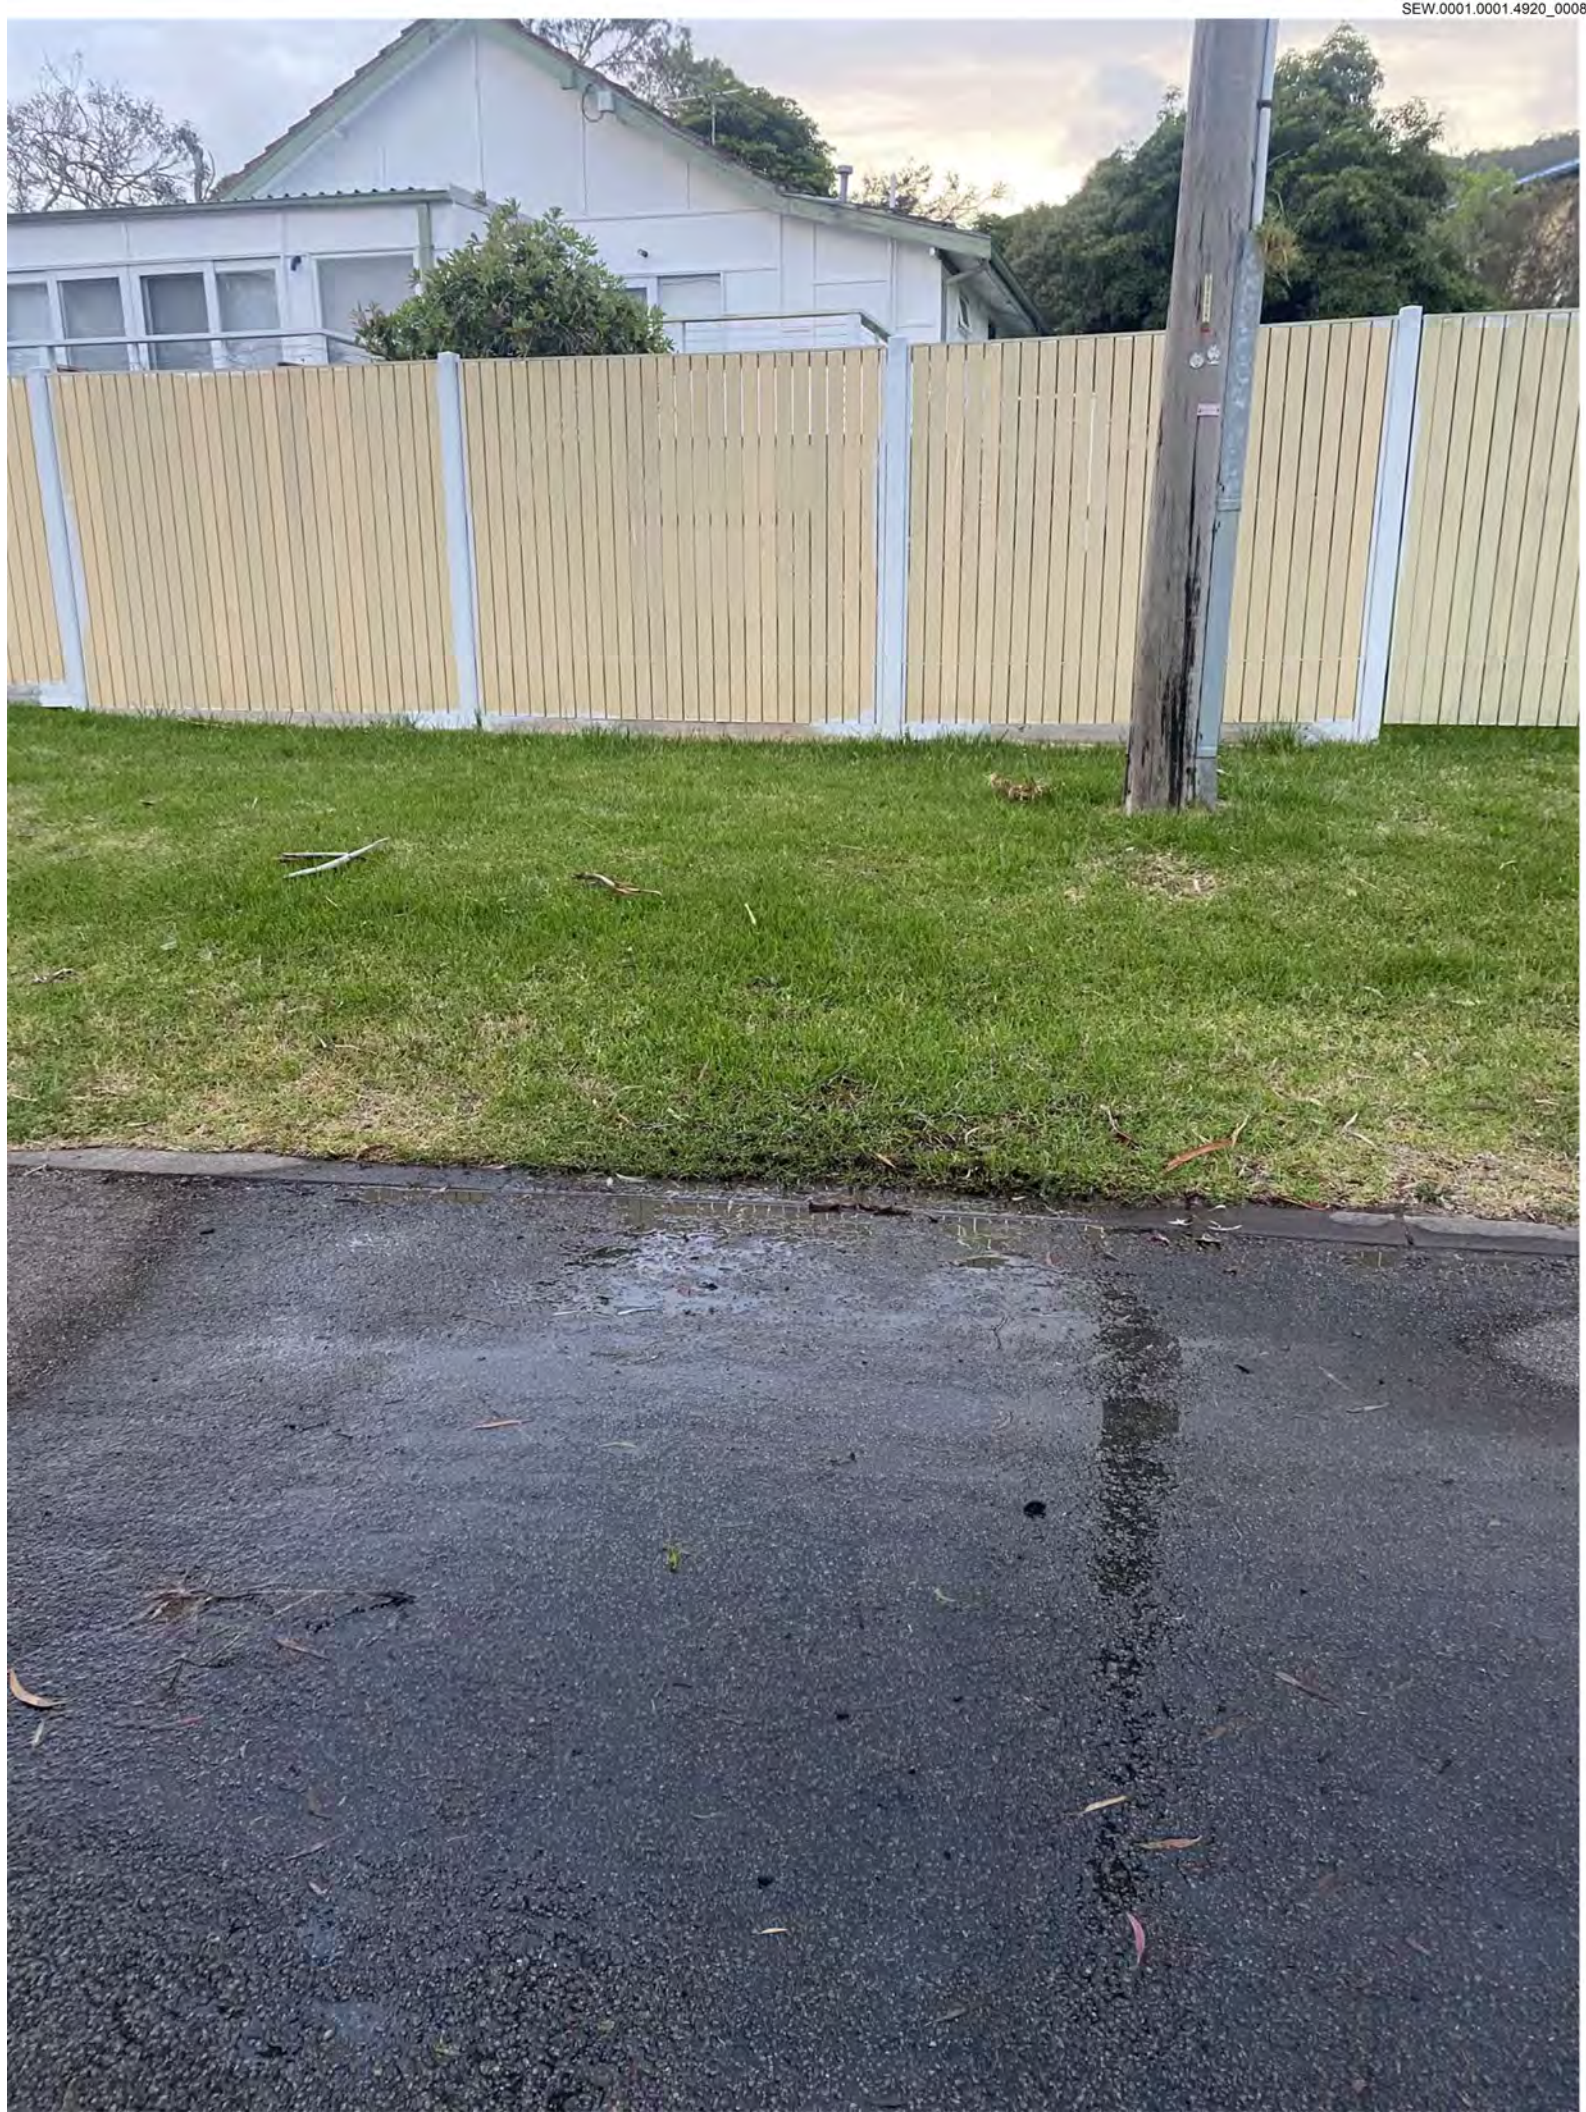
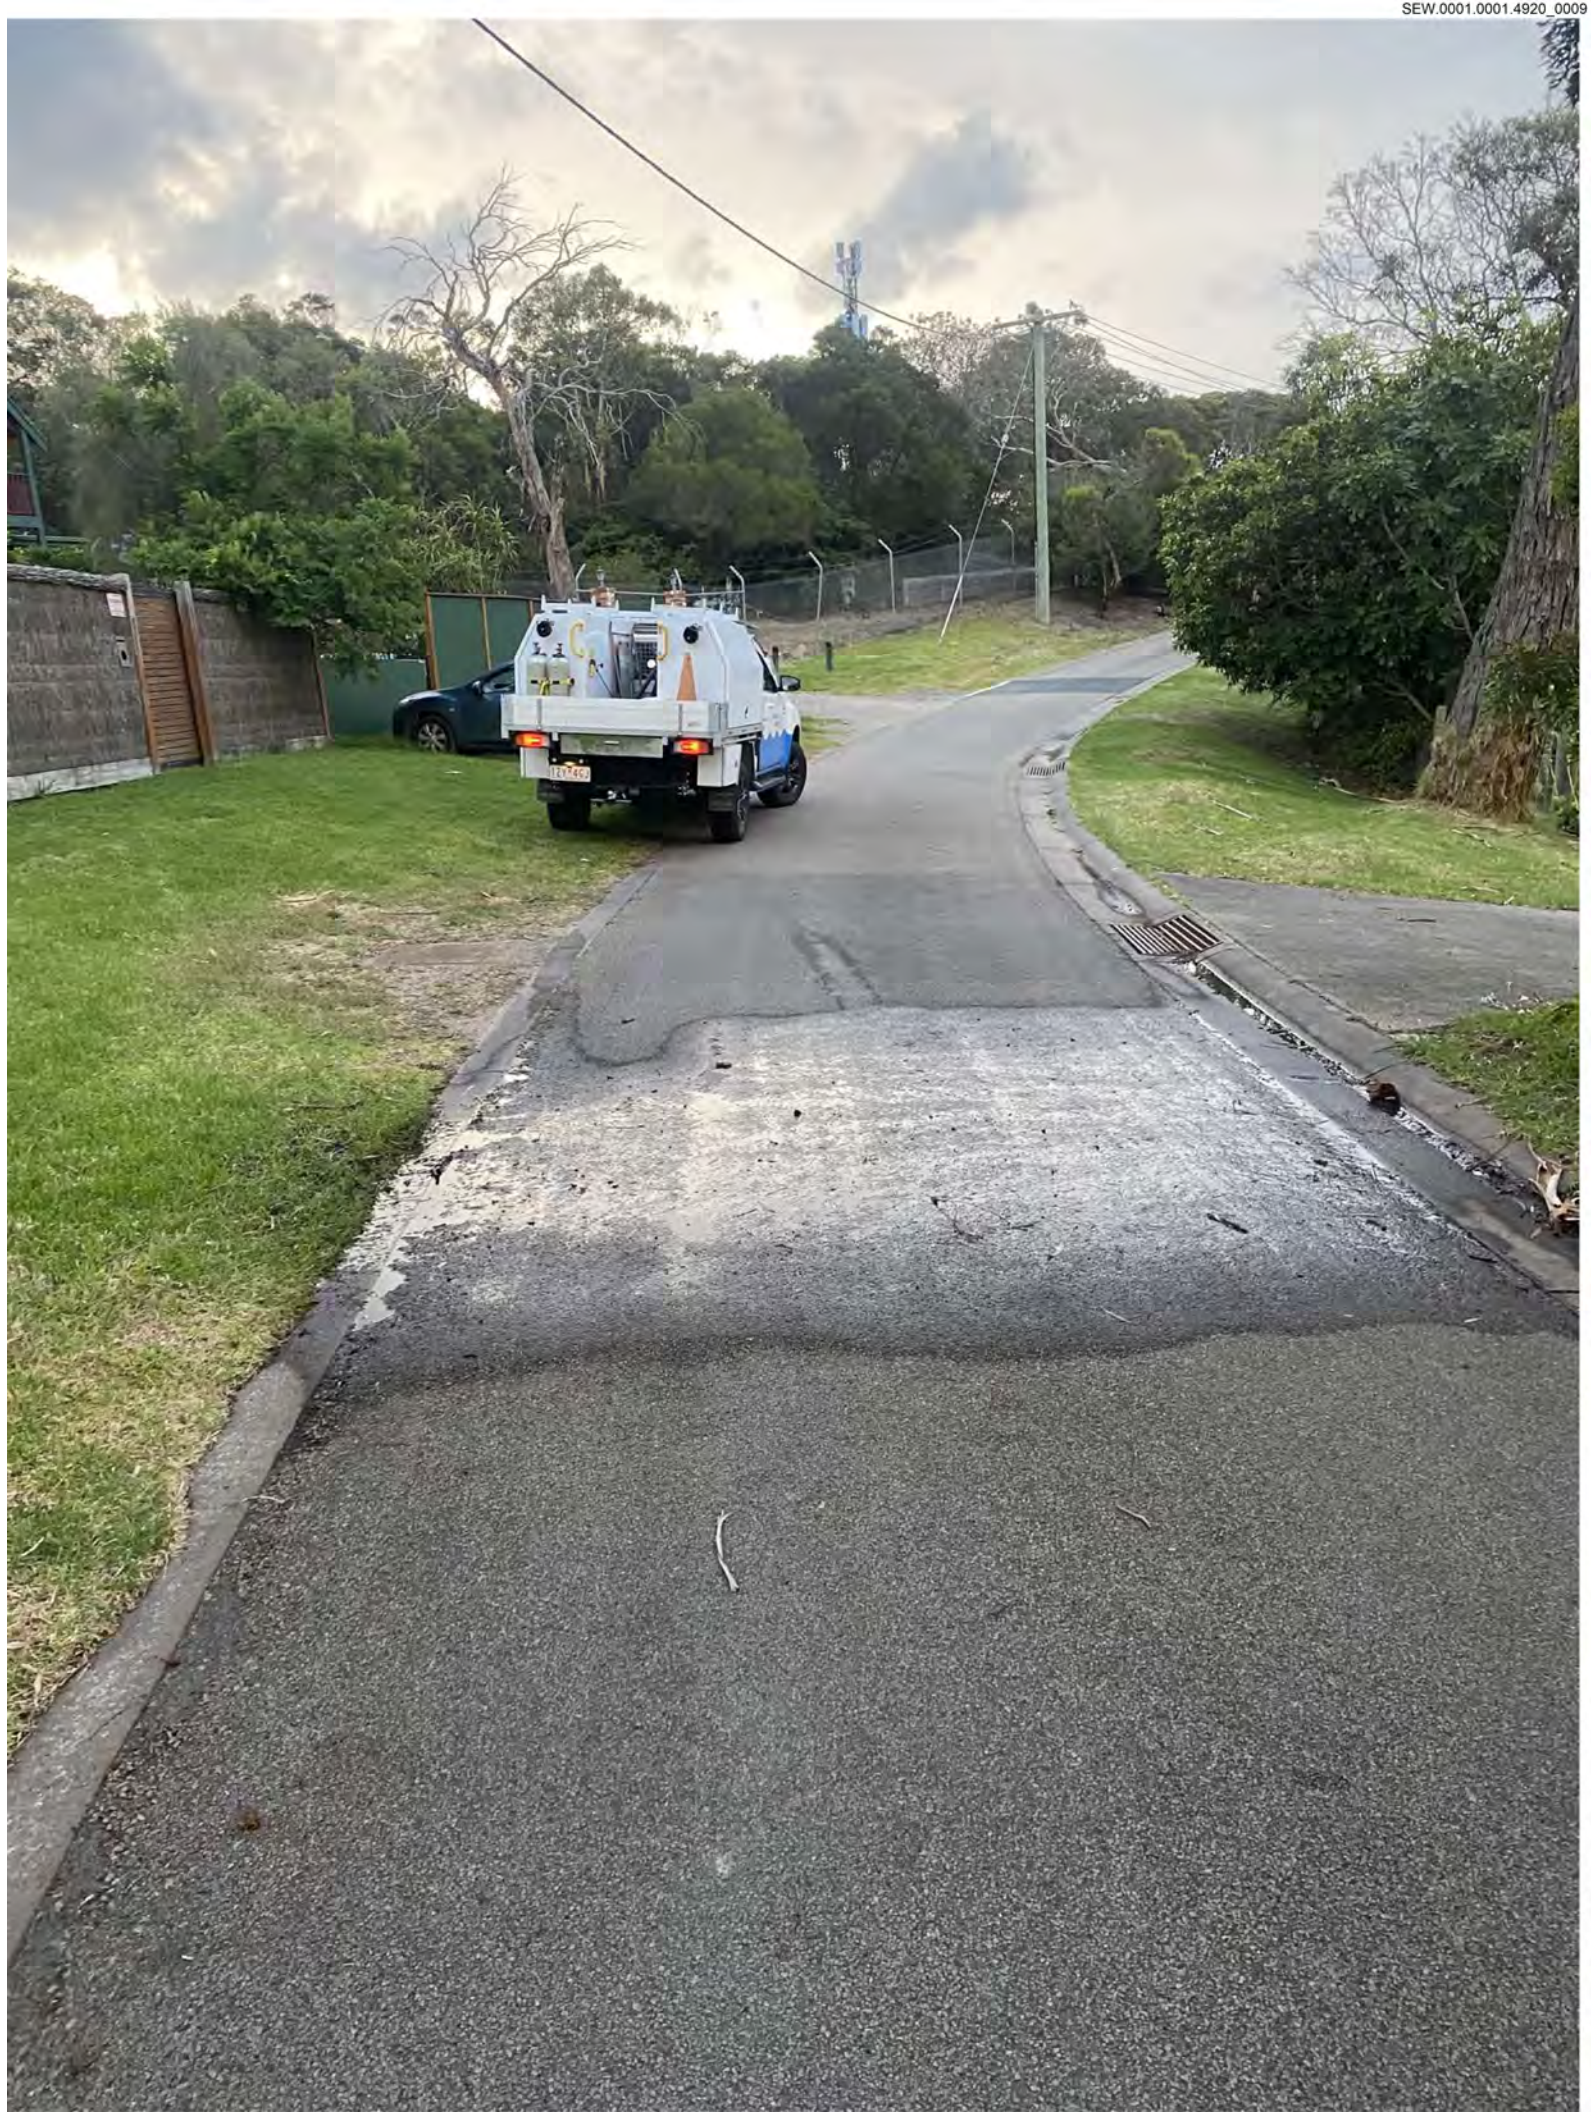
**Task Story:**[Exall,Kirsty] [16/12/2024 13:45] [AWARDED] Property Number:02E//00478/4 [Ludewig,Ralph] [16/12/2024 13:48] [AWARDED] Checked [FT] [SSf0213] [17/12/2024 06:35] [ON SITE] on site water seeping from nature main on other side of rdway sounded all long and short side services sounded nearby valves and fireplug no noise gained access to no1 water siiting in nfrount yard tested at 225 meter not turning raining on site no indication of sew asset leak storm water [Copeland,Bryce] [17/12/2024 18:25] [DATA COMPLETE] Margret Campbell [PI] from 4 Waller PI, called with another report for this one. advised we have already attended and there doesn't seem to be any leaks from the main or nearby. She reports water bubbling up from the ground around #1 on the corner of Charlesworth St, will adv. dispatch and see if there is anything else we can do.

**Caller Details:**sss**Request Details:**sss adved water is leaking on the nature strip and trickling into the gutter case 08515345**Action Taken :**Water Network - Water Main - Inspection**Task CCT:**Water Network - Water Main - Repair of leak in nature strip**Failure Details:**0 Not Our Asset - Not Our Asset - Not Our Asset**Task Priority:**5 17/12/2024 13:45**Is Chargeable:**No**Is Pending:**No**Is Cancelled:**No**Is Component Type:**No**PO Department:**Water Maintenance**PO Supervisor:****Contractor:**ServiceStream**Created By:**Exall, Kirsty**Department:**ServiceStream Water**Supervisor:**Corrin,Jason**Allocatee:****Task Status:**CLOSED**Asset List**

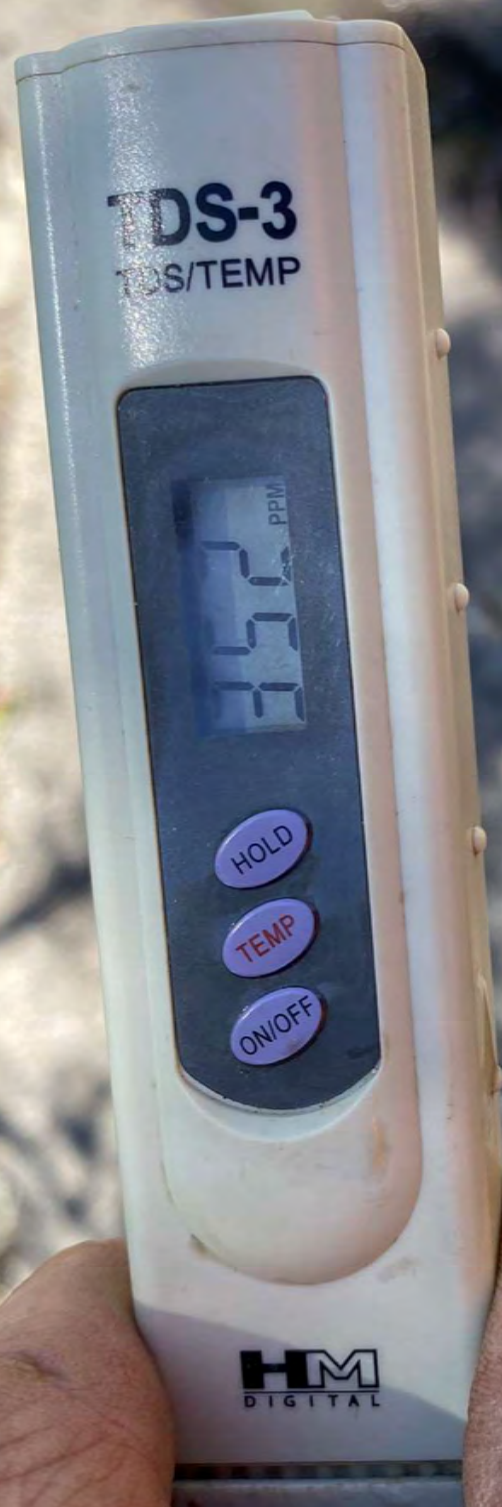
**Task Story:**[Springs,Michelle] [17/12/2024 19:43] [AWARDED] Checked [FT] [SSf0213] [19/12/2024 14:02] [ON SITE] on site tested water in gutter 352 storm water area is beginning to dry spoke with resident at no 4 she explained she had not complained but stated this has occurred before as with other areas of seepage storm water in area and are used to it no leak as per previous notes [Manning,Kim] [20/12/2024 05:14] [WORK COMPLETE] costed [Aitken,Steve] [20/12/2024 09:22] [WORK COMPLETE] Jenna PI from Fulton Hogan called - advised amount of pressurized water running they think its not storm water they checked all there storm water assets on behalf of council & no storm water issues found. said the road is getting bad & might have to close the road down due to water affecting condition of road. adv dispatch to see if supervisor can look into sending leak detection or what they want to do? fulton hogan can meet SEW crew at site.

**Request Details:**got a call from a neighbour following up on this one, saying she can see water bubbling up from the ground and running into the gutter n/s is very soft and ground is water logged please reattend and assess whether they may be a leak from elsewhere, as customer is adamant that it's more than seepage

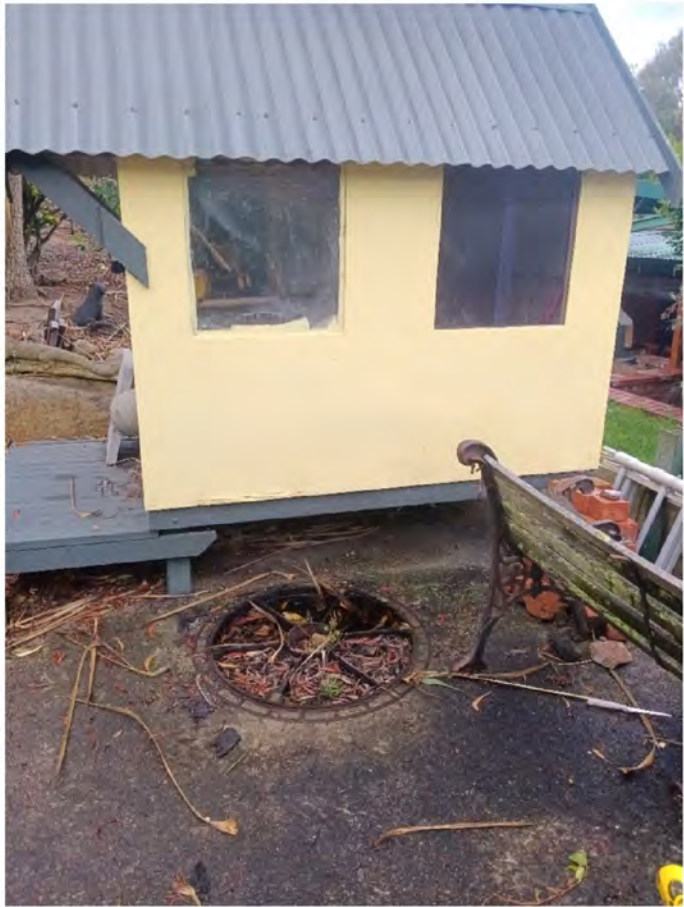
a4c184c5-834f-4d6e-8fcb-cde7b68b94a0

Sounded all assets in the area, followed suspect 300mm main and no leaks were detected. Chlorine sample needs to be taken when rain stops.

We also surveyed Bayview Rd above the Highway with no leak noises detected.

I don't believe there's any leaks on the mains but still some of the smaller pipes really haven't checked out. Jason Marsh will return take samples when it's not raining for a few days.
