**Task Number:**1337352/001**Task Address:**27 COBURN AVENUE, MCCRAE VIC 3938**Program Name:**ServiceStream - FY2425 - CCTV Retic 3 (Apr25)**Task Work Type:**Scheduled Maintenance - CCTV Inspection**Source Of Work:****Facility:****Permit Not Required:**No**Permit Pre Approved:**No**Permit Reason:**Other**Permit Other Reason:**

**Request Details:**Clean + CCTV Inspection Program McCrae Package: 1. All lines to be cleaned PRIOR to CCTV Inspection 2. CCTV Inspection using WSA 05 2020 Codes 3. Any manhole alterations required to complete works, action request to be raised and Sewer Maintenance Technician to be contacted SI's to be completed: 1. Sewer Clean 2. Sewer CCTV 3. Sewer Manhole Fault and Inspection

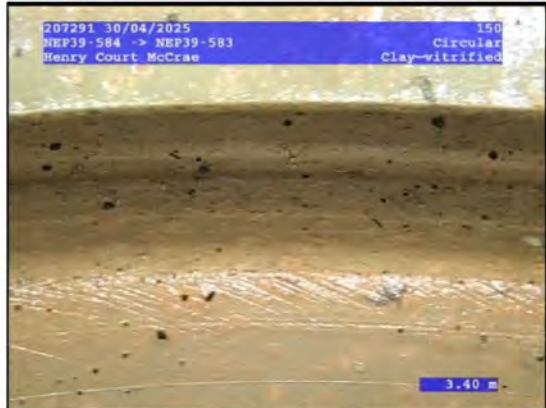
<table><tr> <th>1:561</th> <th>m+</th> <th>Code</th> <th>Observation Text</th> <th>MPEG</th> <th>Photo</th> <th>Grade</th> </tr><tr> <td></td> <td>3.41</td> <td>JDL</td> <td>Joint displaced longitudinally, 10mm</td> <td>00:02:15</td> <td>1</td> <td>1</td> </tr></table>

1, 00:02:15, 3.41  
Joint displaced longitudinally, 10mm

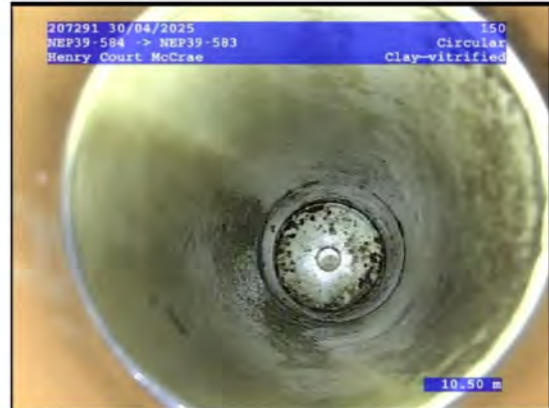
2, 00:05:23, 10.50  
Junction, unlined, open, Height/Diameter (mm): 100 at 12 o'clock

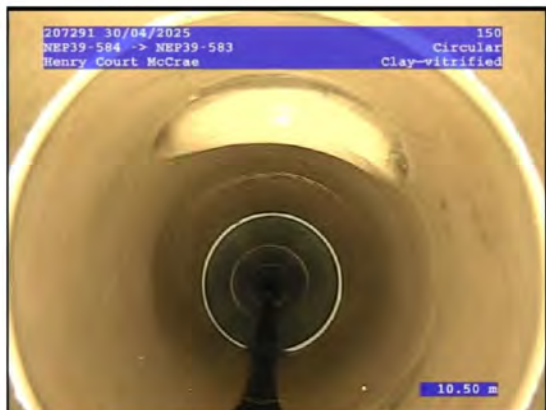
3, 00:05:23, 10.50  
Junction, unlined, open, Height/Diameter (mm): 100 at 12 o'clock

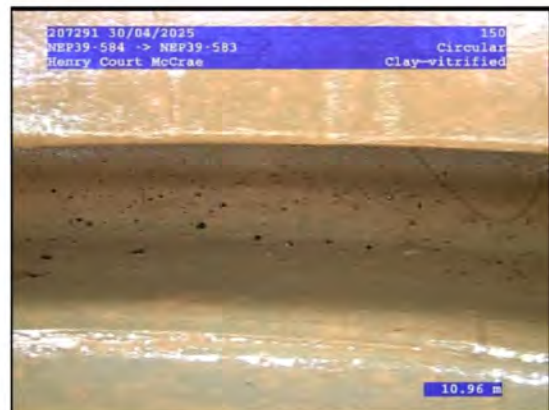
<table><tr> <th>1:561</th> <th>m+</th> <th>Code</th> <th>Observation Text</th> <th>MPEG</th> <th>Photo</th> <th>Grade</th> </tr><tr> <td></td> <td>10.96</td> <td>JDL</td> <td>Joint displaced longitudinally, 10mm</td> <td>00:06:09</td> <td>4</td> <td>1</td> </tr></table>

4, 00:06:09, 10.96  
Joint displaced longitudinally, 10mm

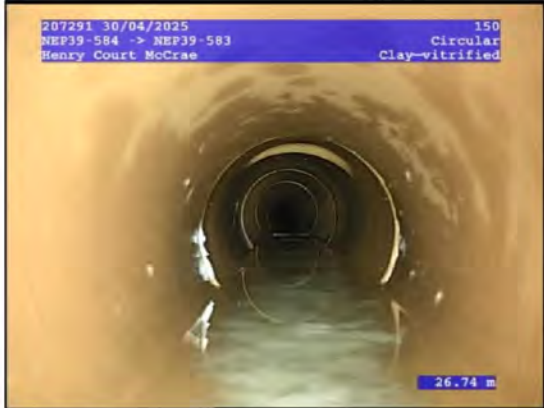
<table><tr> <th>1:561</th> <th>m+</th> <th>Code</th> <th>Observation Text</th> <th>MPEG</th> <th>Photo</th> <th>Grade</th> </tr><tr> <td></td> <td>26.74</td> <td>WLPT</td> <td>Ponding of water with or without flow turbid or discoloured water, 10-20 mm</td> <td>00:11:39</td> <td>5</td> <td>1</td> </tr></table>

5, 00:11:39, 26.74  
Ponding of water with or without flow turbid or discoloured water, 10-20 mm

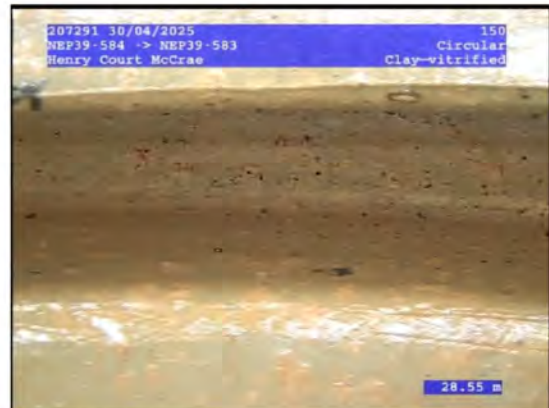
8, 00:13:38, 28.54  
Joint displaced longitudinally, 20mm

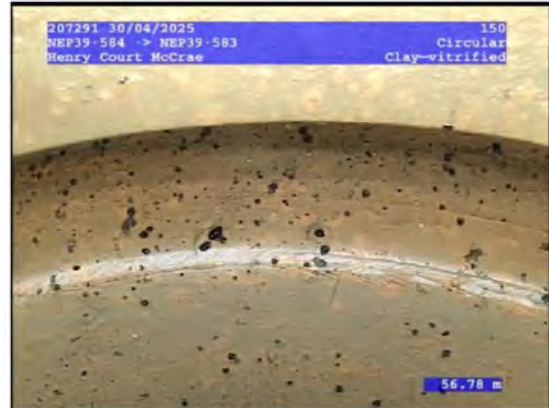
10, 00:25:50, 56.78  
Joint displaced longitudinally, 20mm

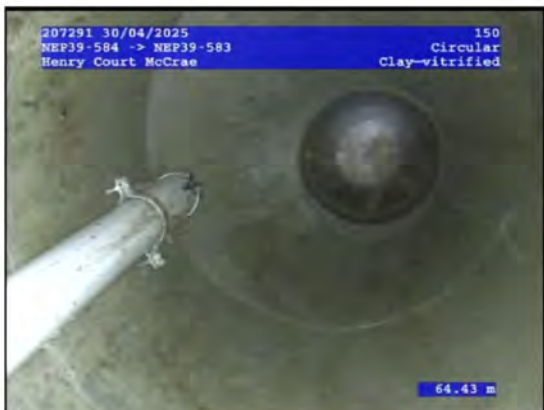
11, 00:30:07, 64.43  
Finish node, maintenance hole, Nodename:, NEP39-583

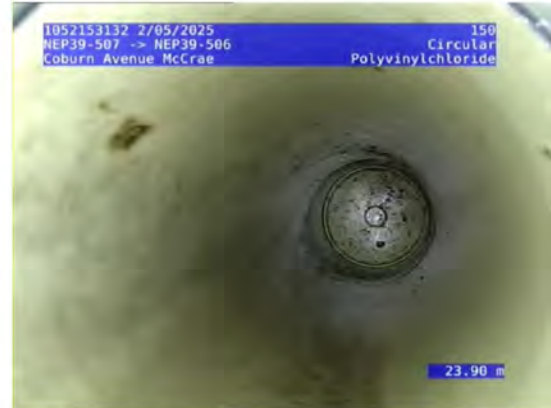
2, 00:05:29, 23.90  
Junction, unlined, open, Height/Diameter (mm): 100 at 12 o'clock

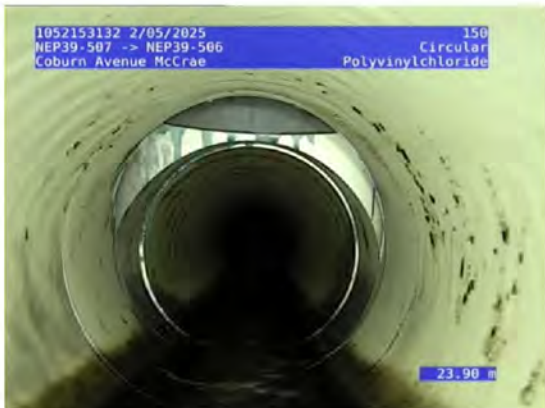
3, 00:05:29, 23.90  
Junction, unlined, open, Height/Diameter (mm): 100 at 12 o'clock

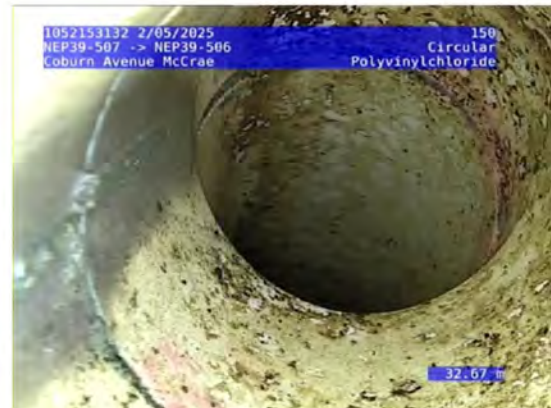
4, 00:08:17, 32.67  
Junction, unlined, open, Height/Diameter (mm): 100 at 10 o'clock

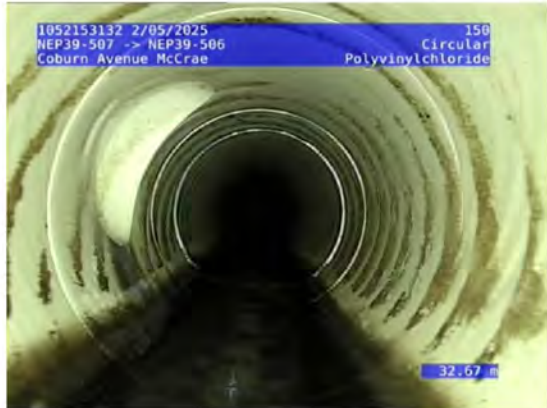
5, 00:08:17, 32.67  
Junction, unlined, open, Height/Diameter (mm): 100 at 10 o'clock

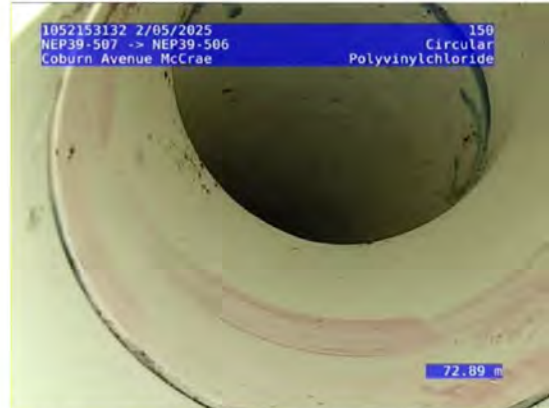
6, 00:16:36, 72.89  
Junction, unlined, open, Height/Diameter (mm): 100 at 10 o'clock

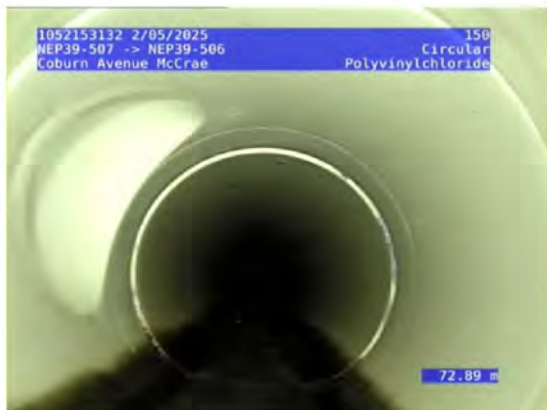
7, 00:16:36, 72.89  
Junction, unlined, open, Height/Diameter (mm): 100 at 10 o'clock

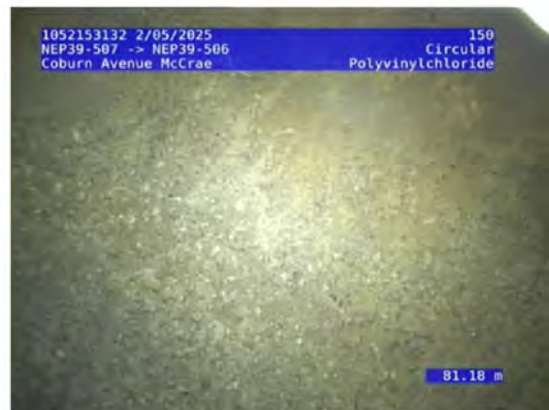
8, 00:19:40, 81.18  
Finish node, maintenance hole, Nodename:, NEP39-506, reference: drop pipe

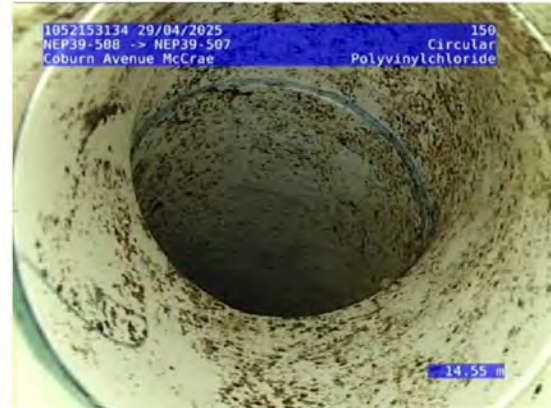
2, 00:03:50, 14.55  
Junction, unlined, open, Height/Diameter (mm): 100 at 10 o'clock

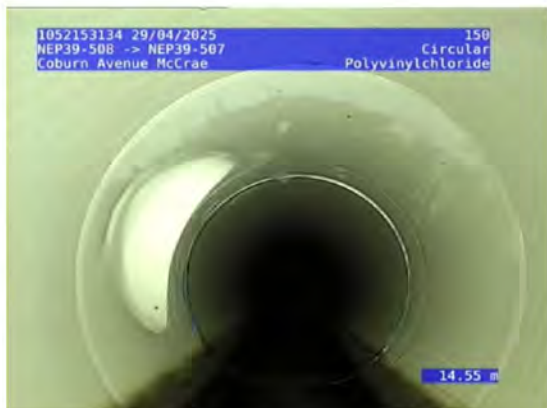
3, 00:03:50, 14.55  
Junction, unlined, open, Height/Diameter (mm): 100 at 10 o'clock

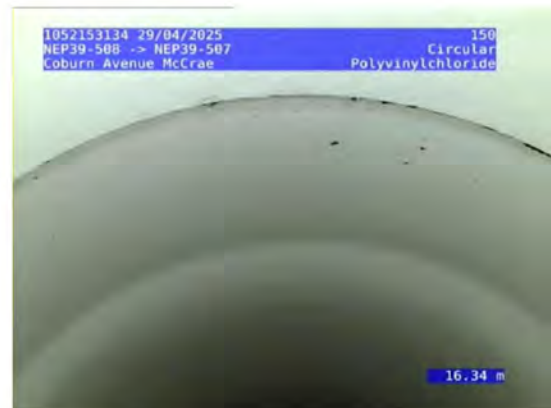
4, 00:05:02, 16.34  
Joint displaced longitudinally, 40mm

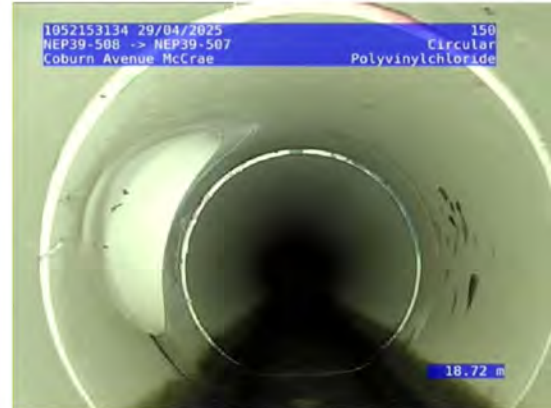
6, 00:05:33, 18.72  
Junction, unlined, open, Height/Diameter (mm): 100 at 10 o'clock

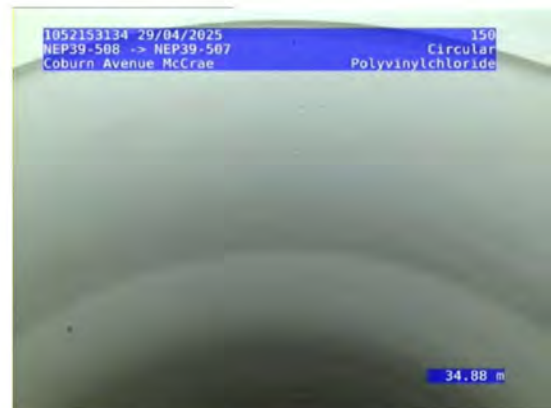
8, 00:09:50, 34.88  
Joint displaced longitudinally, 50mm

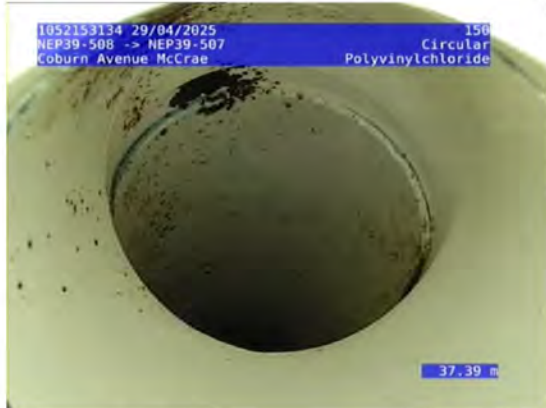
9, 00:10:26, 37.39  
Junction, unlined, open, Height/Diameter (mm): 100 at 10 o'clock

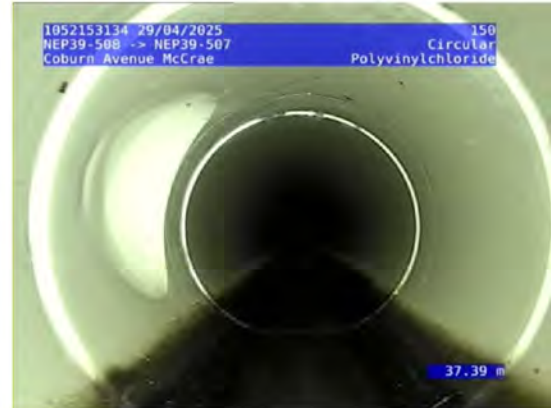
10, 00:10:26, 37.39  
Junction, unlined, open, Height/Diameter (mm): 100 at 10 o'clock

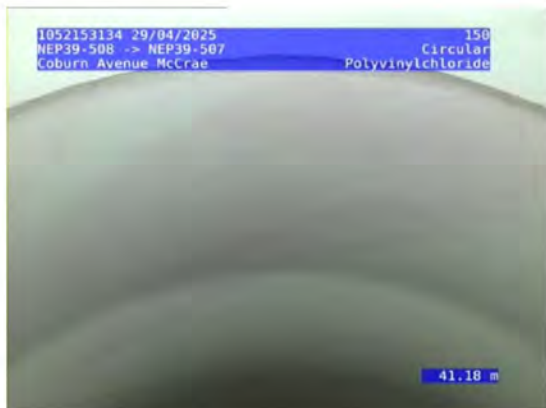
11, 00:12:08, 41.18  
Joint displaced longitudinally, 50mm

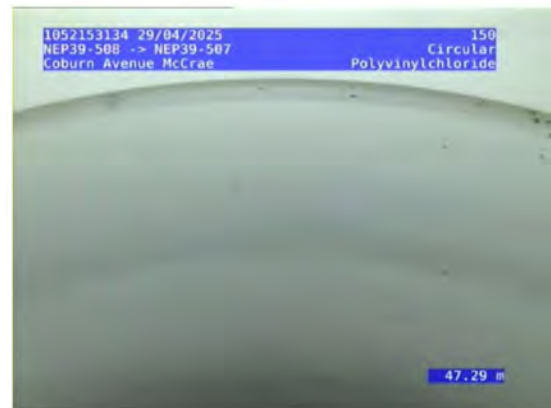
12, 00:13:18, 47.29  
Joint displaced longitudinally, 40mm

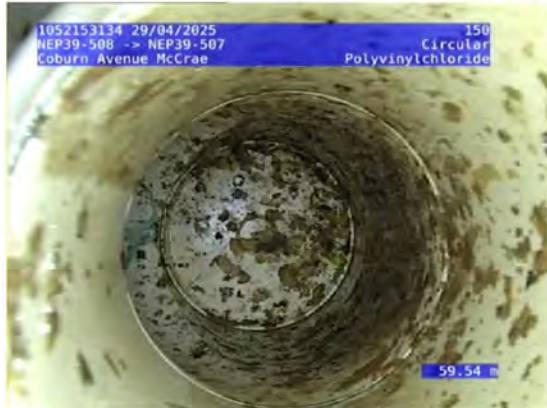
13, 00:15:36, 59.54  
Junction, unlined, open, Height/Diameter (mm): 100 at 12 o'clock / 150 junction into 100 connection

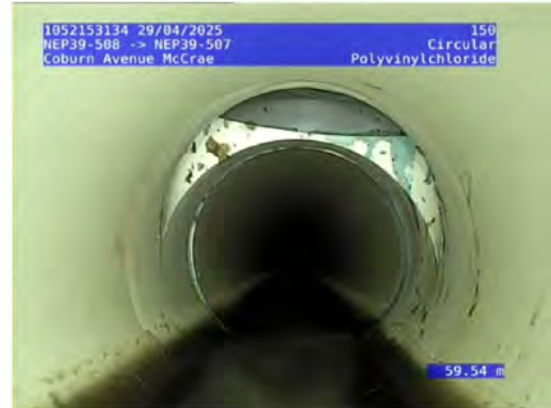
14, 00:15:36, 59.54  
Junction, unlined, open, Height/Diameter (mm): 100 at 12 o'clock / 150 junction into 100 connection

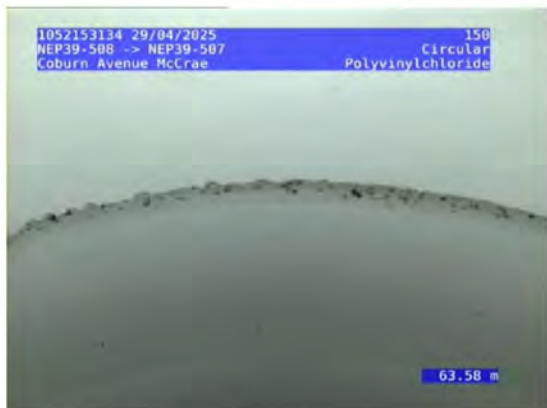
15, 00:16:48, 63.58  
Joint displaced longitudinally, 30mm

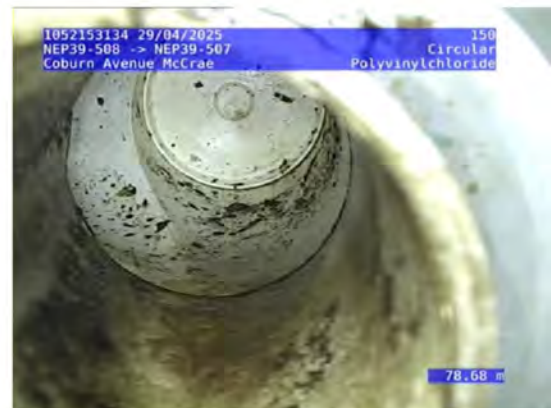
16, 00:19:28, 78.68  
Junction, unlined, open, Height/Diameter (mm): 100 at 12 o'clock / 150 junction with 100mm connection

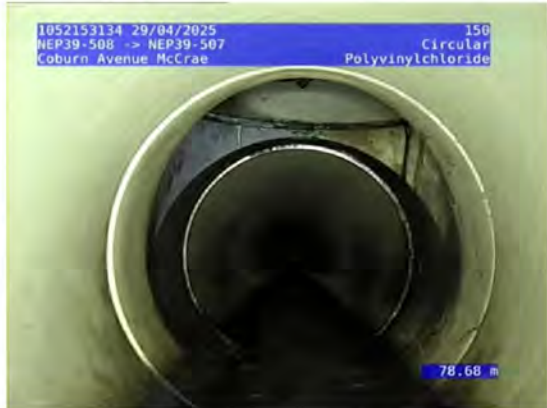
17, 00:19:28, 78.68  
Junction, unlined, open, Height/Diameter (mm): 100 at 12 o'clock / 150 junction with 100mm connection

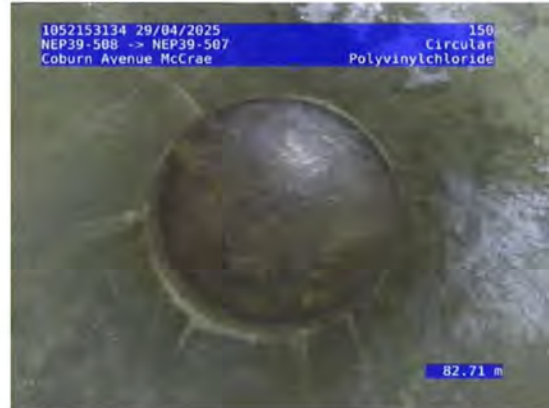
18, 00:21:24, 82.72  
Finish node, maintenance hole, Nodename:, NEP39-507

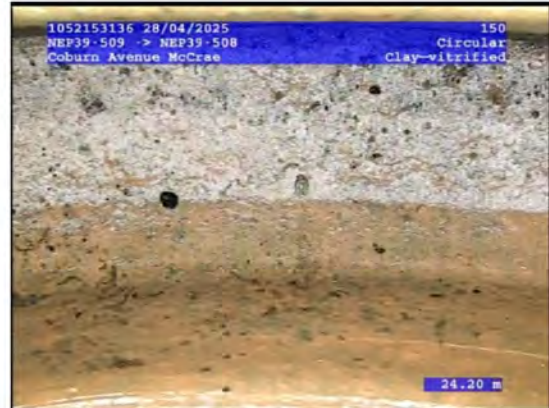
2, 00:08:03, 24.20  
Joint displaced longitudinally, 40mm

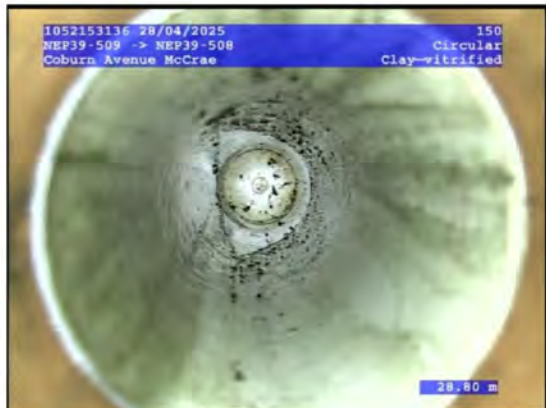
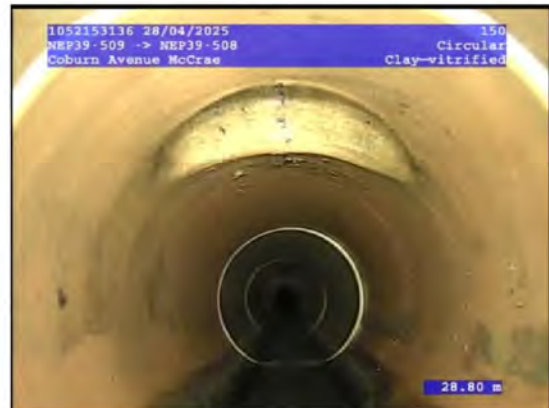
3, 00:09:45, 28.80  
Junction, unlined, open, Height/Diameter (mm): 100 at 12 o'clock

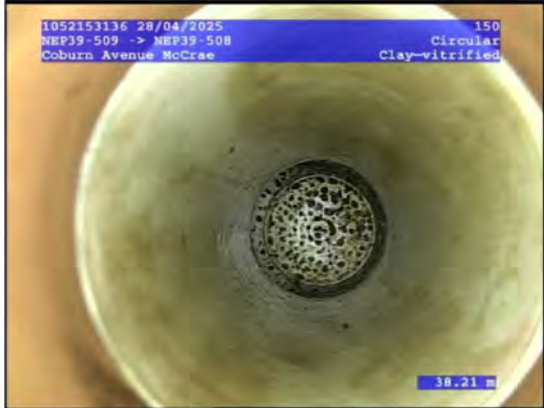
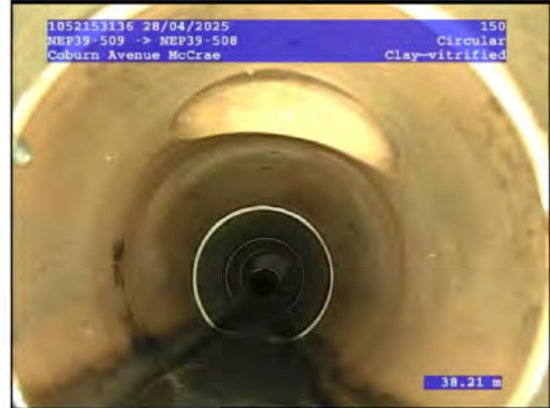
5, 00:13:48, 38.21  
Junction, unlined, open, Height/Diameter (mm): 100 at 12 o'clock

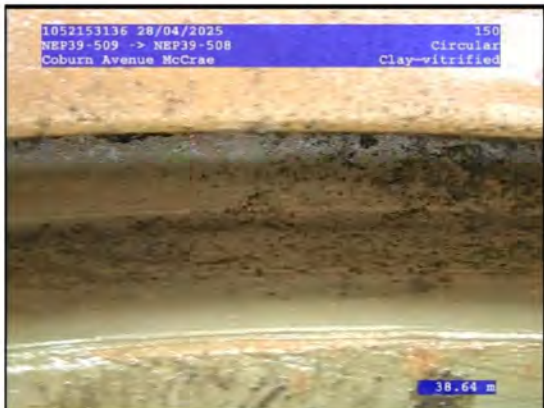
7, 00:14:35, 38.64  
Joint displaced longitudinally, 10mm

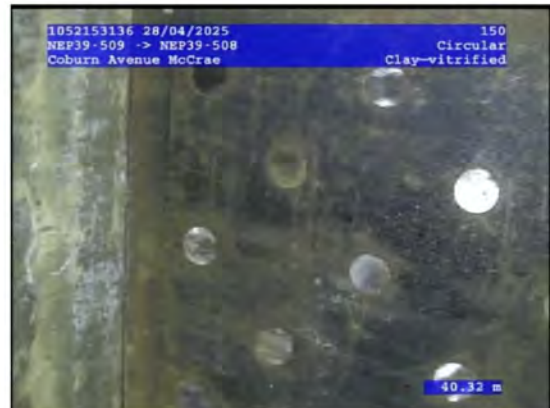
8, 00:15:53, 40.32  
Finish node, maintenance hole, Nodename:, NEP39-508

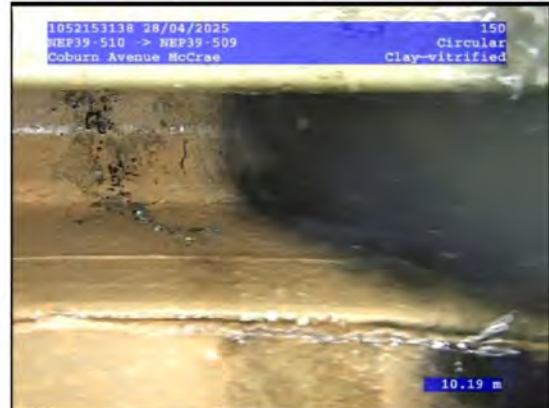
2, 00:04:32, 10.19  
Joint displaced longitudinally, 10mm

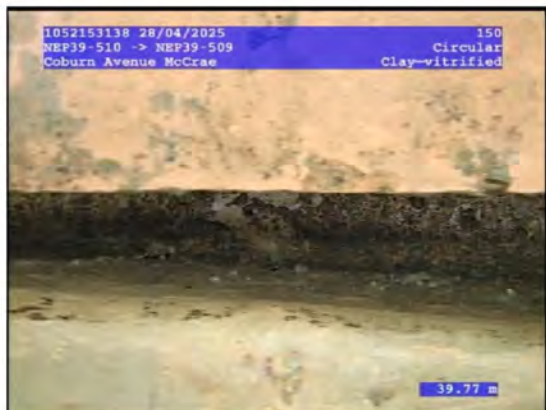
3, 00:13:07, 39.77  
Joint displaced angular at 12 o'clock

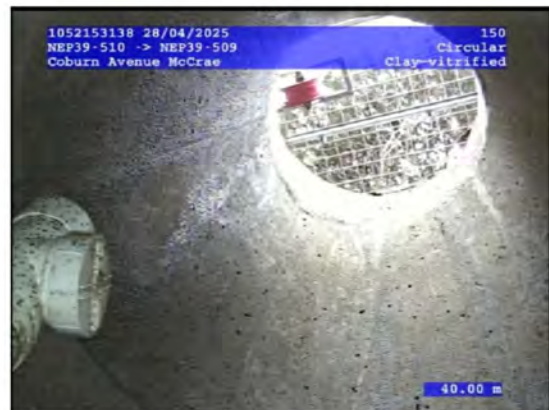
4, 00:13:39, 40.00  
Finish node, maintenance hole, Nodename:, NEP39-509

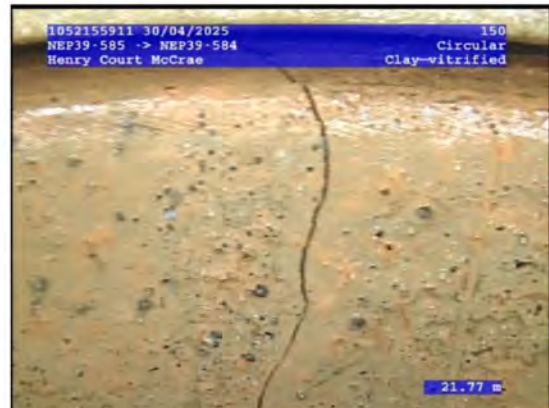
<table><tr> <th>1:349</th> <th>m+</th> <th>Code</th> <th>Observation Text</th> <th>MPEG</th> <th>Photo</th> <th>Grade</th> </tr><tr> <td></td> <td>21.77</td> <td>CL</td> <td>Longitudinal cracking, at joint, width: 1mm at 8 o'clock</td> <td>00:09:43</td> <td>4</td> <td>1</td> </tr></table>

4, 00:09:43, 21.77  
Longitudinal cracking, at joint, width: 1mm at 8 o'clock

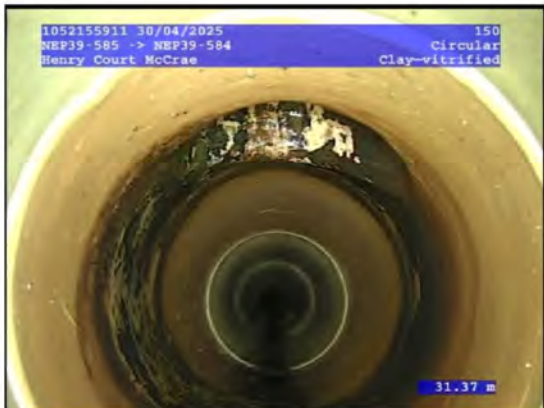
14, 00:15:38, 31.37  
Junction, unlined, open, Height/Diameter (mm): 100 at 12 o'clock

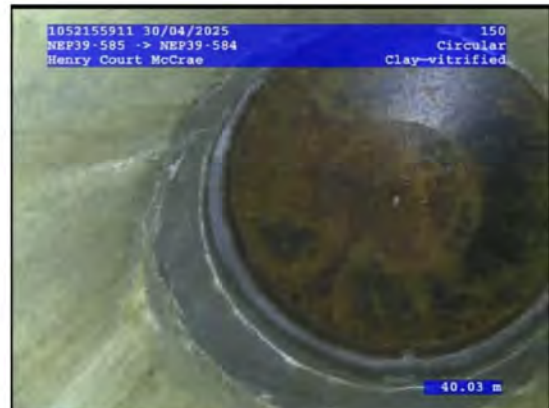
16, 00:19:47, 40.03  
Finish node, maintenance hole, Nodename: NEP39-584

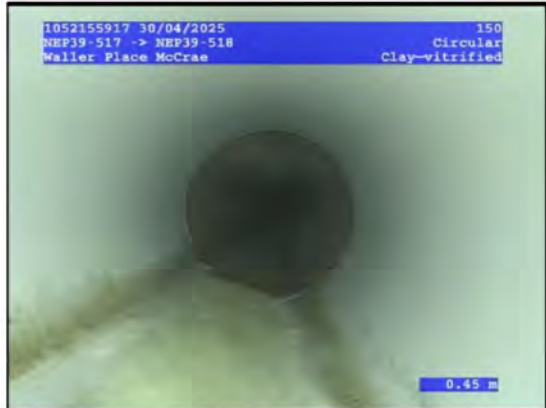
1, 00:00:25, 0.45  
Water flow at constant depth, turbid or discoloured water, <5% / Pulsating

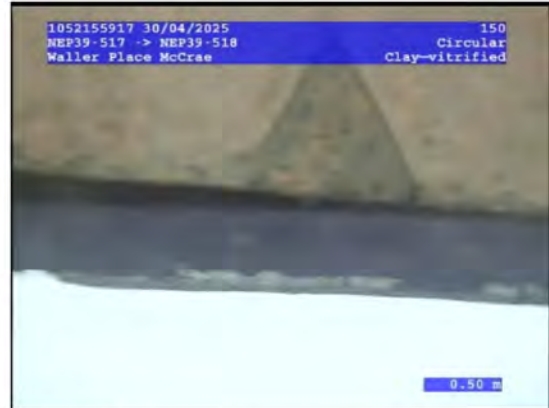
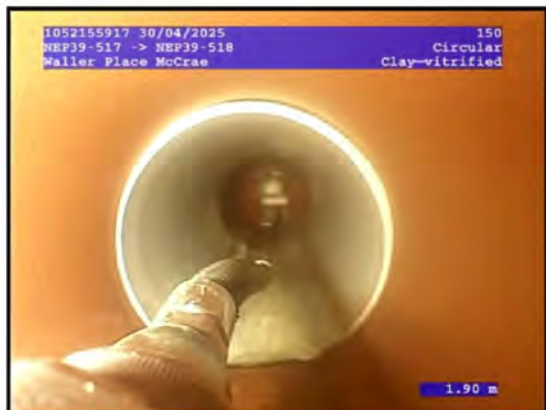
2, 00:01:13, 0.50  
Change of conduit material. New material, Polyvinyl chloride, at joint

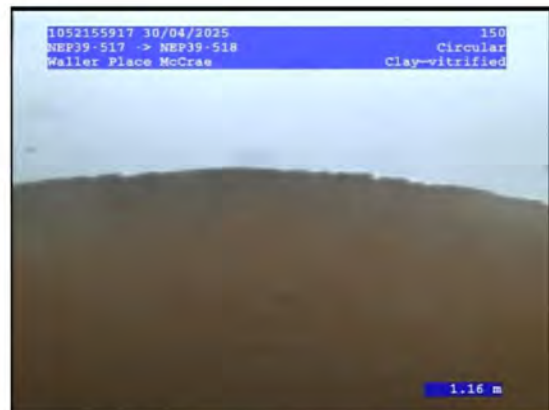
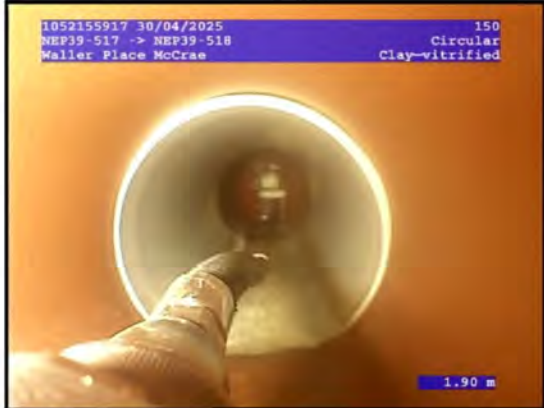
4, 00:01:53, 1.16  
Change of conduit material. New material, Vitrified clay, at joint

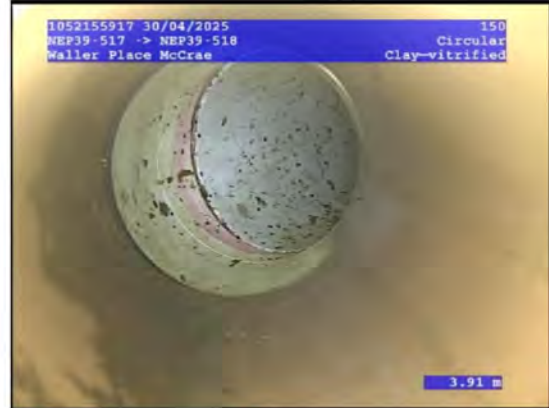
6, 00:03:03, 3.91  
Connection, unlined, connection appears to be open,  
Height/Diameter (mm): 100 at 2 o'clock

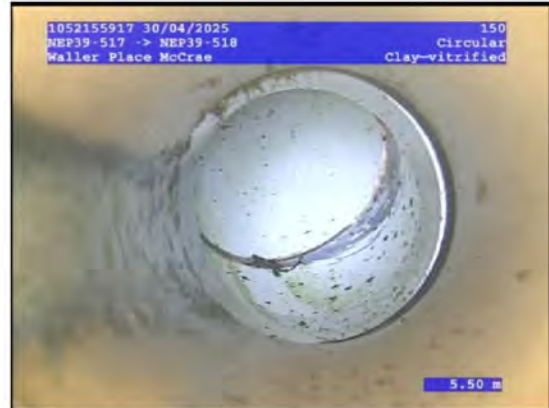
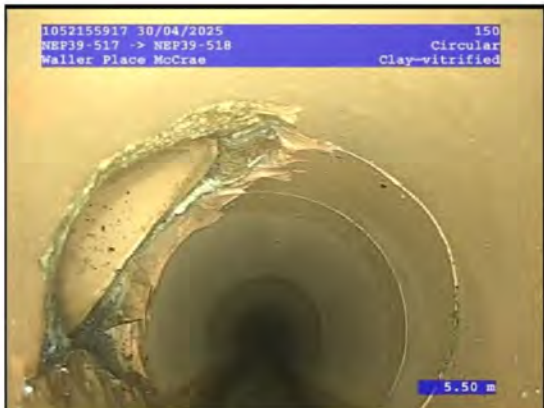
10, 00:04:32, 5.50  
Connection, unlined, connection appears to be open, Height/Diameter (mm): 100 at 10 o'clock

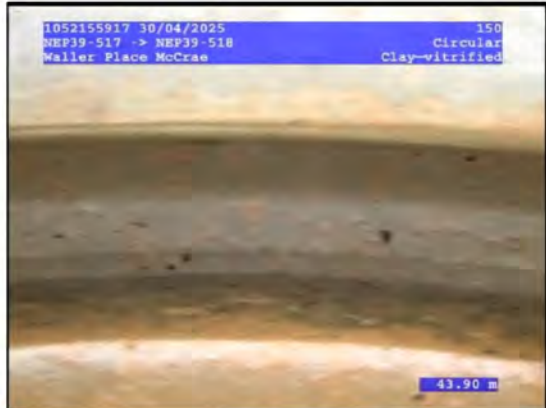
13, 00:17:28, 43.90  
Joint displaced longitudinally, 20mm

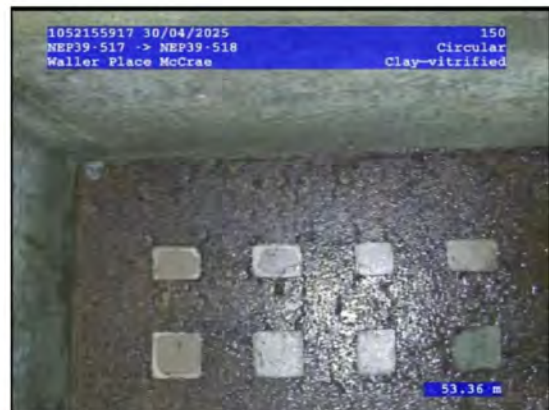
16, 00:21:20, 53.36  
Finish node, maintenance hole, Nodename: NEP39-518

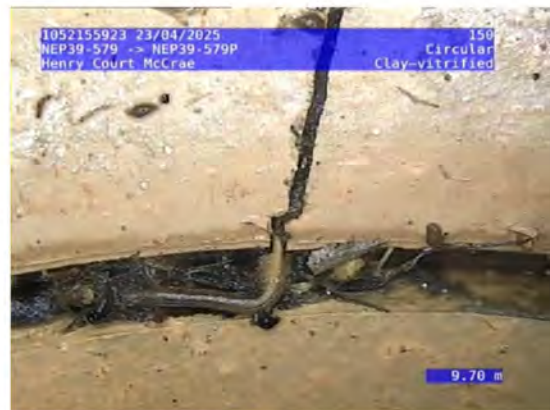
4, 00:05:32, 9.70  
Recently cut interwoven mass of mostly fine roots leaving a beard of roots, Obstruction: 10%, at joint from 3 o'clock to 9 o'clock

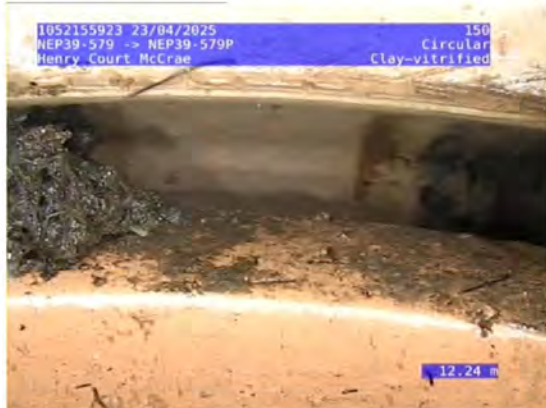
5, 00:06:23, 12.24  
Joint displaced longitudinally, 20mm

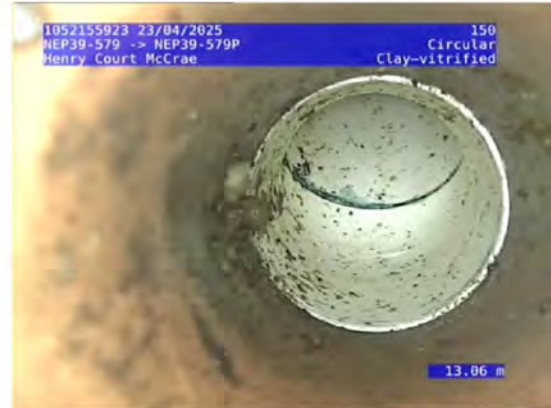
6, 00:06:53, 13.06  
Junction, unlined, open, Height/Diameter (mm): 100 at 9 o'clock

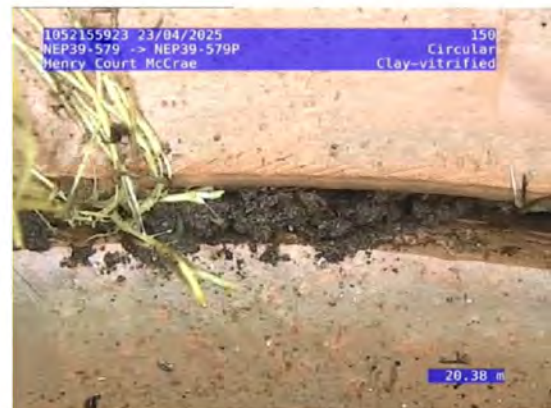
8, 00:09:19, 20.38  
Recently cut interwoven mass of mostly fine roots leaving a beard of roots, at joint from 12 o'clock to 12 o'clock

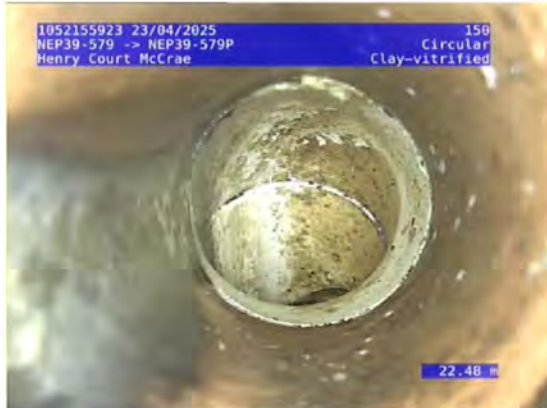
9, 00:10:32, 22.48  
Junction, unlined, open, Height/Diameter (mm): 100 at 10 o'clock

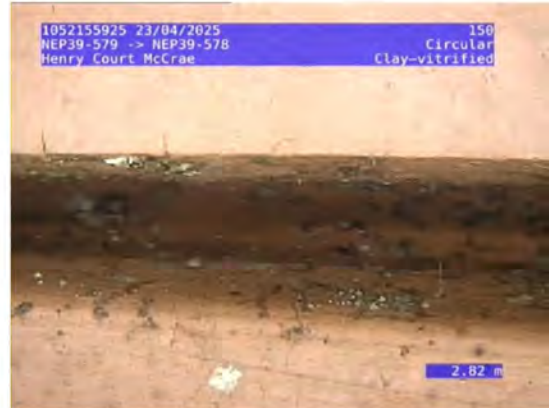
<table><tr> <th>1:50</th> <th>m+</th> <th>Code</th> <th>Observation Text</th> <th>MPEG</th> <th>Photo</th> <th>Grade</th> </tr><tr> <td></td> <td>2.82</td> <td>JDA</td> <td>Joint displaced angular at 3 o'clock</td> <td>00:01:53</td> <td>2</td> <td></td> </tr></table>

2, 00:01:53, 2.82  
Joint displaced angular at 3 o'clock

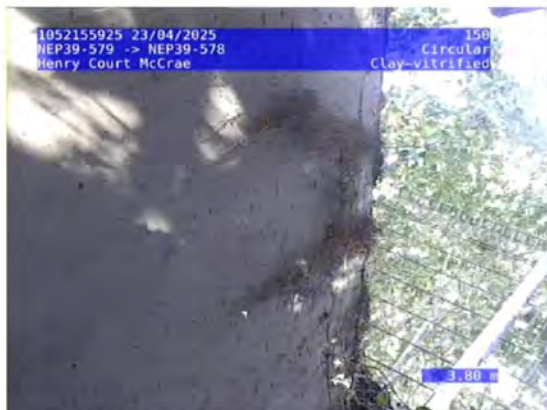
3, 00:03:02, 3.80  
Finish node, maintenance hole, Nodename:, NEP39-578

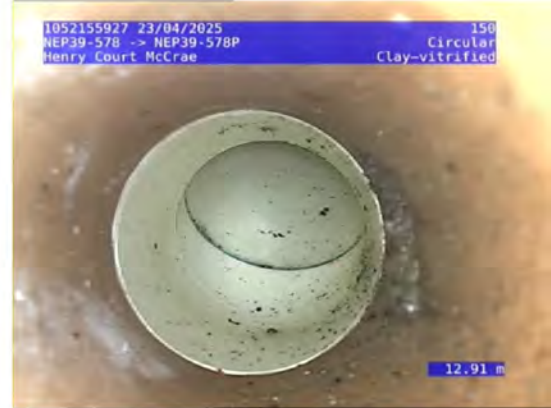
2, 00:04:59, 12.91  
Junction, unlined, open, Height/Diameter (mm): 100 at 2 o'clock

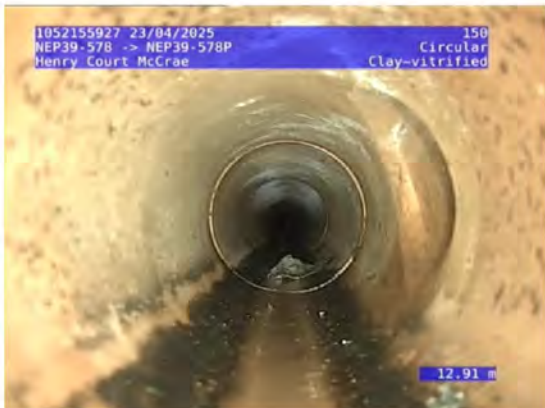
3, 00:04:59, 12.91  
Junction, unlined, open, Height/Diameter (mm): 100 at 2 o'clock

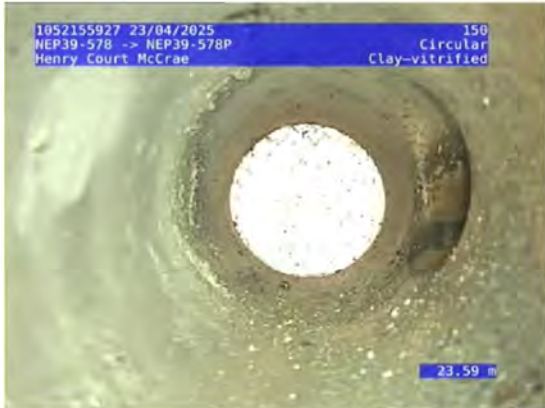
5, 00:08:21, 23.59  
Junction, unlined, open, Height/Diameter (mm): 100 at 2 o'clock

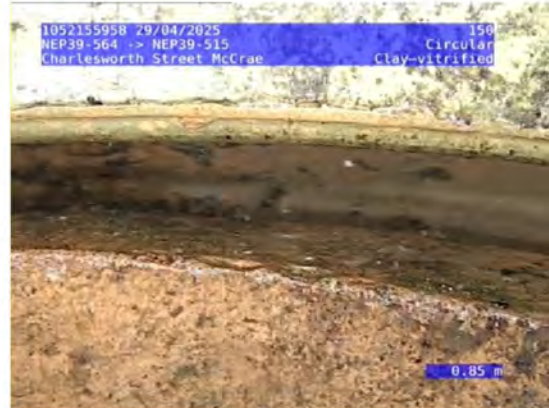
2, 00:01:13, 0.85  
Joint displaced angular at 3 o'clock

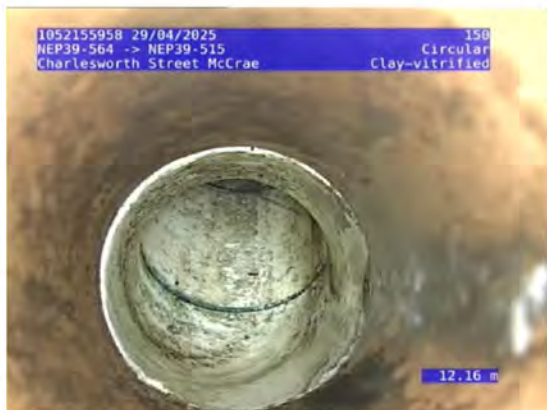
3, 00:04:57, 12.16  
Junction, unlined, open, Height/Diameter (mm): 100 at 2 o'clock

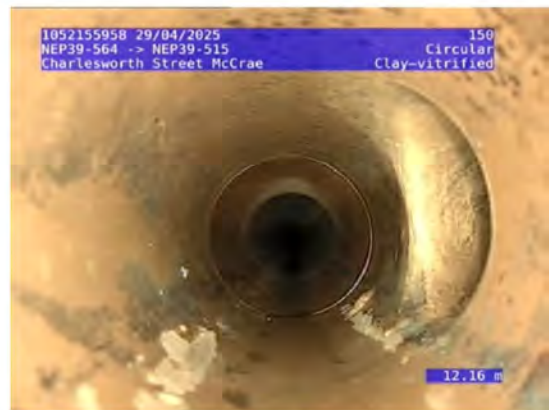
4, 00:04:57, 12.16  
Junction, unlined, open, Height/Diameter (mm): 100 at 2 o'clock

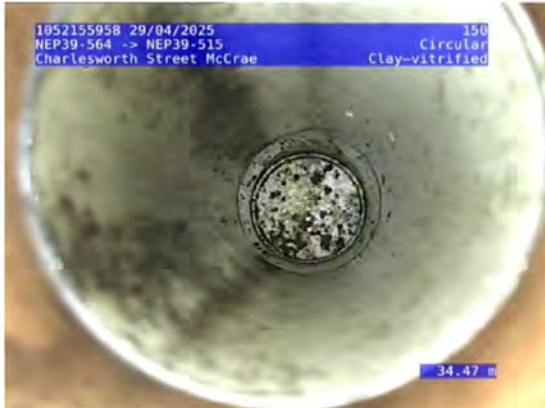
5, 00:12:16, 34.47  
Junction, unlined, open, Height/Diameter (mm): 100 at 12 o'clock

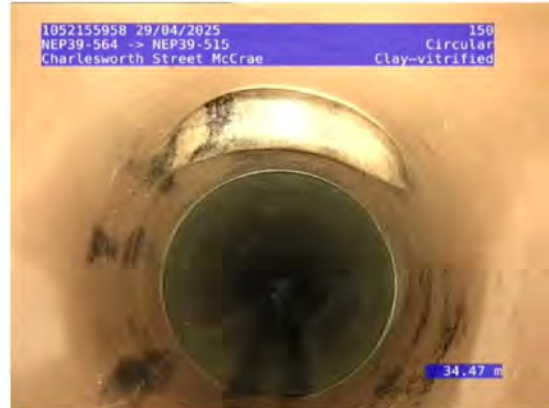
6, 00:12:16, 34.47  
Junction, unlined, open, Height/Diameter (mm): 100 at 12 o'clock

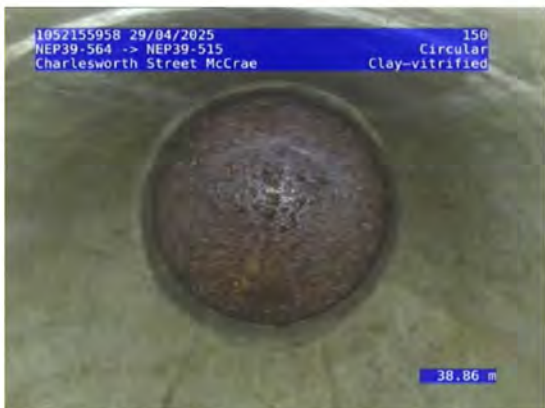
7, 00:14:50, 38.86  
Finish node, maintenance hole, Nodename:, NEP39-515

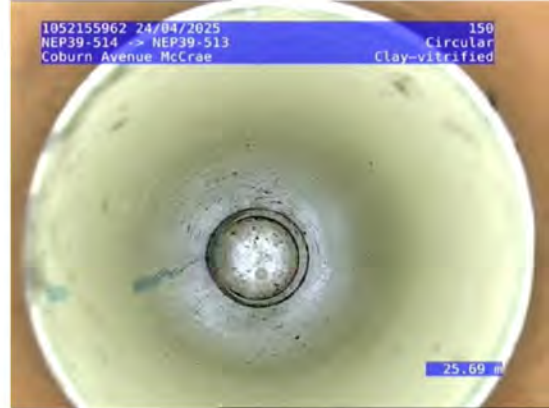
2, 00:08:07, 25.69  
Junction, unlined, open, Height/Diameter (mm): 100 at 12 o'clock

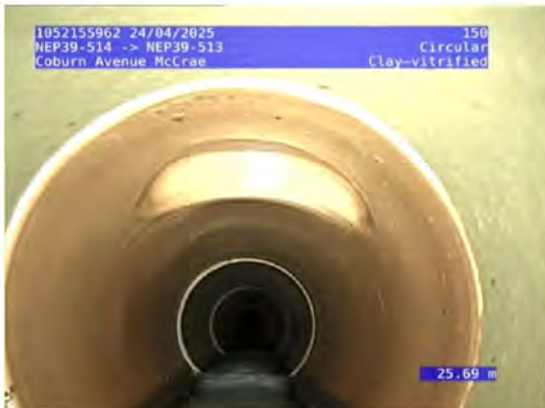
3, 00:08:07, 25.69  
Junction, unlined, open, Height/Diameter (mm): 100 at 12 o'clock

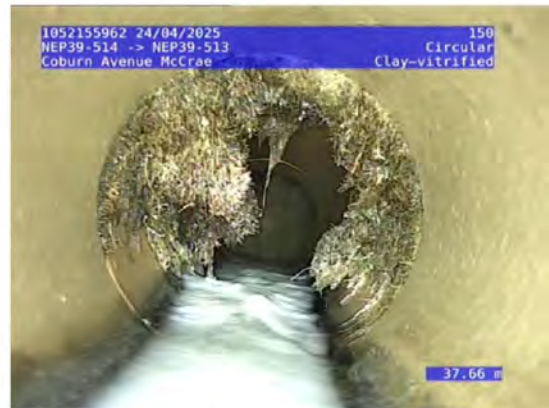
<table><tr> <th>1:336</th> <th>m+</th> <th>Code</th> <th>Observation Text</th> <th>MPEG</th> <th>Photo</th> <th>Grade</th> </tr><tr> <td></td> <td>37.66</td> <td>RRB</td> <td>Recently cut interwoven mass of mostly fine roots leaving a beard of roots, Obstruction: 20%, at joint from 12 o'clock to 12 o'clock</td> <td>00:12:06</td> <td>4</td> <td>1</td> </tr></table>

4, 00:12:06, 37.66  
Recently cut interwoven mass of mostly fine roots leaving a beard of roots, Obstruction: 20%, at joint from 12 o'clock to 12 o'clock

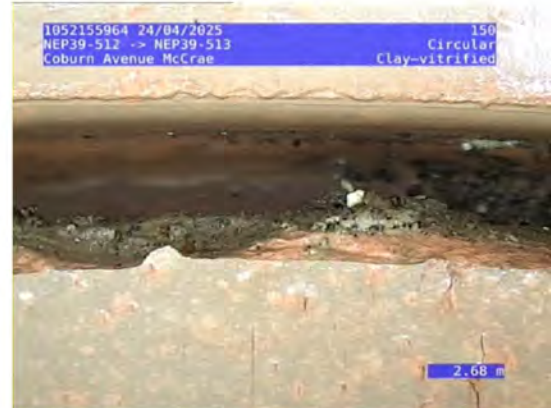
2, 00:01:42, 2.68  
Joint displaced longitudinally, 10mm

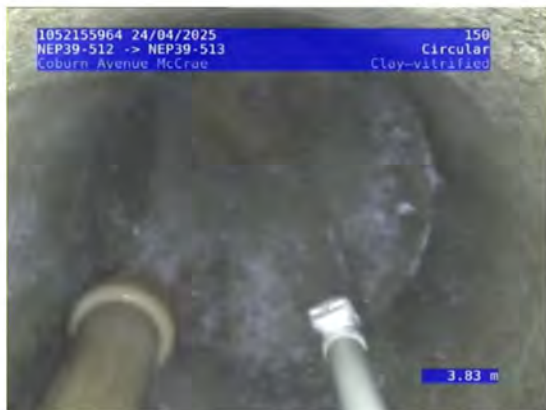
3, 00:02:33, 3.83  
Finish node, maintenance hole, Nodename:, NEP39-513

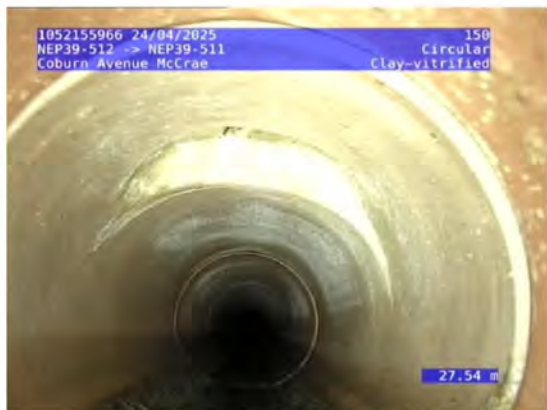
3, 00:09:04, 27.54  
Junction, unlined, open, Height/Diameter (mm): 100 at 12 o'clock

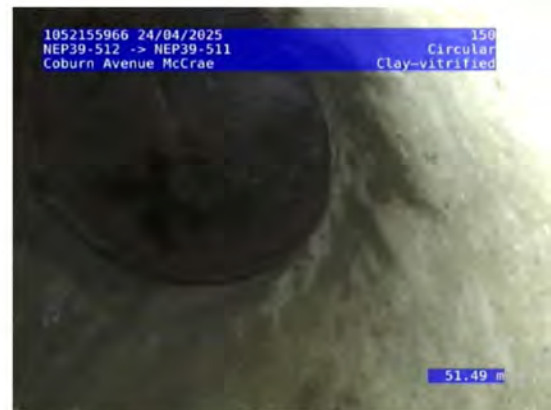
4, 00:16:46, 51.49  
Finish node, maintenance hole, Nodename:, NEP39-511

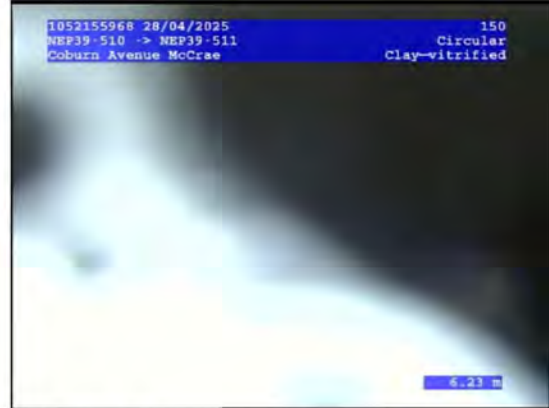
2, 00:03:54, 6.23  
Finish node, maintenance hole, Nodename:, NEP39-511

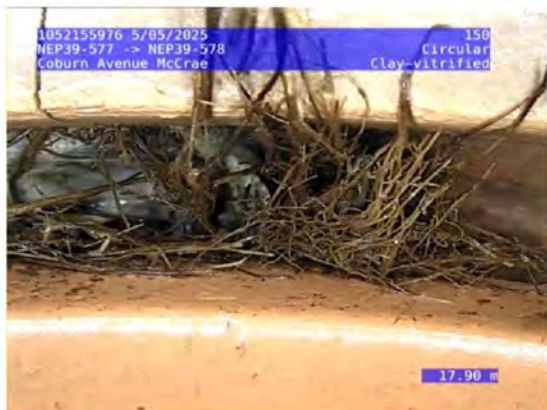
3, 00:06:48, 17.90  
Recently cut interwoven mass of mostly fine roots leaving a beard of roots, at joint from 2 o'clock to 3 o'clock

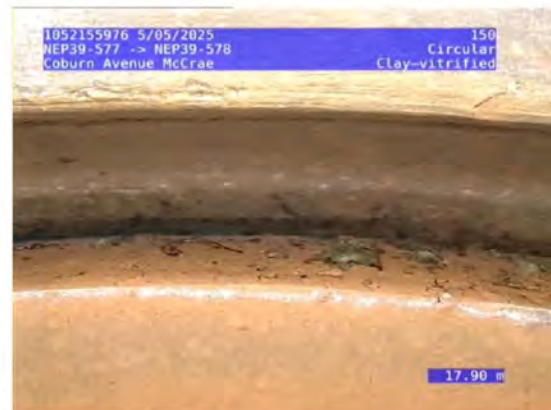
4, 00:07:00, 17.90  
Joint displaced longitudinally, 10mm

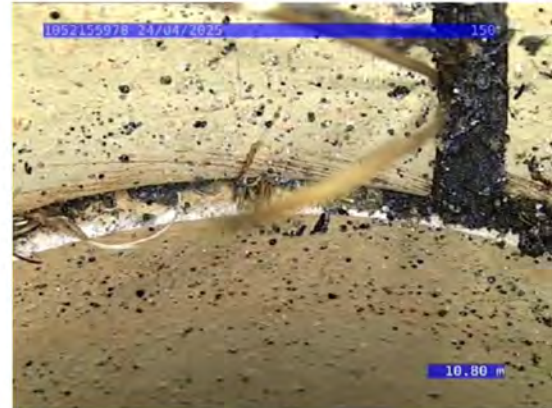
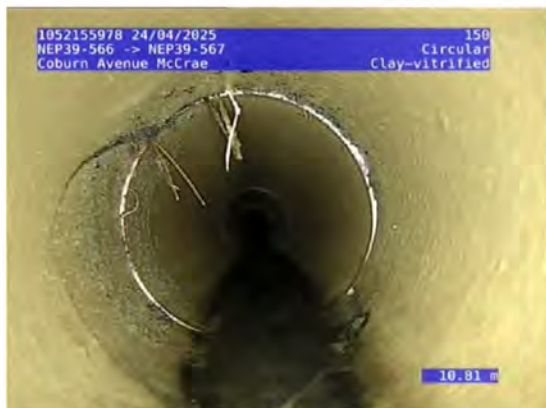
2, 00:03:37, 10.80  
Recently cut interwoven mass of mostly fine roots leaving a beard of roots, at joint from 12 o'clock to 12 o'clock

3, 00:03:37, 10.80  
Recently cut interwoven mass of mostly fine roots leaving a beard of roots, at joint from 12 o'clock to 12 o'clock

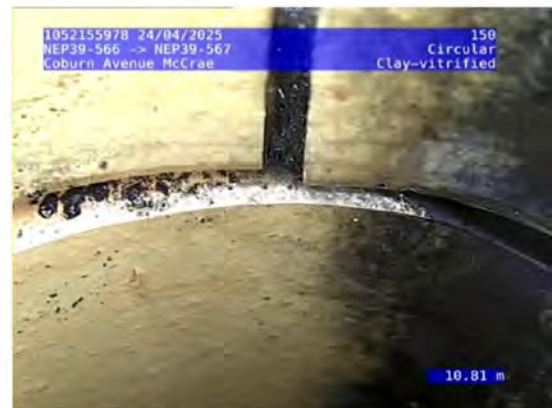
4, 00:04:09, 10.81  
Breaking, all pieces are present but some of them are visibly displaced from position, length of break: 200mm from 4 o'clock to 11 o'clock

Breaking, all pieces are present but some of them are visibly displaced from position, length of break: 200mm from 4 o'clock to 11 o'clock

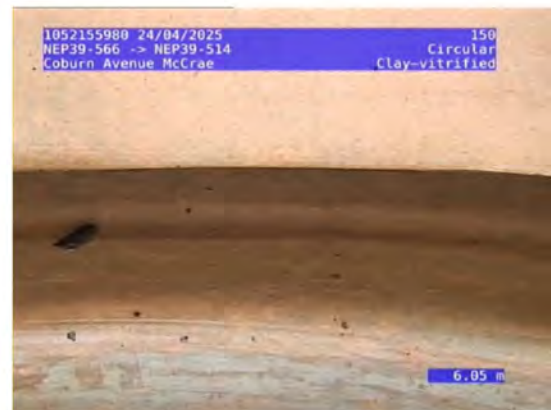
4, 00:03:34, 6.05  
Joint displaced longitudinally, 10mm

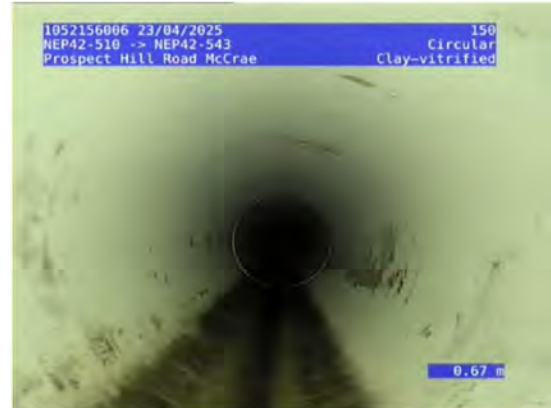
2, 00:00:58, 0.67  
Change of conduit material. New material, Polyvinyl chloride

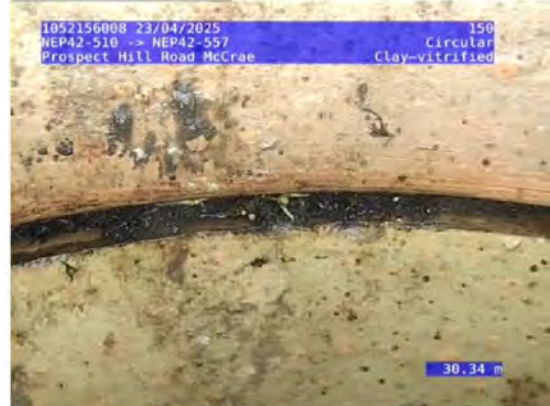
2, 00:09:04, 30.34  
Recently cut interwoven mass of mostly fine roots leaving a beard of roots, at joint from 3 o'clock to 9 o'clock

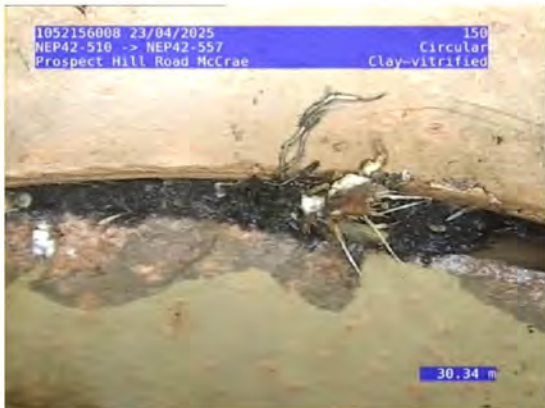
3, 00:09:04, 30.34  
Recently cut interwoven mass of mostly fine roots leaving a beard of roots, at joint from 3 o'clock to 9 o'clock

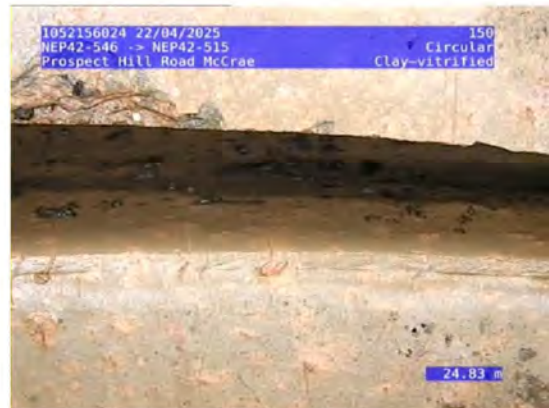
4, 00:08:25, 24.83  
Joint displaced angular at 3 o'clock

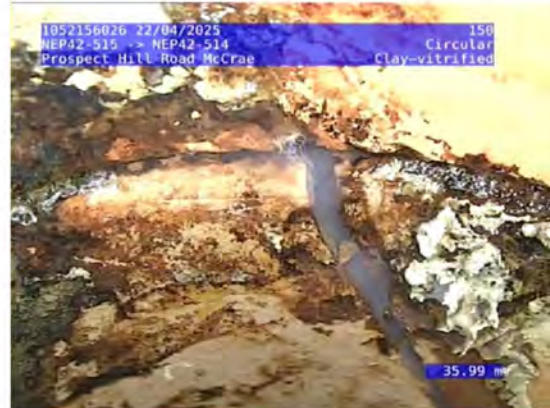
<table><tr> <th>1:318</th> <th>m+</th> <th>Code</th> <th>Observation Text</th> <th>MPEG</th> <th>Photo</th> <th>Grade</th> </tr><tr> <td></td> <td>35.99</td> <td>BD</td> <td>Breaking, all pieces are present but some of them are visibly displaced from position, length of break: 100mm from 10 o'clock to 2 o'clock</td> <td>00:10:52</td> <td>2, 3</td> <td>3</td> </tr></table>

2, 00:10:52, 35.99  
Breaking, all pieces are present but some of them are visibly displaced from position, length of break: 100mm from 10 o'clock to 2 o'clock

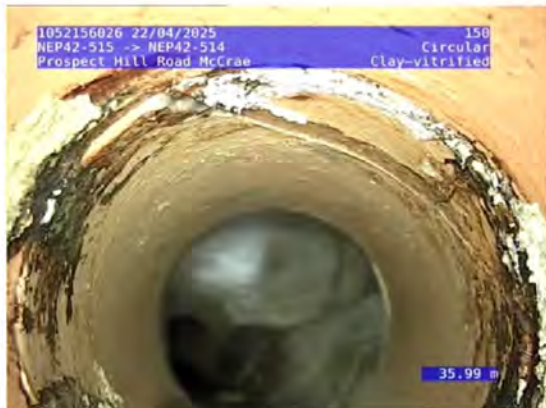
3, 00:10:52, 35.99  
Breaking, all pieces are present but some of them are visibly displaced from position, length of break: 100mm from 10 o'clock to 2 o'clock

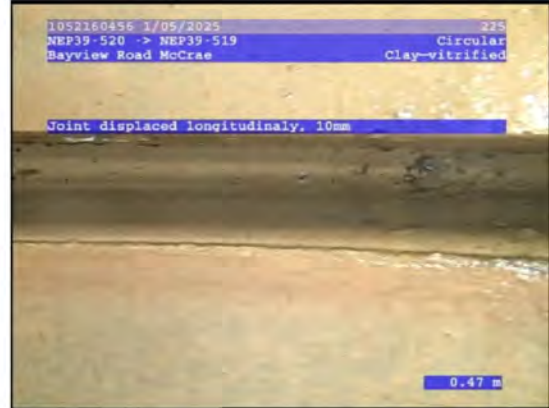
2, 00:00:58, 0.47  
Joint displaced longitudinally, 10mm
