**Task Number:**1337352/001**Task Address:**27 COBURN AVENUE, MCCRAE VIC 3938**Program Name:**ServiceStream - FY2425 - CCTV Retic 3 (Apr25)**Task Work Type:**Scheduled Maintenance - CCTV Inspection**Source Of Work:****Facility:****Permit Not Required:**No**Permit Pre Approved:**No**Permit Reason:**Other**Permit Other Reason:**

**Request Details:**Clean + CCTV Inspection Program McCrae Package: 1. All lines to be cleaned PRIOR to CCTV Inspection 2. CCTV Inspection using WSA 05 2020 Codes 3. Any manhole alterations required to complete works, action request to be raised and Sewer Maintenance Technician to be contacted SI's to be completed: 1. Sewer Clean 2. Sewer CCTV 3. Sewer Manhole Fault and Inspection

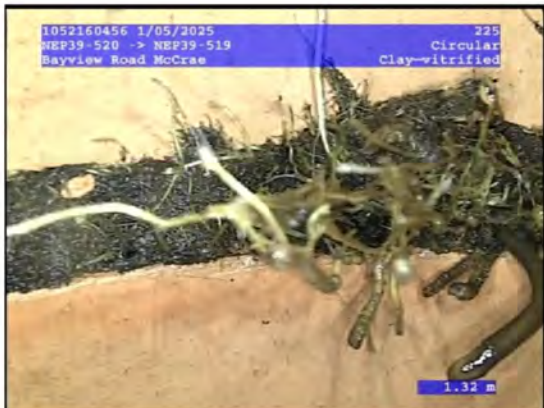
3, 00:01:23, 1.32  
Recently cut interwoven mass of mostly fine roots leaving a beard of roots, Obstruction: 10%, at joint from 12 o'clock to 12 o'clock

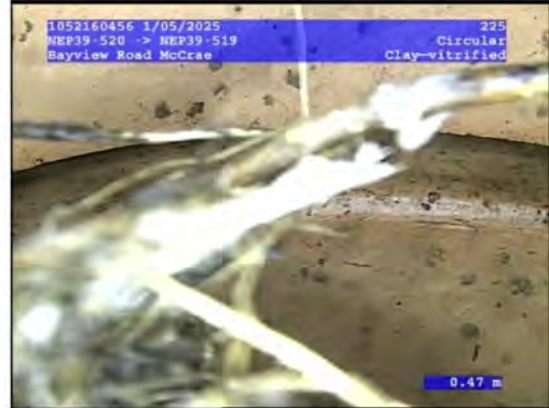
2, 00:01:26, 0.47  
Recently cut interwoven mass of mostly fine roots leaving a beard of roots, Obstruction: 30%, at joint from 12 o'clock to 12 o'clock

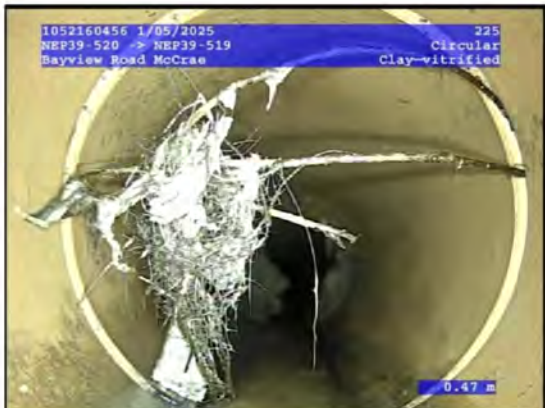
3, 00:01:26, 0.47  
Recently cut interwoven mass of mostly fine roots leaving a beard of roots, Obstruction: 30%, at joint from 12 o'clock to 12 o'clock

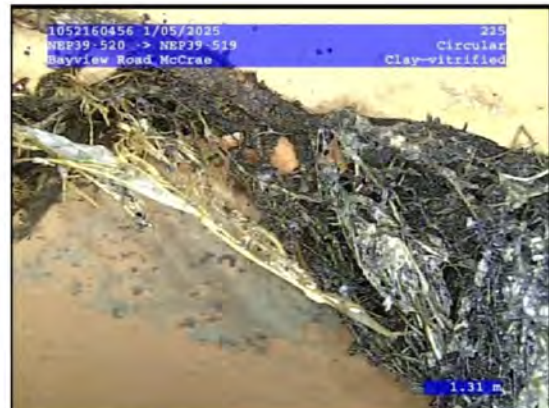
4, 00:02:11, 1.31  
Recently cut interwoven mass of mostly fine roots leaving a beard of roots, Obstruction: 70%, at joint from 12 o'clock to 12 o'clock

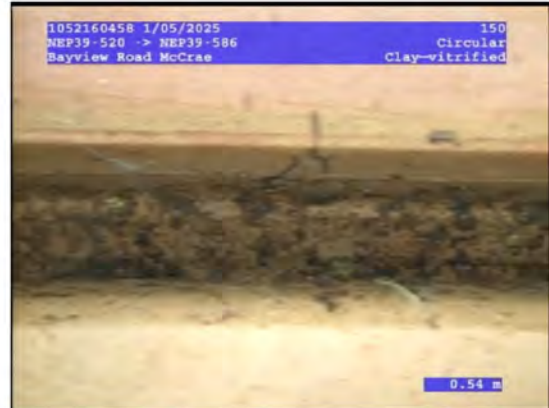
<table><tr> <th>1:228</th> <th>m+</th> <th>Code</th> <th>Observation Text</th> <th>MPEG</th> <th>Photo</th> <th>Grade</th> </tr><tr> <td></td> <td>0.54</td> <td>JDL</td> <td>Joint displaced longitudinally, 10mm</td> <td>00:00:59</td> <td>2</td> <td>1</td> </tr></table>

2, 00:00:59, 0.54  
Joint displaced longitudinally, 10mm

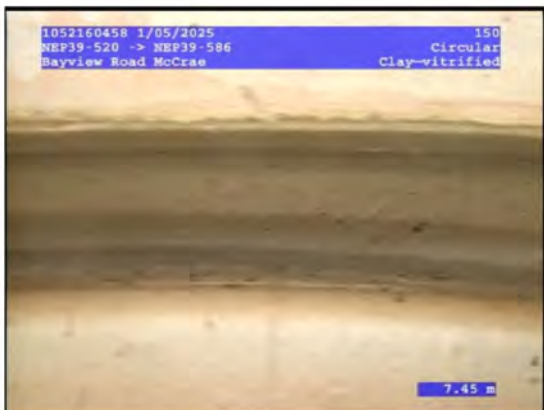
<table><tr> <th>1:228</th> <th>m+</th> <th>Code</th> <th>Observation Text</th> <th>MPEG</th> <th>Photo</th> <th>Grade</th> </tr><tr> <td></td> <td>7.45</td> <td>JDL</td> <td>Joint displaced longitudinally, 10mm</td> <td>00:03:02</td> <td>3</td> <td>1</td> </tr></table>

3, 00:03:02, 7.45  
Joint displaced longitudinally, 10mm

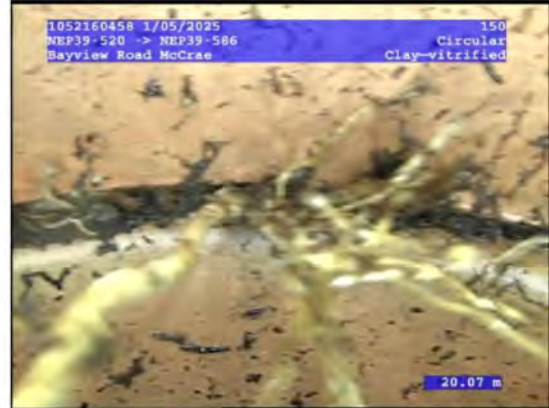
<table><tr> <th>1:228</th> <th>m+</th> <th>Code</th> <th>Observation Text</th> <th>MPEG</th> <th>Photo</th> <th>Grade</th> </tr><tr> <td></td> <td>20.07</td> <td>RRB</td> <td>Recently cut interwoven mass of mostly fine roots leaving a beard of roots, at joint from 12 o'clock to 12 o'clock</td> <td>00:06:58</td> <td>6, 7</td> <td>2</td> </tr></table>

6, 00:06:58, 20.07  
Recently cut interwoven mass of mostly fine roots leaving a beard of roots, at joint from 12 o'clock to 12 o'clock

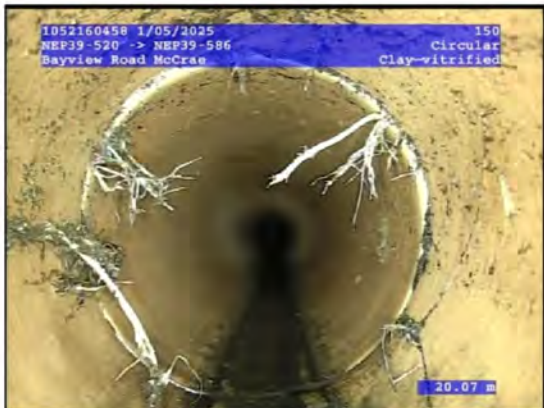
7, 00:06:58, 20.07  
Recently cut interwoven mass of mostly fine roots leaving a beard of roots, at joint from 12 o'clock to 12 o'clock

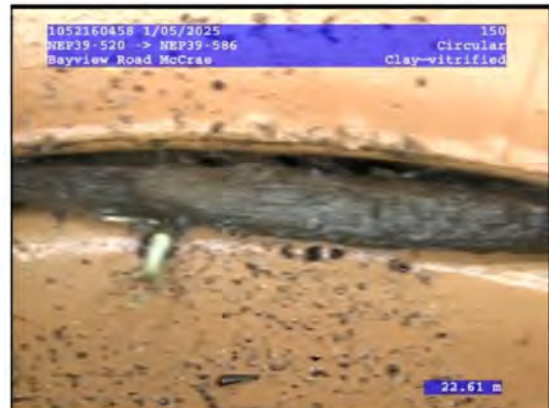
8, 00:07:55, 22.61  
Recently cut tap roots, a small number of cut major roots (10mm or greater) is evident, at joint from 2 o'clock to 3 o'clock

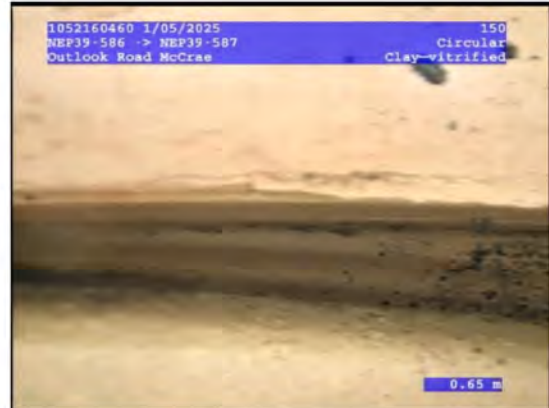
2, 00:00:40, 0.65  
Joint displaced angular at 9 o'clock

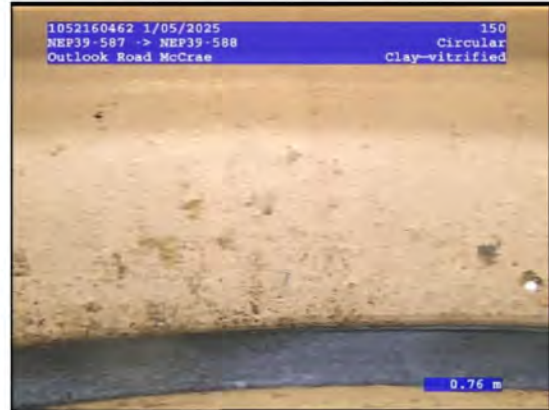
2, 00:00:56, 0.76  
Joint displaced longitudinally, 60mm

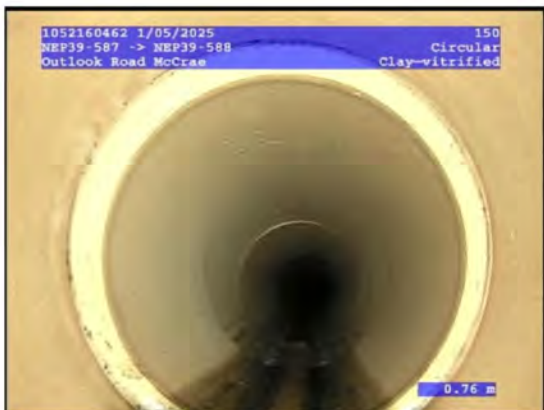
3, 00:00:56, 0.76  
Joint displaced longitudinally, 60mm

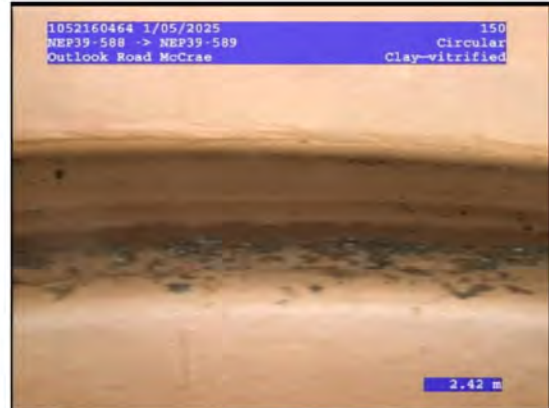
2, 00:04:09, 2.42  
Joint displaced longitudinally, 10mm

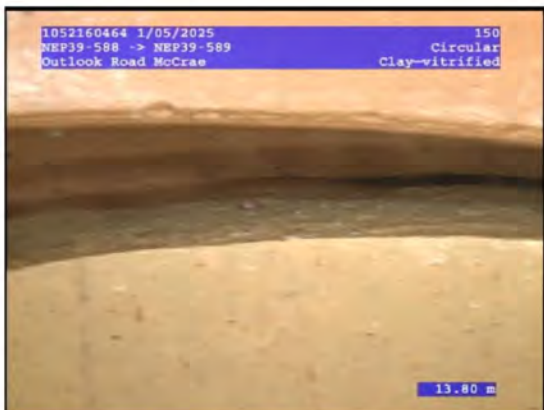
3, 00:13:34, 13.80  
Joint displaced angular at 3 o'clock

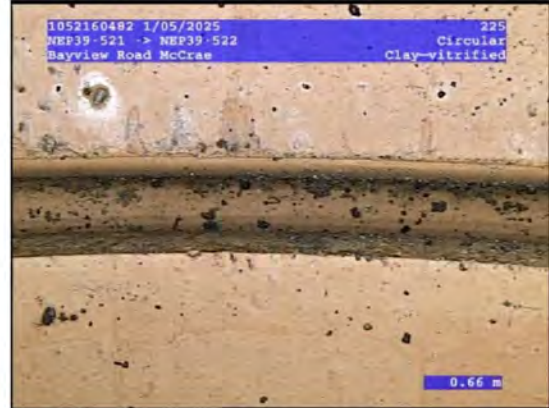
2, 00:00:59, 0.66  
Joint displaced longitudinally, 10mm

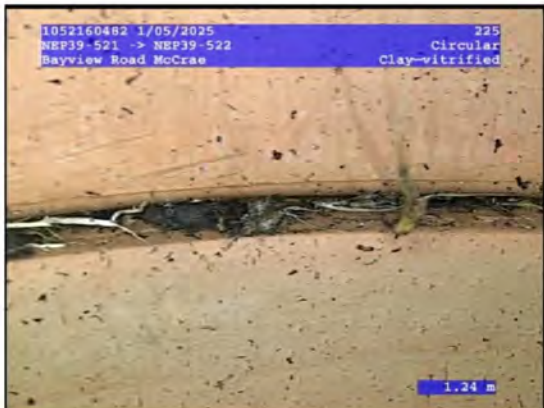
3, 00:01:21, 1.24  
Recently cut fine roots-a relatively small number of cut minor roots remain, Obstruction: 10%, at joint from 12 o'clock to 12 o'clock

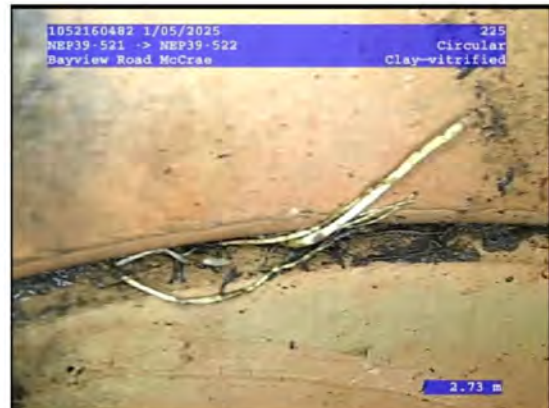
4, 00:02:02, 2.73  
Recently cut fine roots-a relatively small number of cut minor roots remain, Obstruction: 10%, at joint from 3 o'clock to 9 o'clock

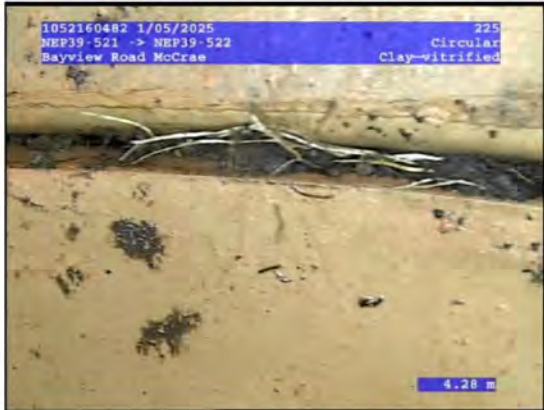
5, 00:02:55, 4.28  
Recently cut fine roots-a relatively small number of cut minor roots remain, at joint from 3 o'clock to 9 o'clock

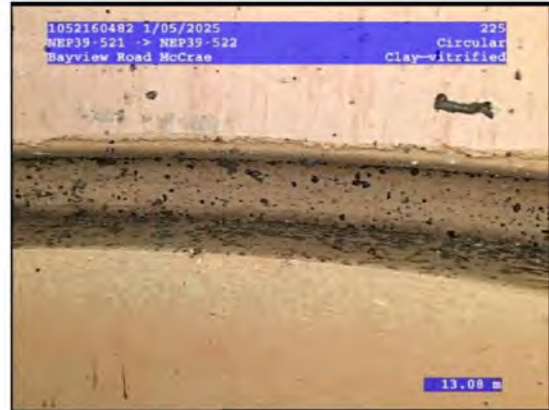
6, 00:05:51, 13.08  
Joint displaced longitudinally, 10mm

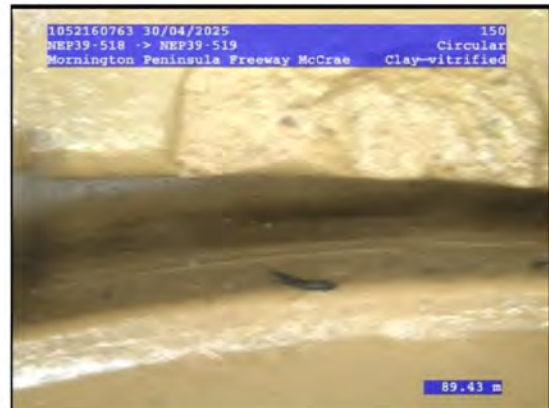
8, 00:45:20, 89.43  
Joint displaced angular at 3 o'clock

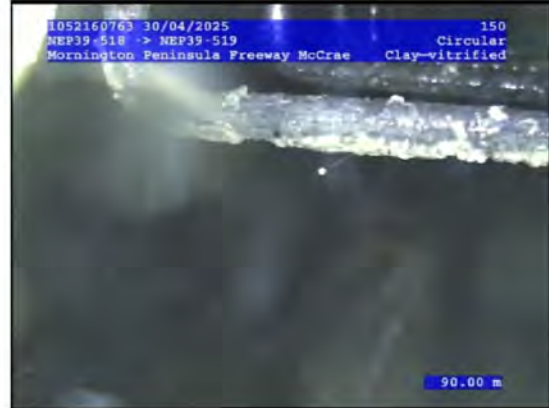
10, 00:46:13, 90.00  
Finish node, maintenance hole, Nodename:, NEP39-519

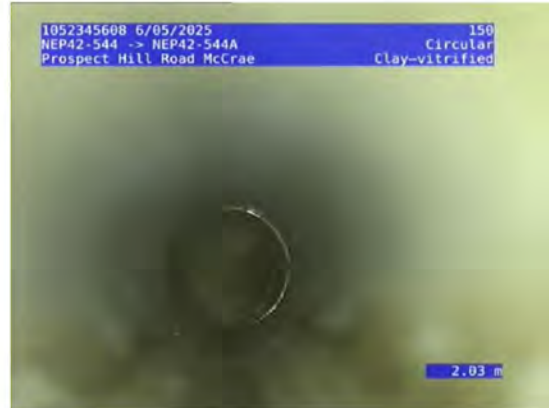
2, 00:05:45, 2.03  
Inspection (survey) abandoned, obstruction / camera unable to drive further, but line visible clear and working

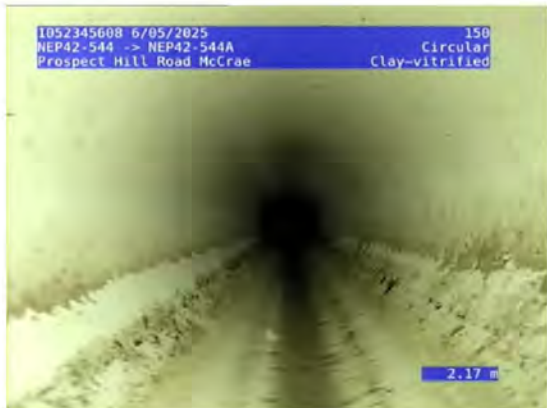
3, 00:05:45, 2.03  
Inspection (survey) abandoned, obstruction / camera unable to drive further, but line visible clear and working
