Multidisciplinary Expert Supplementary Report

Board of Inquiry into McCrae Landslide

Prepared for: Thomson Geer

30 July 2025

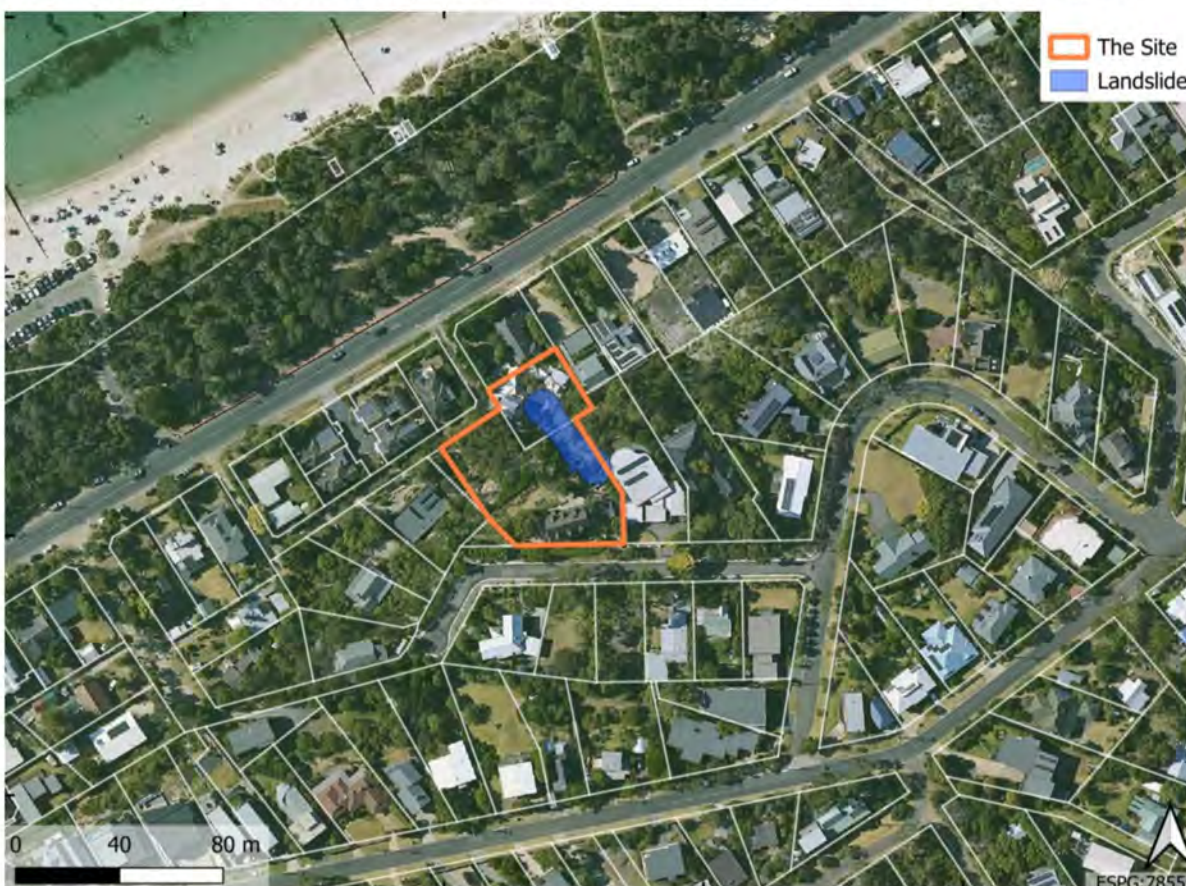
The landslides originated within the property boundary of 10-12 View Point Road, McCrae. Debris flow from the landslides travelled downslope and demolished the property at 3 Penny Lane, immediately to the north. Together these two properties are considered to comprise the 'Site'.

Figure 1: Annotated aerial photography showing the approximate location of the landslide and delineation of the Site (source: MetroMap; 2025-02-01. Annotation of site location added by SMEC)

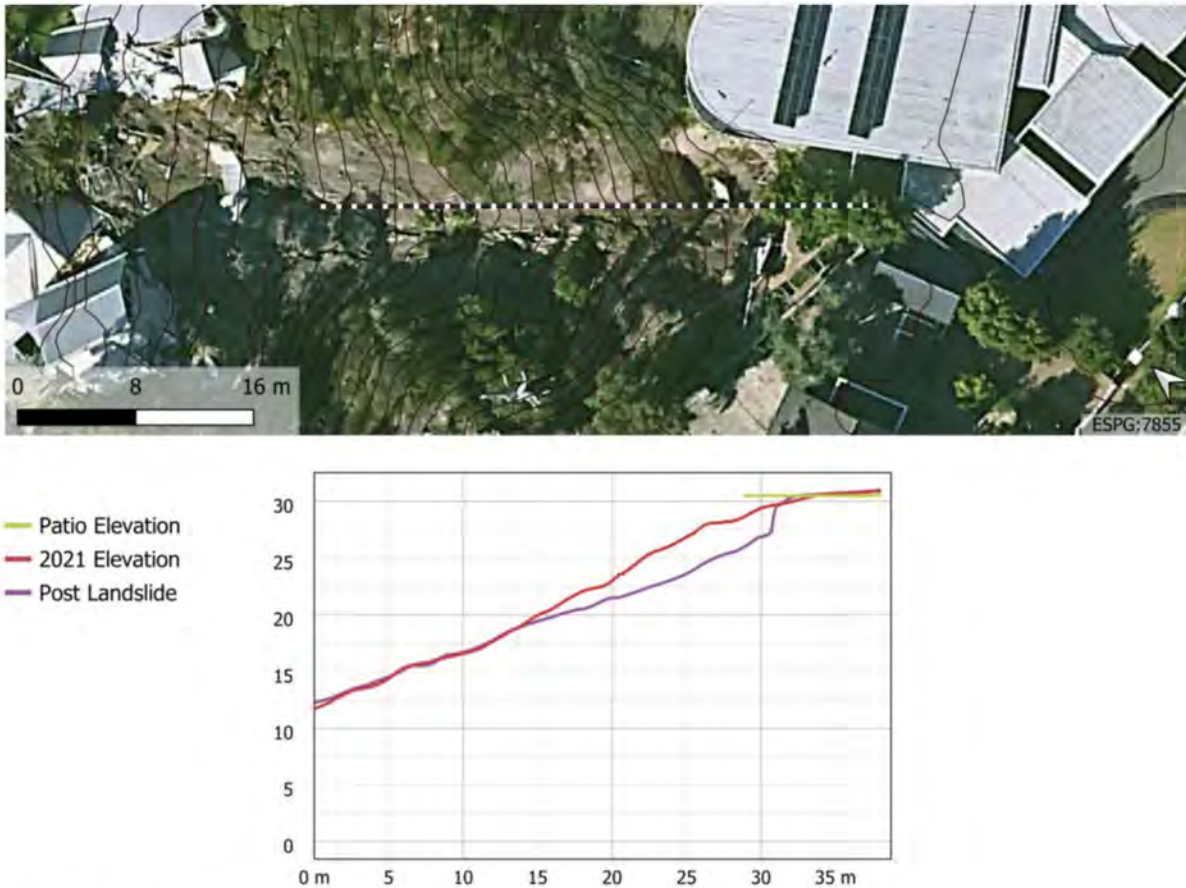
Figure 2: Drone footage illustrating the site features and topography

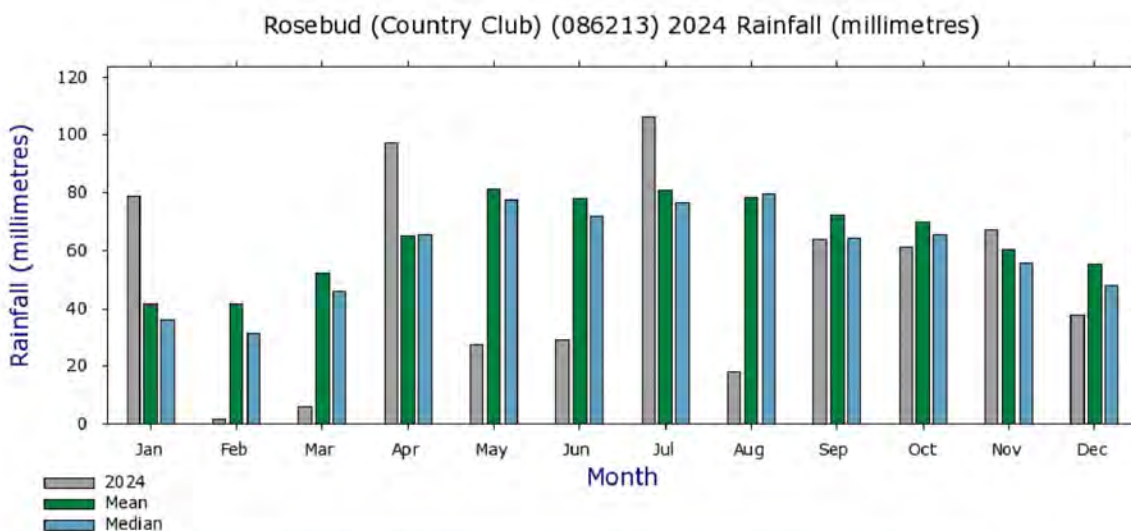
- During a typical year, the median rainfall is generally highest during the winter and spring months, with up to 80mm of median total monthly rainfall anticipated in the area over this period
- During a typical year, median rainfall is generally lowest during summer and early autumn, with a minimum median monthly rainfall of approximately 40mm anticipated in the area during this period
- The total rainfall recorded during December 2024 – just prior to the McCrae Landslide – was atypically low compared to the median. Approximately 40mm of rainfall was recorded compared to the median of approximately 50mm.

Figure 6: Median, mean and 2024 monthly rainfall at Rosebud weather station (source: <http://www.bom.gov.au/>)

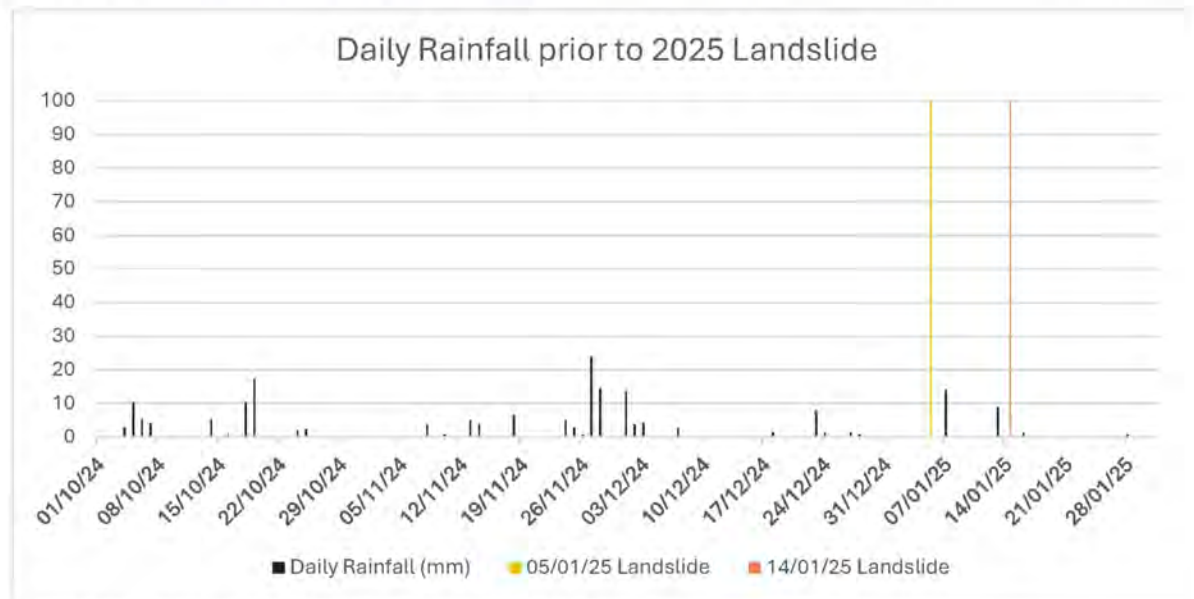
A plot of daily rainfall in the months prior to the McCrae Landslide is presented in Figure 7. No significant rainfall was recorded prior to the initial landslide event on 5 January 2025. Rainfall at the site in the months prior to the landslide showed no great increase over the median.

Figure 7: Daily rainfall prior to 2025 McCrae Landslide at 10-12 View Point Road

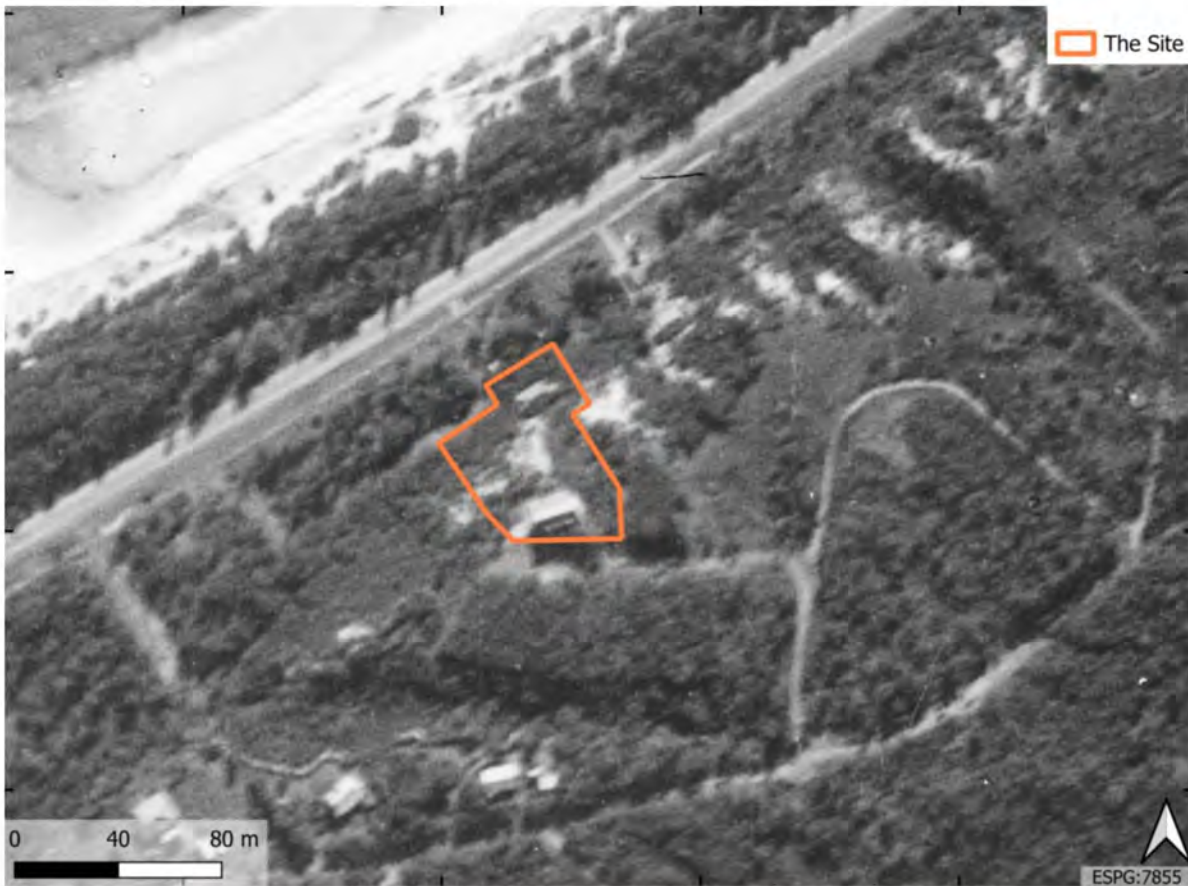
Aerial imagery from 1939 (refer Figure 9) presented in the report by PSM (Appendix B, Ref. 13) indicates that the area had been partially subdivided by this point and the house at 10-12 View Point Road had been constructed, indicating that the house is at least 86 years old. The aerial imagery indicates that the surrounding area was still relatively undeveloped at this time. Erosion appears to be evident along the escarpment to the east of the site.

Figure 9: 1939 Aerial Imagery of Site Locality (source: NAA: B5424, MAP3067/2705. Annotation of 10-12 View Point Road location added by SMEC)

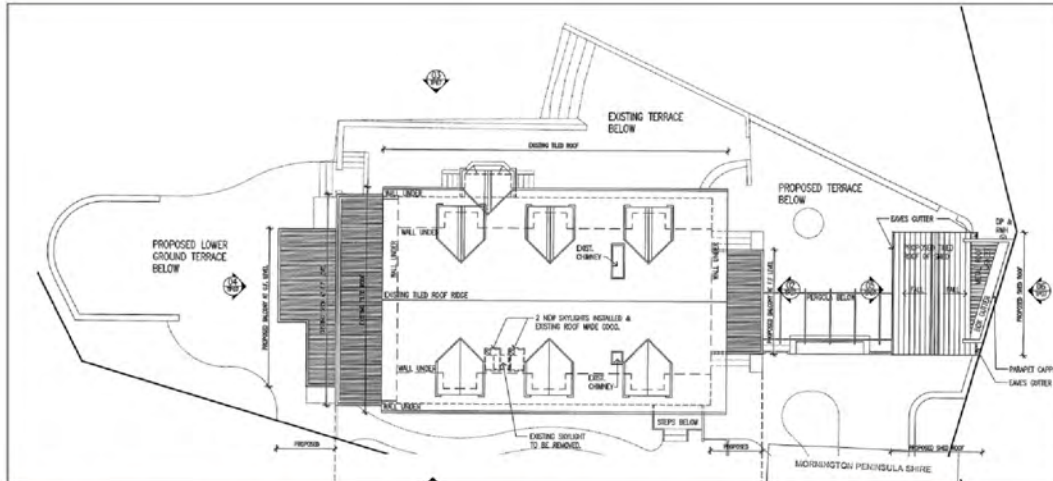
2015 to 2016 – applications were submitted for 10-12 View Point Road comprising alterations to the existing dwelling, extensions, a new outbuilding, retaining walls, hard paving, fences and gates. The submitted plan of the proposed alterations is presented in Figure 12. This plan indicates that new terraces were proposed either side of the house, and a new structure was proposed on the northeastern side of the house. The plans indicate an extension to the terrace on the north-eastern side of the house, requiring the construction of new retaining walls and placement of fill at the crest of the escarpment in the area that the 2025 landslides subsequently occurred.

Figure 12: Plan of proposed development at 10-12 View Point Road (source: JDA Architects – Appendix B, Ref 16)

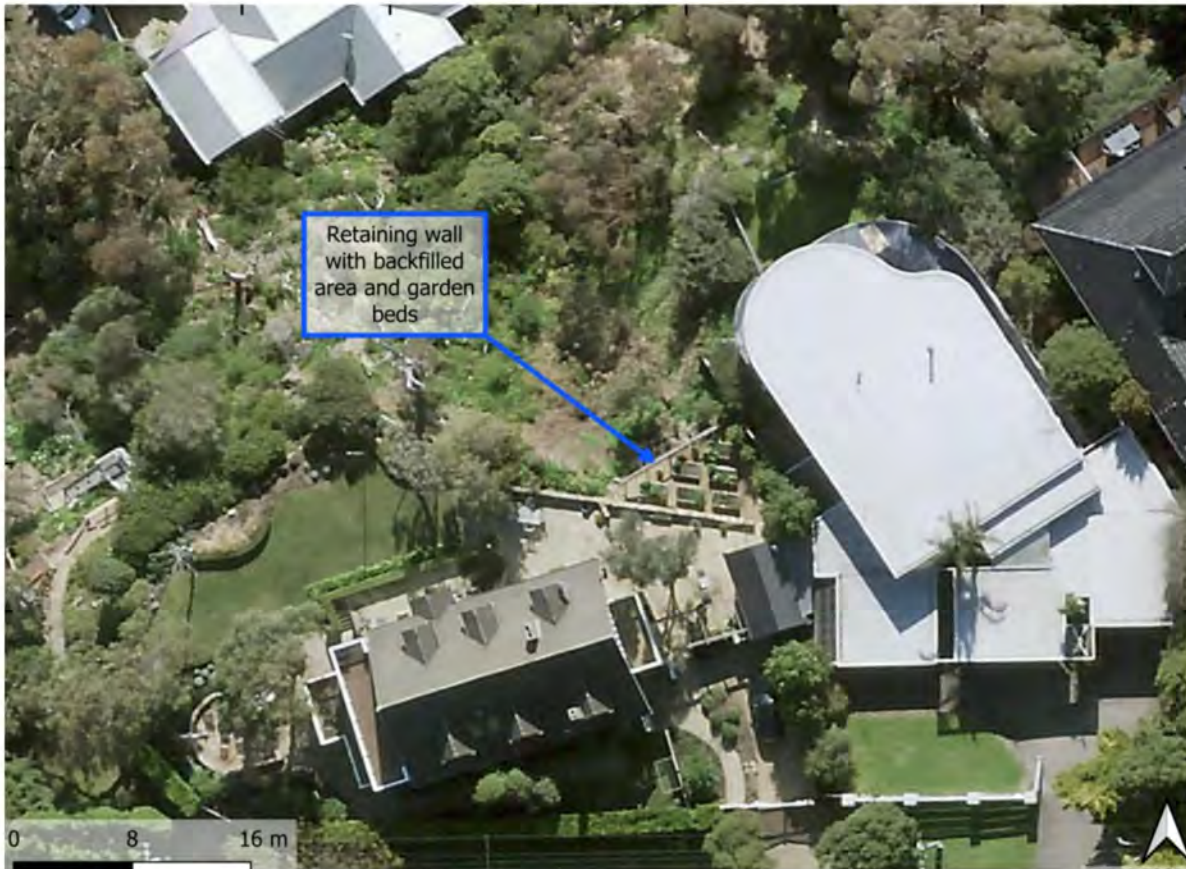
2020 to 2021 – applications were submitted for the installation of a deck and engineered handrail for the edge of a garden. The planning application appears to have been withdrawn at the request of the property owner (Appendix B, Ref. 17). Aerial imagery from Metromap (refer Figure 14) and available photographs indicate that a post and timber panel retaining wall with backfill was completed prior to 30 December 2021 and raised garden beds installed on the backfill by 21 July 2022.

Figure 14: Aerial imagery of 10-12 View Point Road from 21 July 2022 (source: MetroMap accessed on 5 July 2025. Annotation added by SMEC)

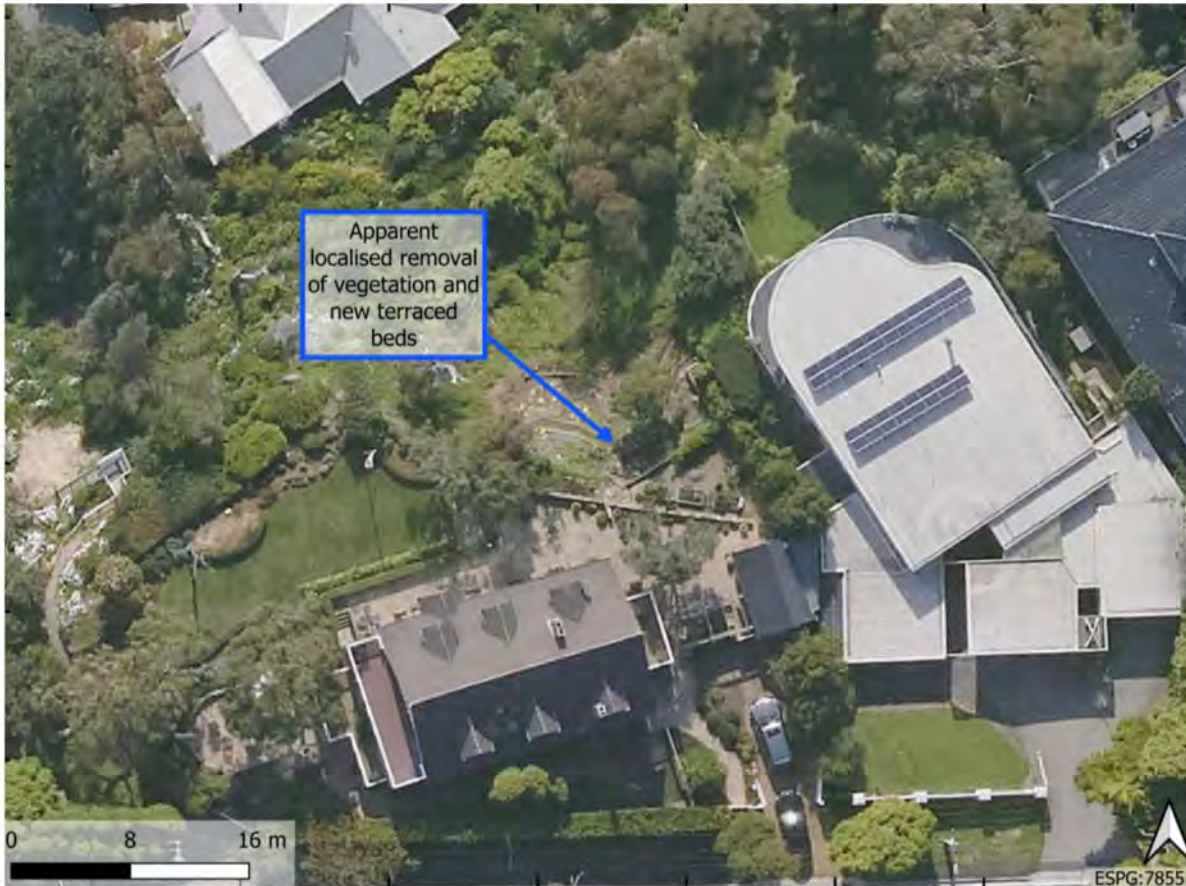
Late 2022 – A steel post and timber plank retaining wall, understood from discussions with Mr. Borghesi during SMEC's site visit of 17 June 2025 (Appendix C) estimated to be up to 900 mm high was constructed, to create a flat area for raised vegetable garden beds behind and across the slope (refer Figure 15). Some fill would have been required to infill behind the wall (Appendix B, Ref 25).

Figure 15: Aerial imagery of 10-12 View Point Road from August 2023 (source: MetroMap accessed on 5 July 2025. Annotation added by SMEC)

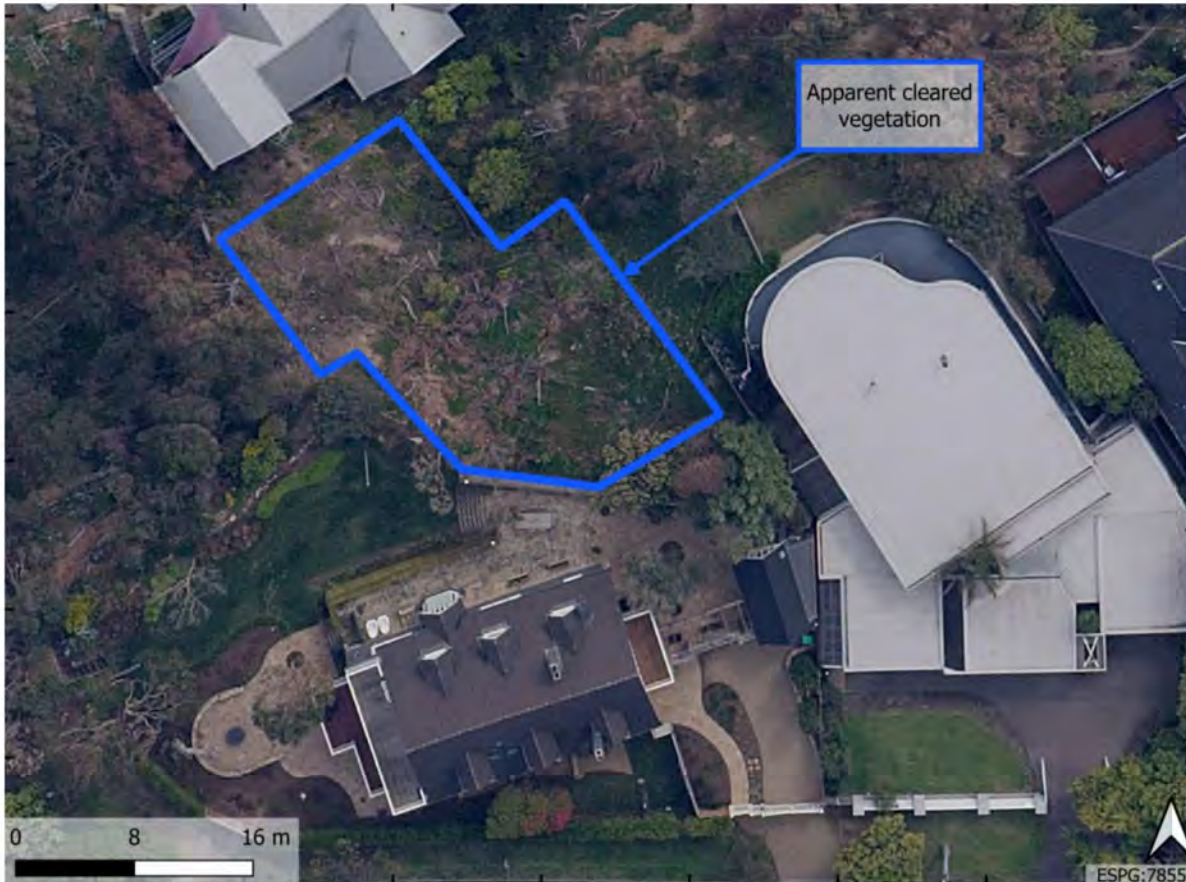
These observations indicate that there have been various instances of vegetation clearing at the Site between 2017 and 2023, including within the area that the 2025 landslide occurred. However, we are not aware of any evidence of significant changes between 2023 and the landslides in 2025. An example of an aerial image indicating removal of vegetation in 2018 is presented in Figure 16.

Figure 16: Aerial imagery of 10-12 View Point Road from September 2018 (source: MetroMap accessed on 5 July 2025. Annotation of vegetation clearing added by SMEC)

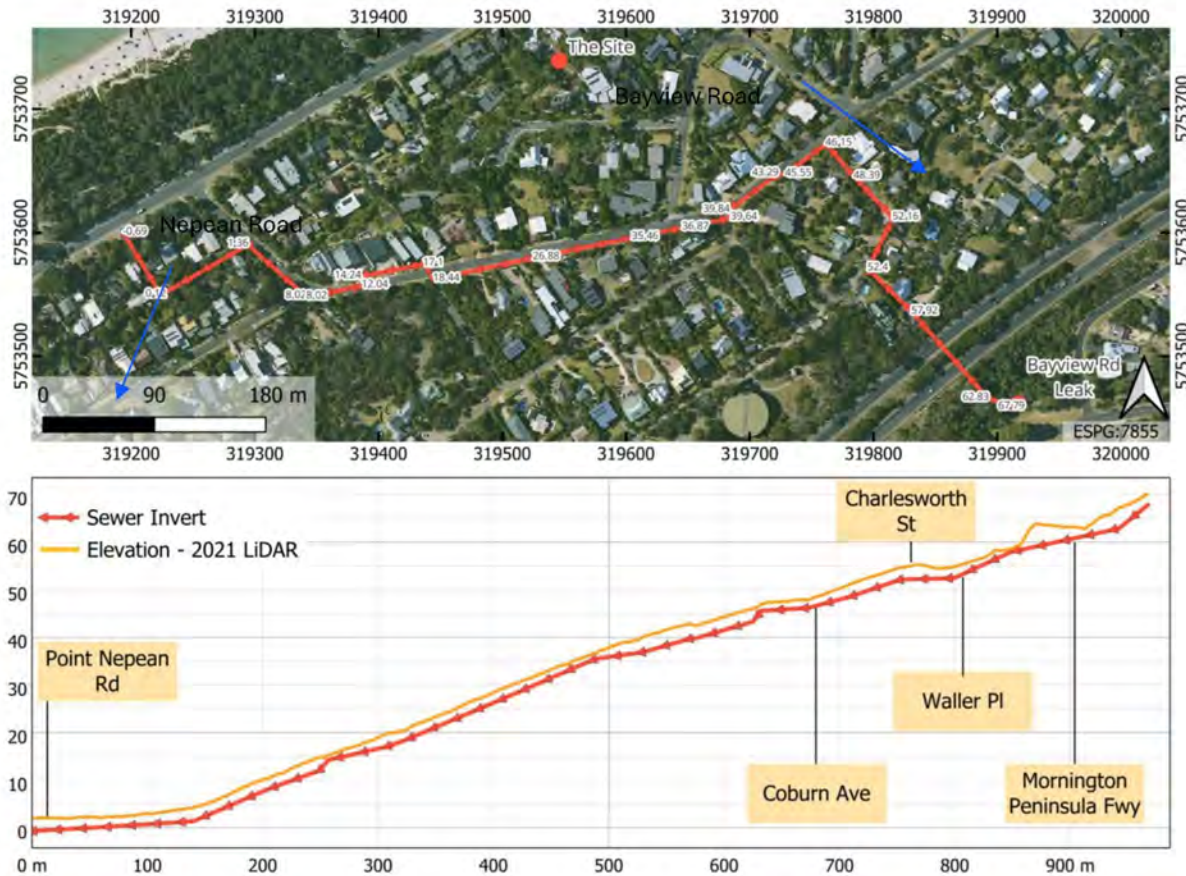
Figure 19 highlights the section of the sewer network between Bayview Road and Point Nepean Road. Chainages 217.75m to 298.25m are located along Charlesworth Street. The depth to invert along Charlesworth Street varies from 2.69m to 1.56m. It is noted that the invert depths along Charlesworth Street are not the shallowest inverts along the alignment.

Figure 19: Graphical long section showing the ground level and invert levels of the sewer network between Bayview Road and Point Nepean Road.

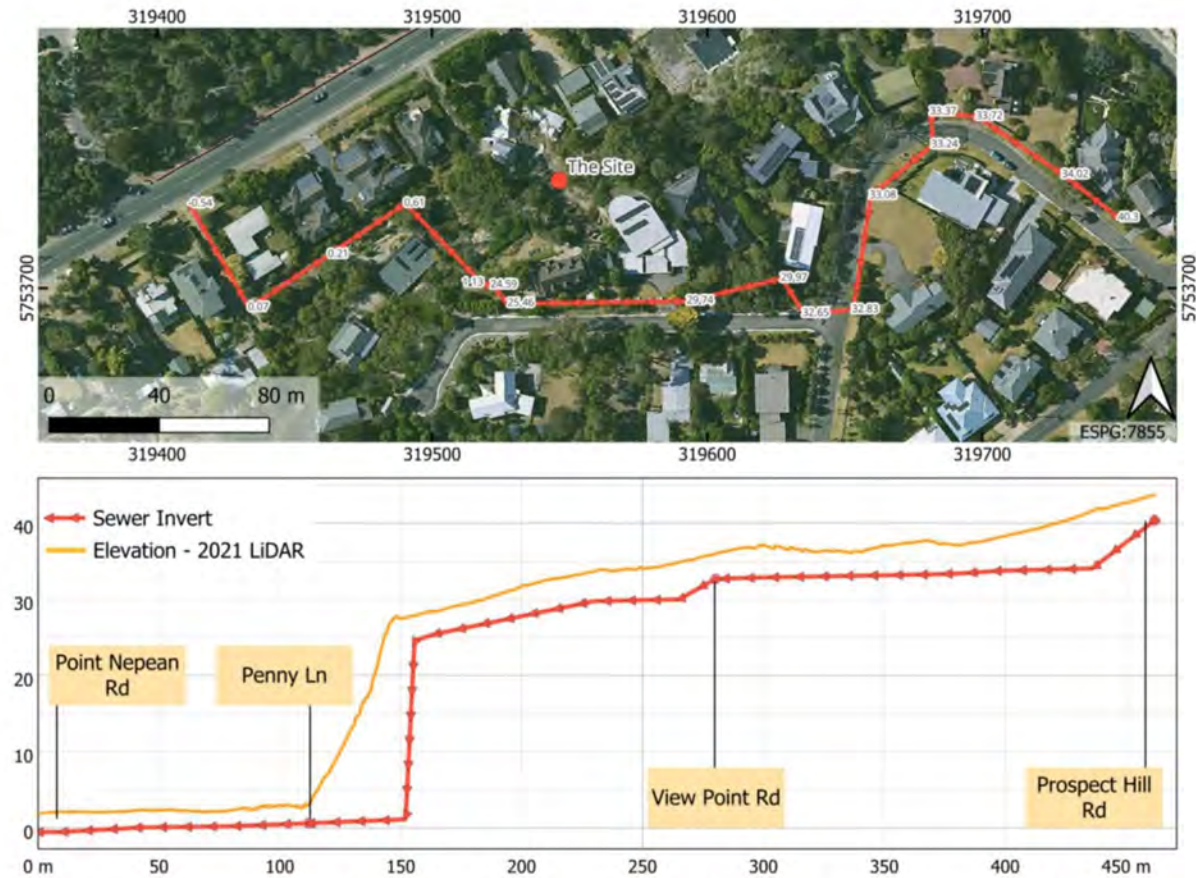
Figure 20 below illustrates the sewer gradient through Prospect Hill Road into View Point Road. 10 View Point Road is at chainage 298.4m. These figures show a fall in invert level along the chainages, irrespective of the ground level. Chainages 83.9m to 93.7m is outside of 10 Prospect Hill Place.

Figure 20: Graphical long section showing the ground level (CL) and invert levels (IL) of the sewer network between Prospect Hill Road and Point Nepean Road.

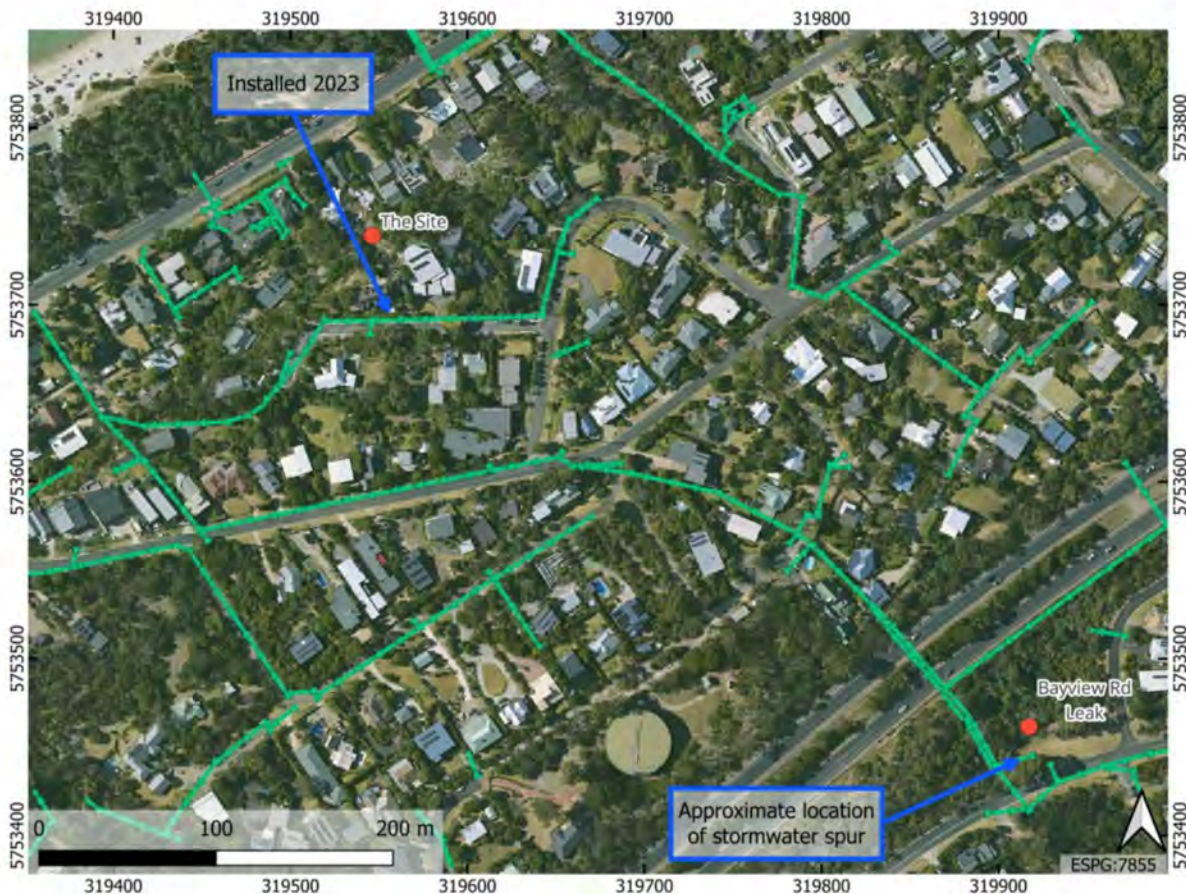
A plan of the stormwater network is presented in Figure 21. This plan has been annotated by SMEC to show the approximate location of known buried stormwater drainage that was installed along View Point Road in 2023. This figure is derived from Before You Dig Australia (BYDA) maps, which have been acknowledged to be incorrect by MPSC. No as-built drawings or site records of these construction works were available to SMEC at the time of writing this report. Based on conversations with MPSC, SMEC understands that the stormwater drainage flows from the front of No.4 to No.22 View Point Road. Drainage is located around the bend of Prospect Hill Road which SMEC understands connects to the newly installed drain along View Point Road.

Based on a memo from SEW, dated 15 May 2025, a separate 'spur' of the stormwater drainage system was identified and confirmed with MPSC on 15 May 2025. This spur is also shown in Figure 21, located near the Bayview Leak site. Given the likelihood that the construction of this spur is similar to other stormwater drainage lengths, it is reasonable to suggest that the embedment material of the spur comprises fine crushed rock or select fill. It is therefore reasonable to suggest that any perched water, or seepage from the Boulevard reserve may be in part, or in total be collected by the spur and the embedment material.

Figure 21: Map (not scaled) showing stormwater drainage network in the locality of the Site. Annotations have been added by SMEC of the stormwater drainage constructed in 2023 and known 'spur' confirmed by MPSC

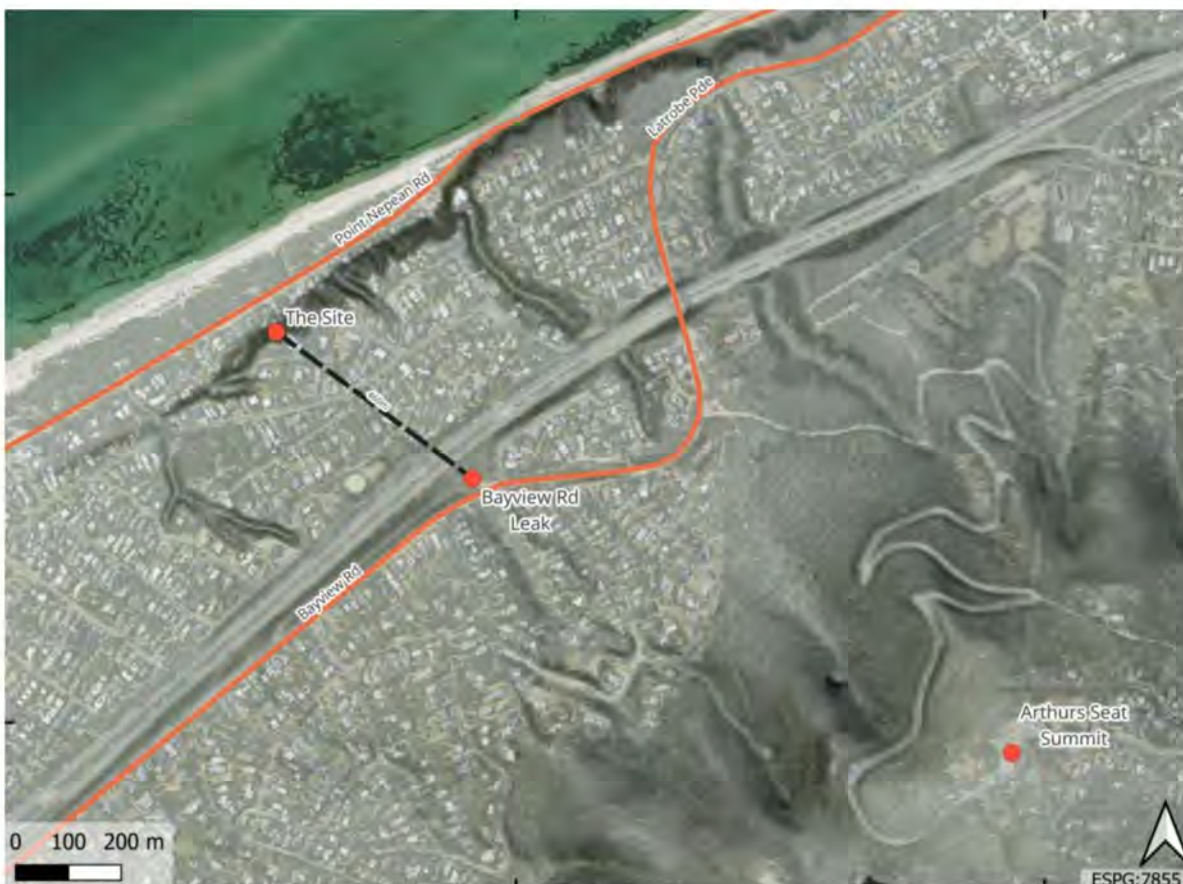
Numerous witness statements and SEW's own records detail a leak that occurred due to a fracture within a PVC water pipe near Bayview Road, approximately 450 m, south and upslope from the Site. SEW has advised that the fracture was located on 30 December 2024 and repaired on 1 January 2025. The date that the water leak began is thought to be in early August 2024 according to a report from the University of Auckland (Appendix B Ref. 40). Residents began to report potential leaks at Charlesworth Street and Waller Place between 26 November 2024 and 1 January 2025. The University of Auckland report estimated, based on SEW raw data, that the volume of water that may have been lost through the leak was 40.3 ML.

Figure 27: Plan showing the location of the water main leak at Bayview Road in relation to the Site

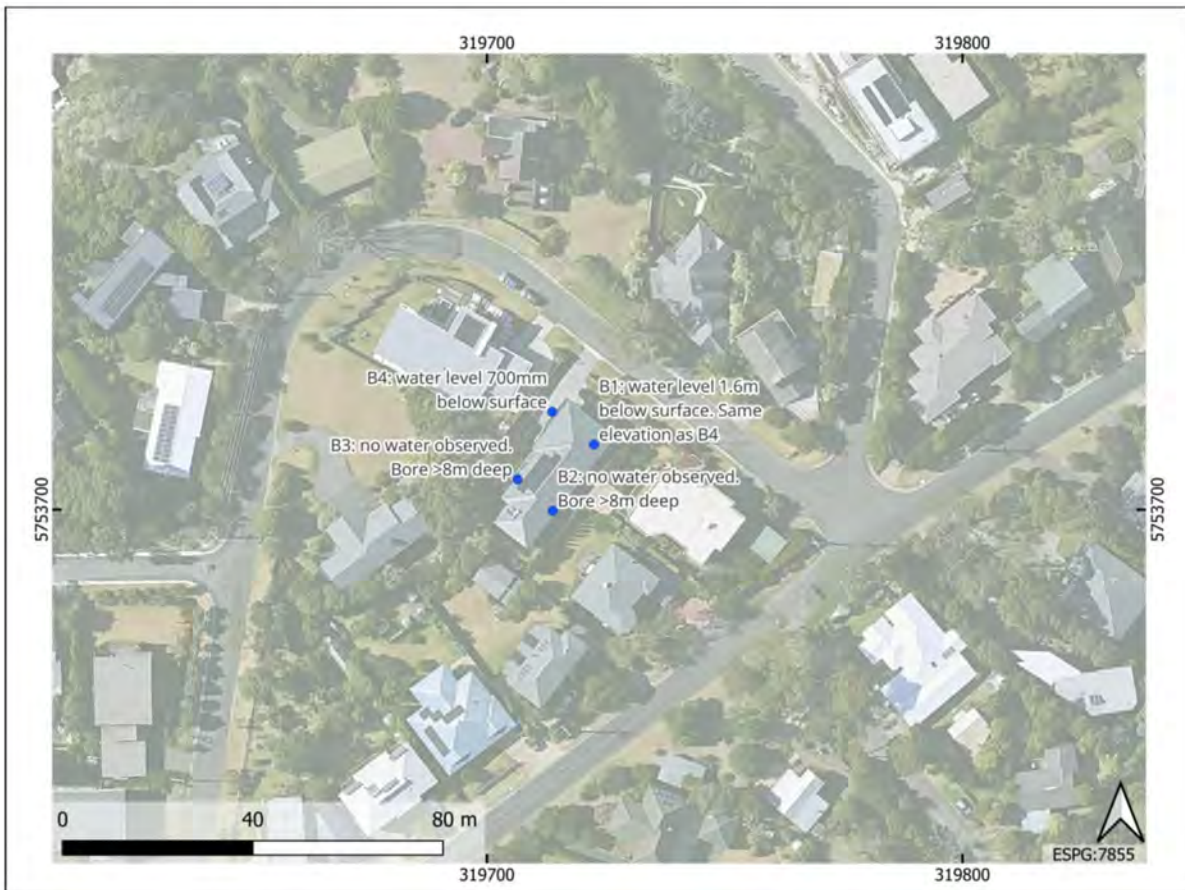
The test results referred to by the landowner were taken on 25 September 2018, within boreholes Bore 3 and Bore 4 as shown in Figure 28. A control sample from Tap water was also taken. Fluoride levels of the samples taken from BGH3 and BH4 were 0.7 mg/l, and 0.6 mg/l compared to 0.5 mg/l for the tap water.

Figure 28: Locations of boreholes drilled in 2018 prior to the construction of No. 5 Prospect Hill Road, noting water level observations.

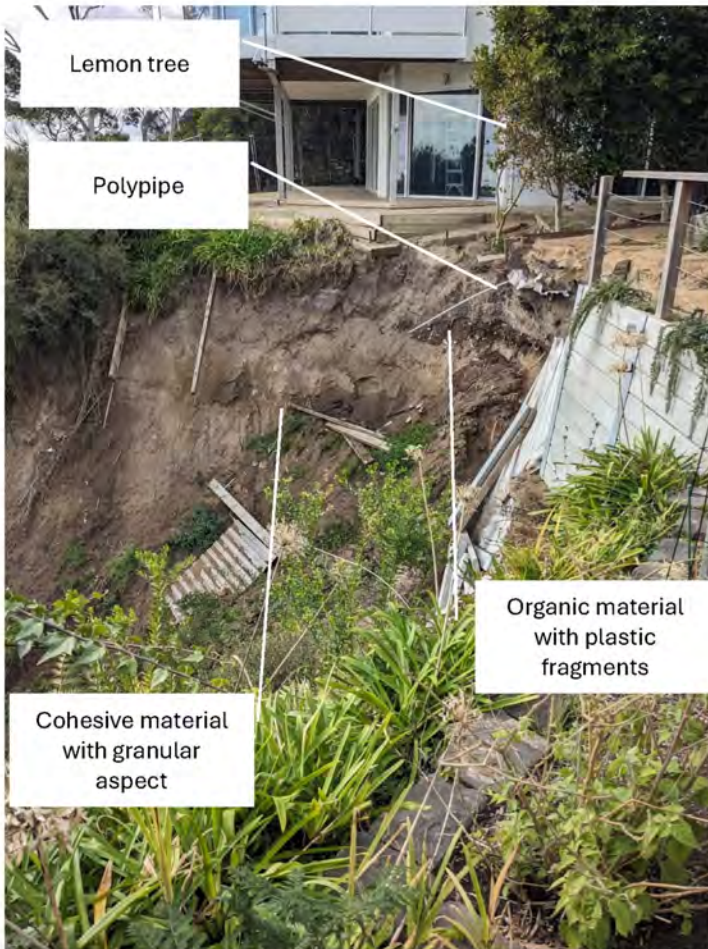
Figure 4: 17/6/25 Photo 01 Looking east showing the detail of the backscarp. Note the vertical nature of the backscarp, approximately 4.5m high.

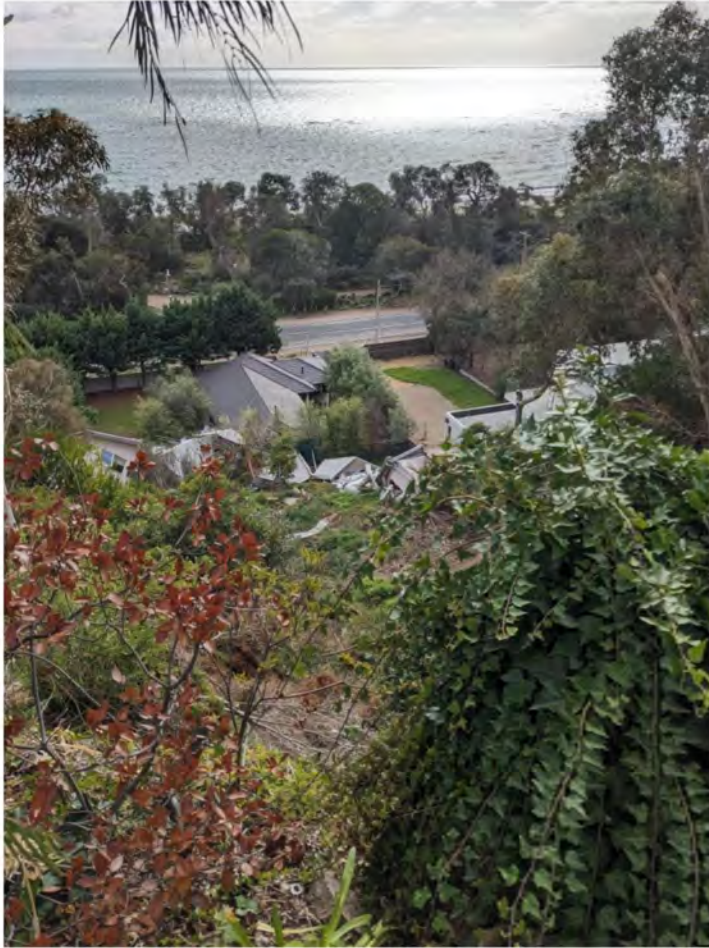
Figure 5: 17/6/25 Photo 02 Looking north showing the extent of landslide

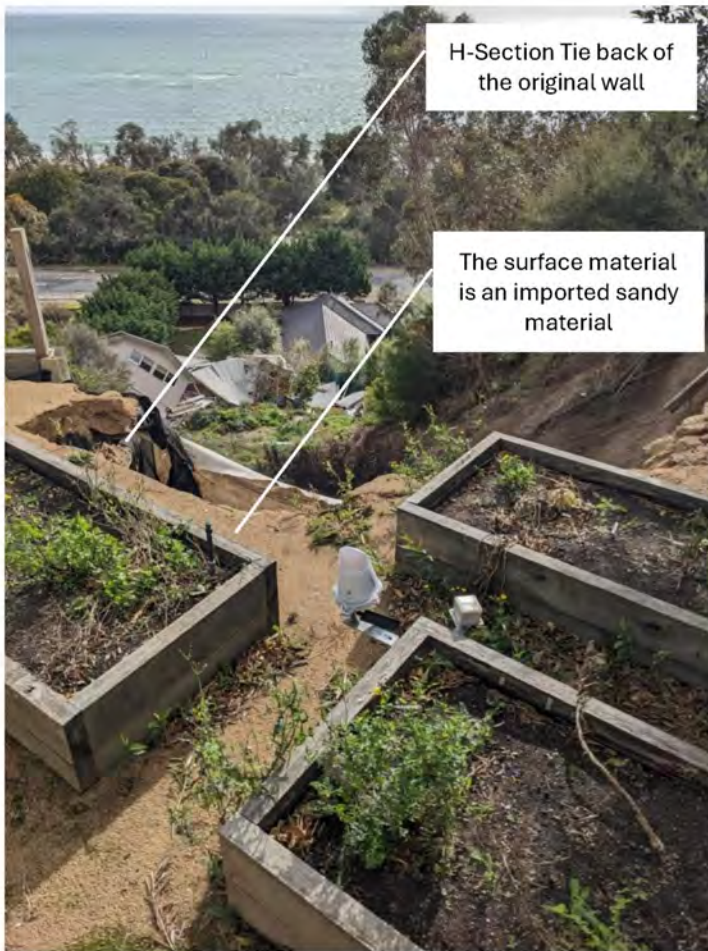
Figure 9: 17/6/25 Photo 06 Looking north from behind the raised vegetable patch, towards the toe debris of the landslide. The tie back of the original retaining wall is visible, as is the white geofabric of the drainage measures of the 'aesthetic' wall

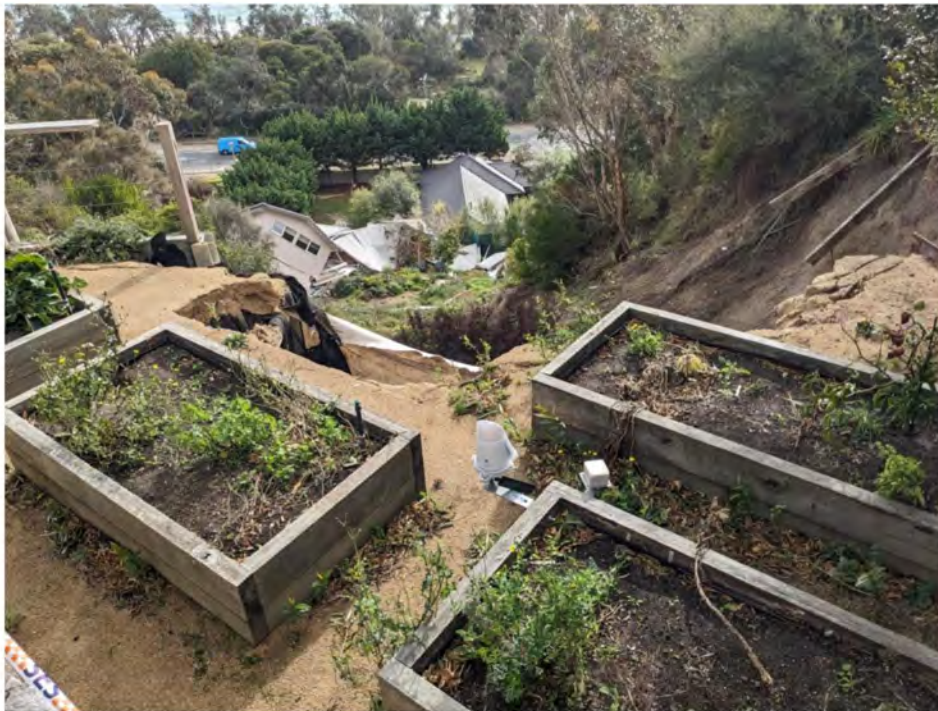
Figure 11: 17/6/25 Photo 08 Looking north over the vegetable garden, showing the crest of the backscarp

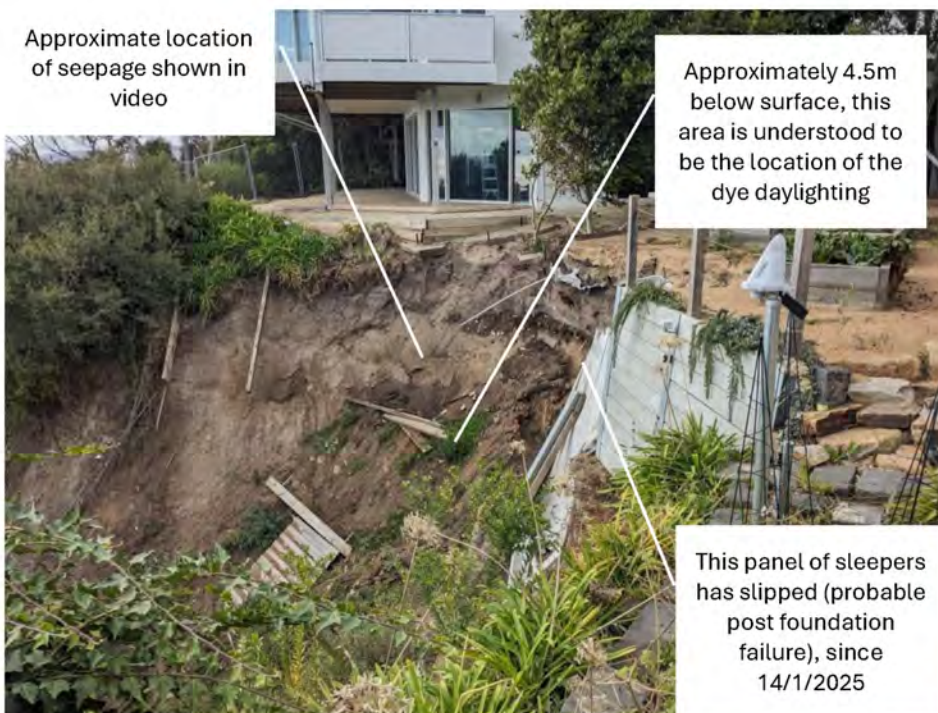
Figure 12: 17/6/25 Photo 09 Looking east showing the location of the seepage videoed by the landowners on 14 January 2025, and location of the dye that was seen daylighting through the backscarp after dye was poured into NDT01/02.

Figure 12 should be compared with Figure 13, which shows three panels of sleepers of the retaining wall still standing.

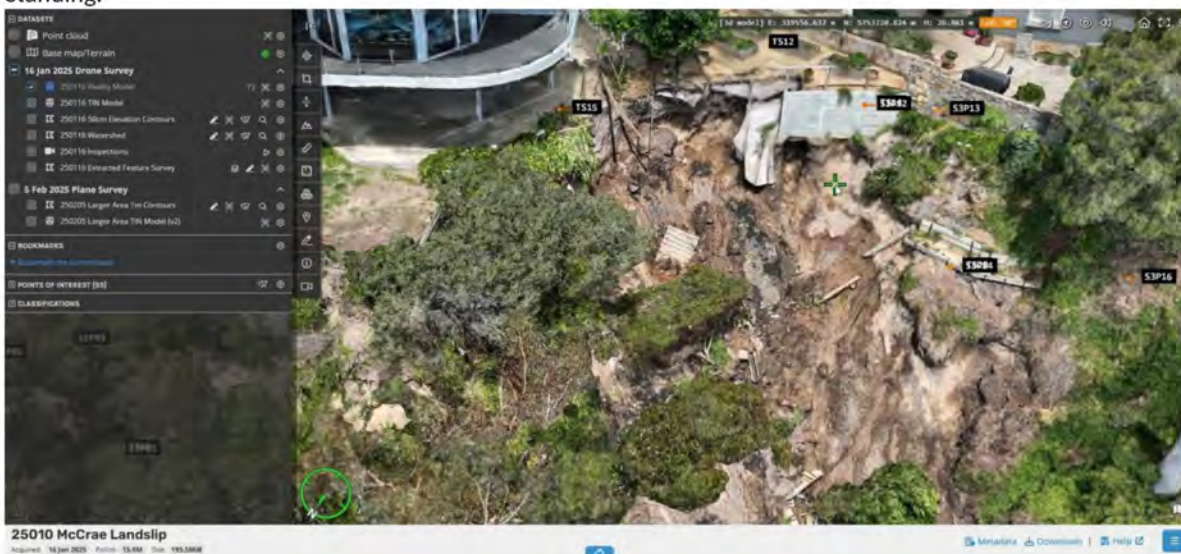
Figure 13: Detail of the landslide drone footage taken on 15/1/25.

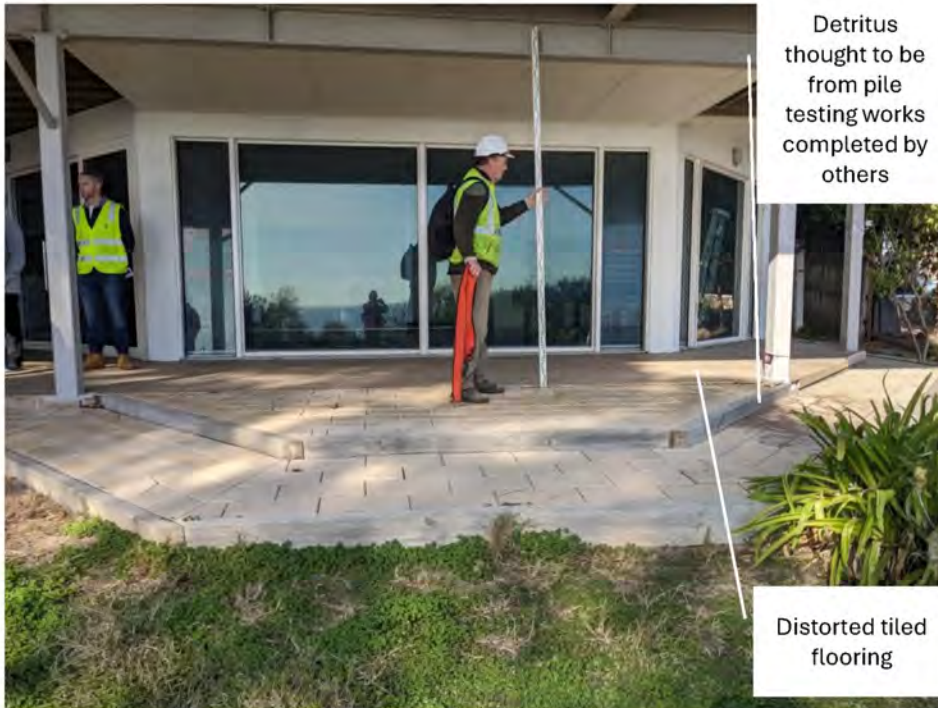
Figure 17: 20/6/25 6 View Point Road, looking south note the disturbed paving, but the house does not show signs of movement.

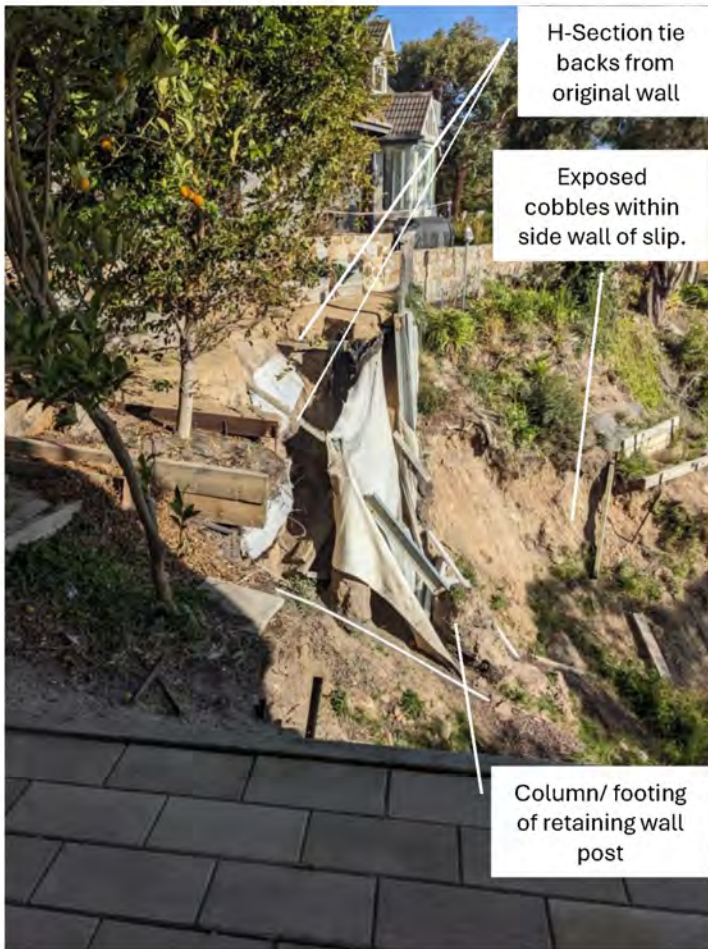
Figure 18: 20/6/25 6 View Point Road looking west along line of retaining walls, showing tie backs, and several irrigation pipes

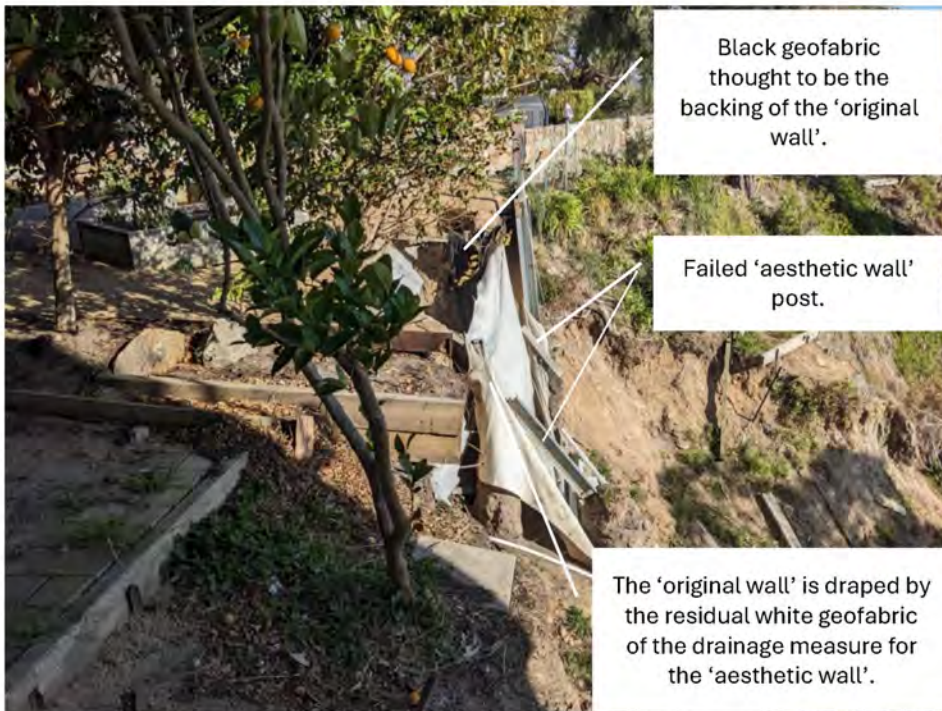
Figure 21: 20/6/25 looking west, showing lemo tree in the foreground, with colluvial material exposed in background.

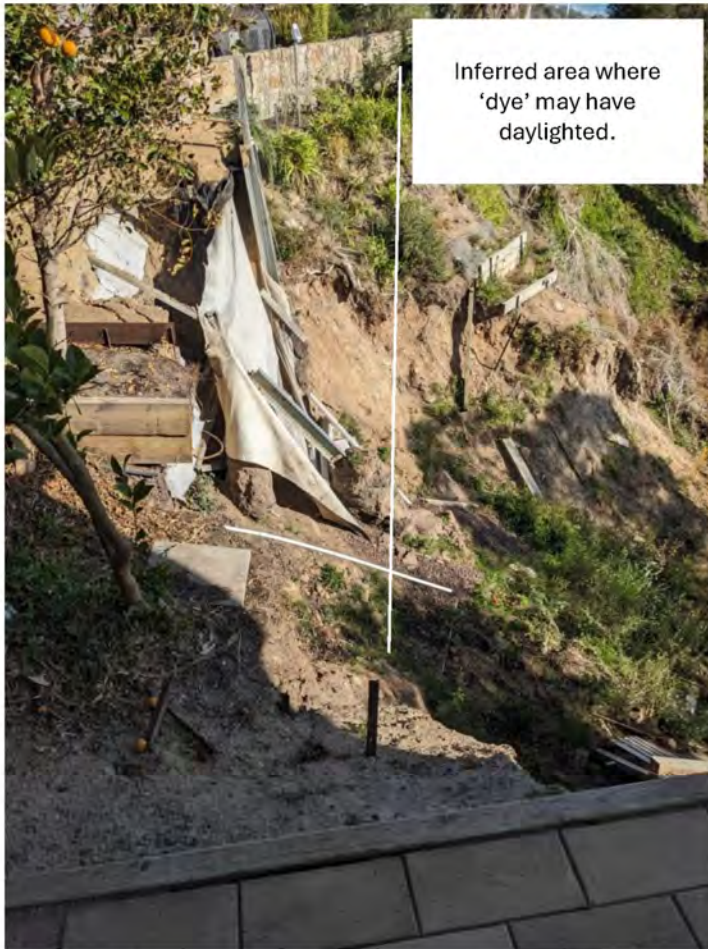
Figure 22: 20/6/25 looking west showing colluvial material exposed , note the geofabric behind the line of the retaining wall.
