Multidisciplinary Expert Supplementary Report

Board of Inquiry into McCrae Landslide

Prepared for: Thomson Geer

30 July 2025

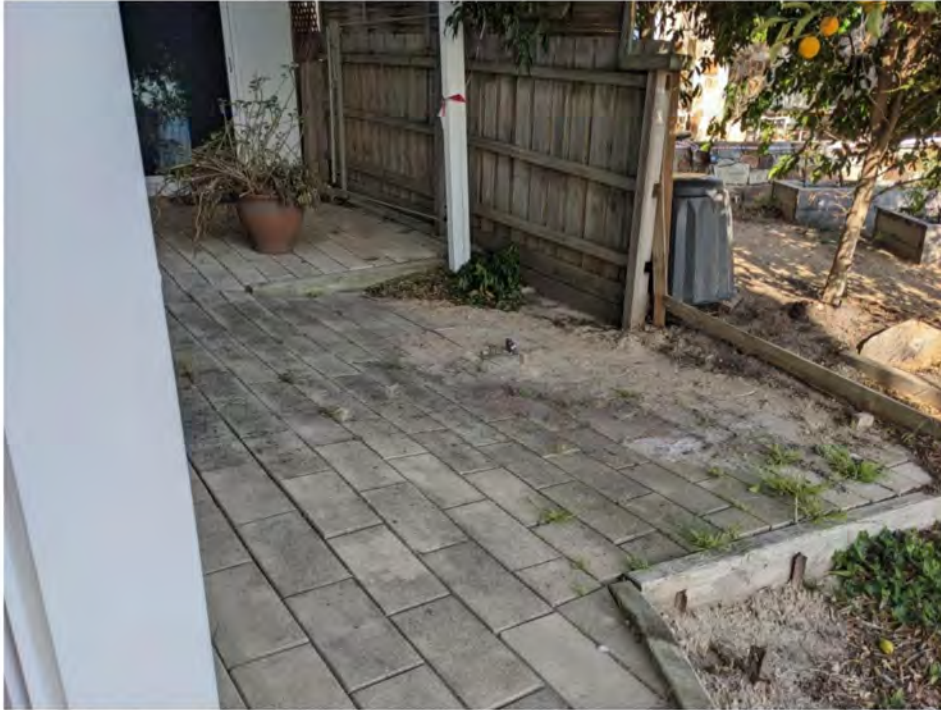
Figure 25: 20/6/25 6 View Point Road, looking south towards fencing with No. 10, showing disturbed ground.

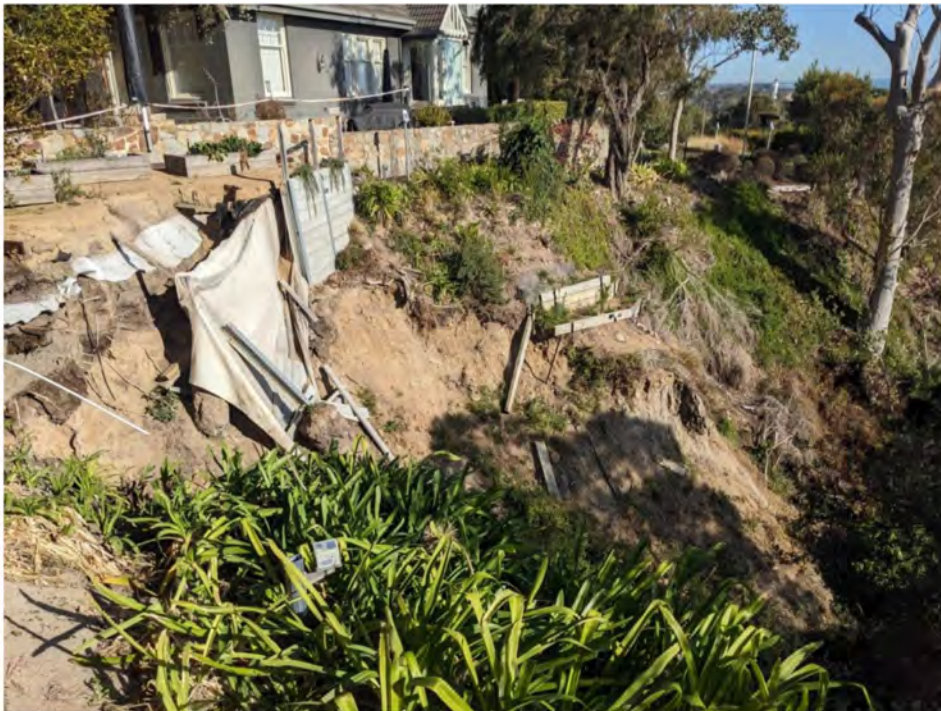
Figure 26: 20/6/25 Looking west from 6 View Point Road. Note the change in geology below the wooden sleepers.

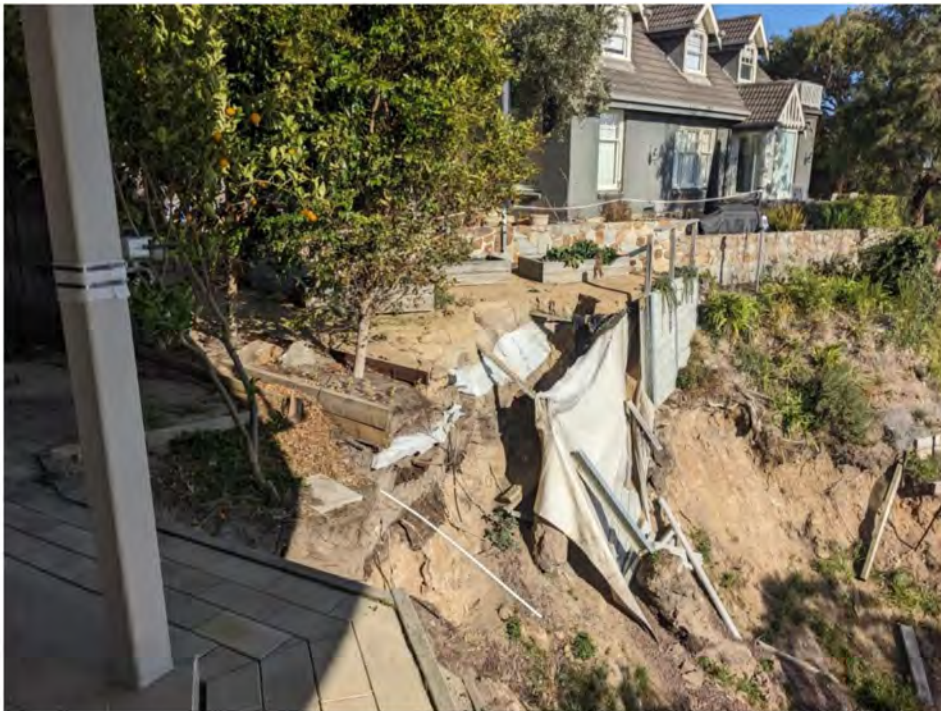
Figure 28: 20/6/25 6 View Point Road looking west. Note the leaning back of the retaining wall posts

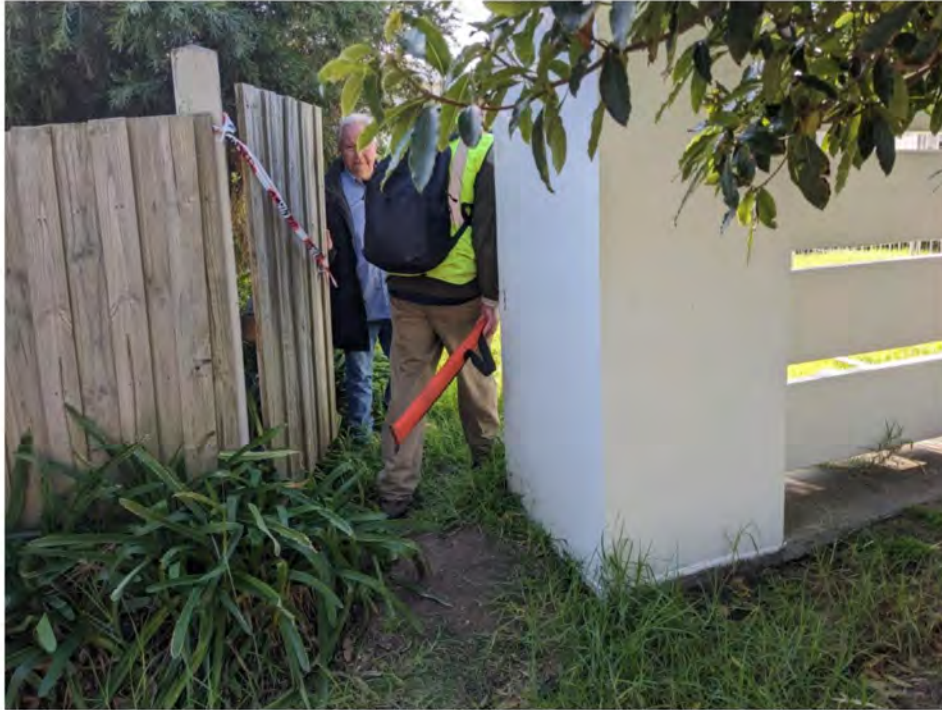
Figure 29: 20/6/25 6 View Point Road looking north showing front gate which has had to be shaved due to toppling concrete pillar.

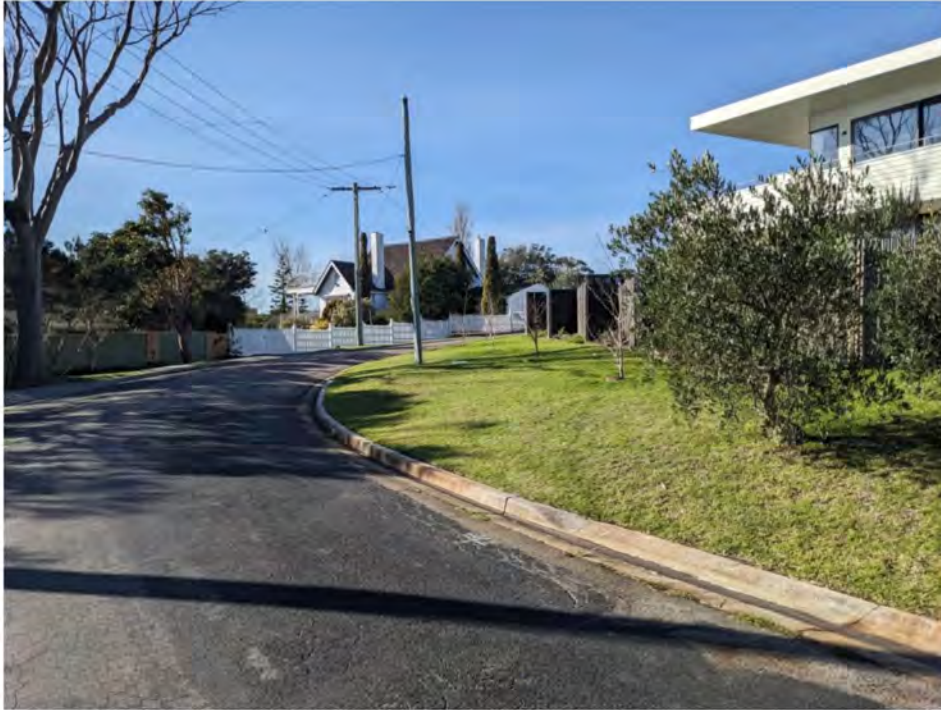
Figure 33: 20/6/25 7 Prospect Hill Road, looking east showing verge

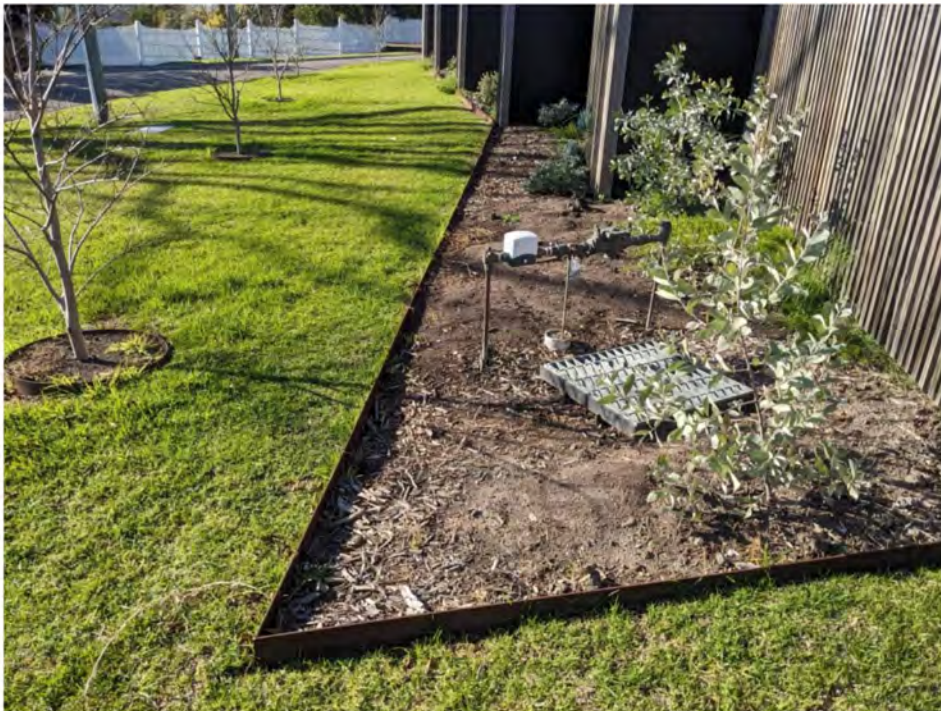
Figure 34: 20/6/25 7 Prospect Hill Road looking east showing gully pot where AG pipes from the property meet, flowing to Stormwater Pit outside No. 11.

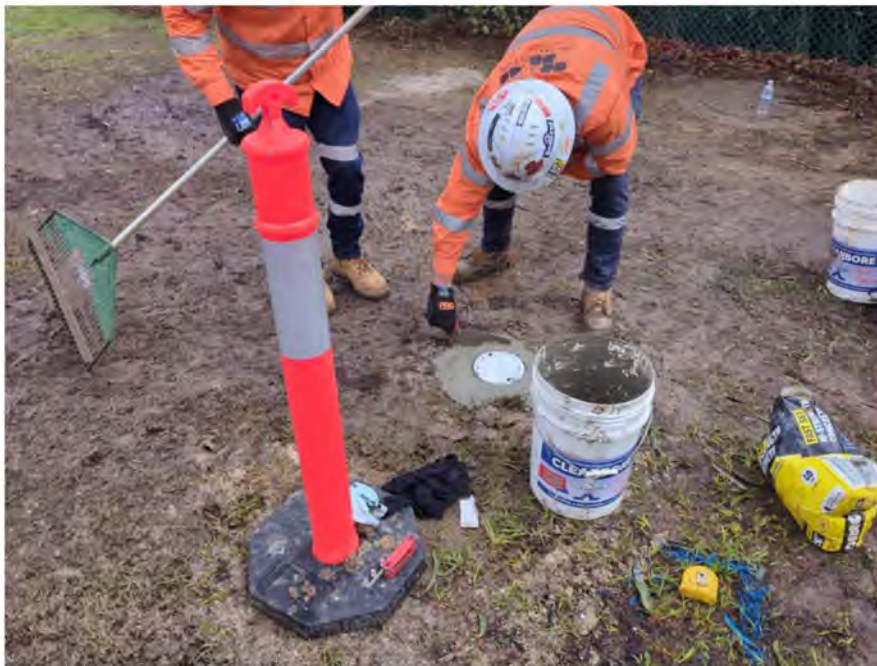
Figure 4: Well installation at BH01

Groundwater monitoring bores were developed in selected locations between 30 June 2025 and 9 July 2025. Water levels were manually gauged using a water dipping tool during site investigation works. Measurements were taken from the top of the PVC casing and results have been tabulated below in Table 4 to Table 7, a typical finished well has also been provided in Figure 4.

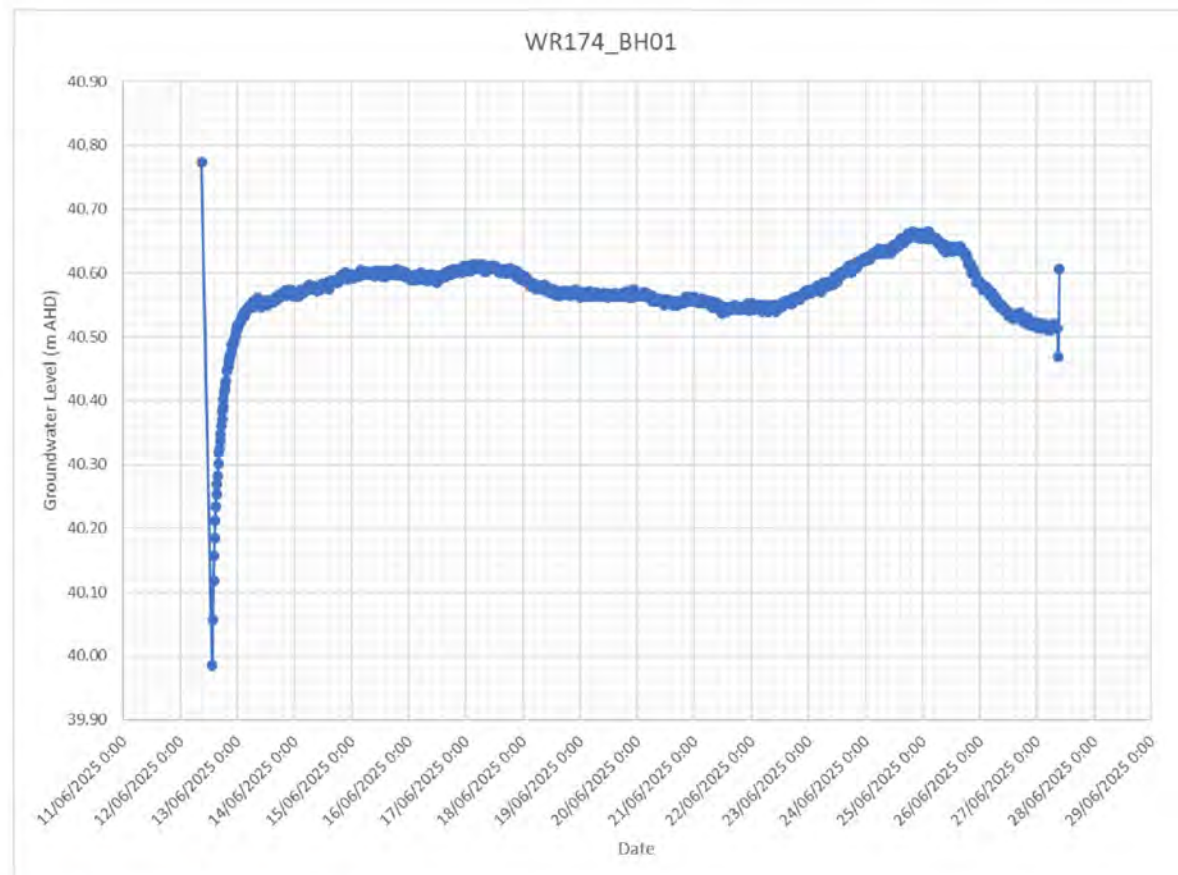
Figure 5: WR174_BH01 groundwater level readings

WR174_BH01 by DP was drilled and a standpipe was installed to a toe depth of 22.3m bgl. Figure 5 below shows the continuous monitoring of groundwater levels observed within this groundwater well. It is observed that the data logger was installed on 12 June 2025 and continuous measurements at 15-minute intervals until 27 June 2025.

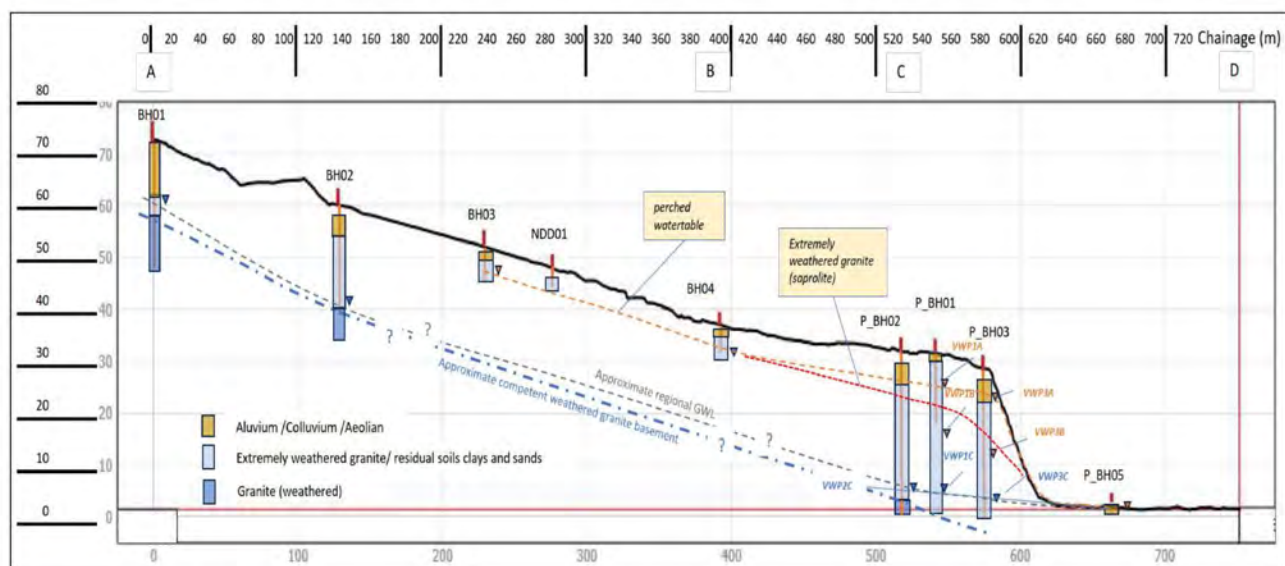
Figure 4: Interpretative hydrogeological cross section

Figure 4 below is a summary of aquifer zones intercepted by the drilling in the area and the groundwater levels.

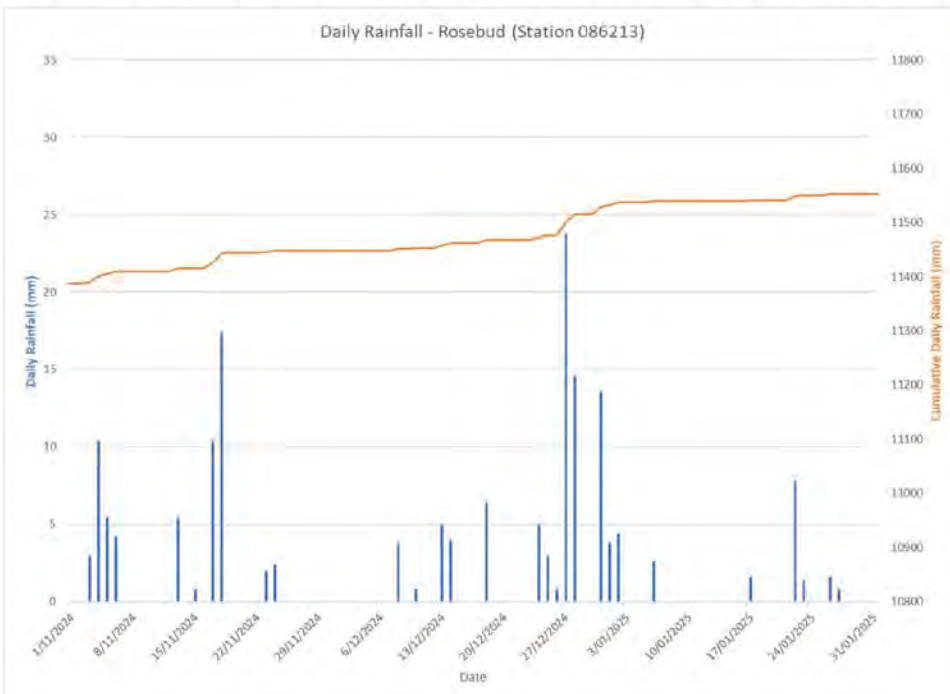
Figure 7: Daily Rainfall for Rosebud monitoring station 086213 for the period 1/11/24 to 31/1/25

Daily rainfall data and the accumulated daily rainfall around the time of the landslips is presented in Figure 7.

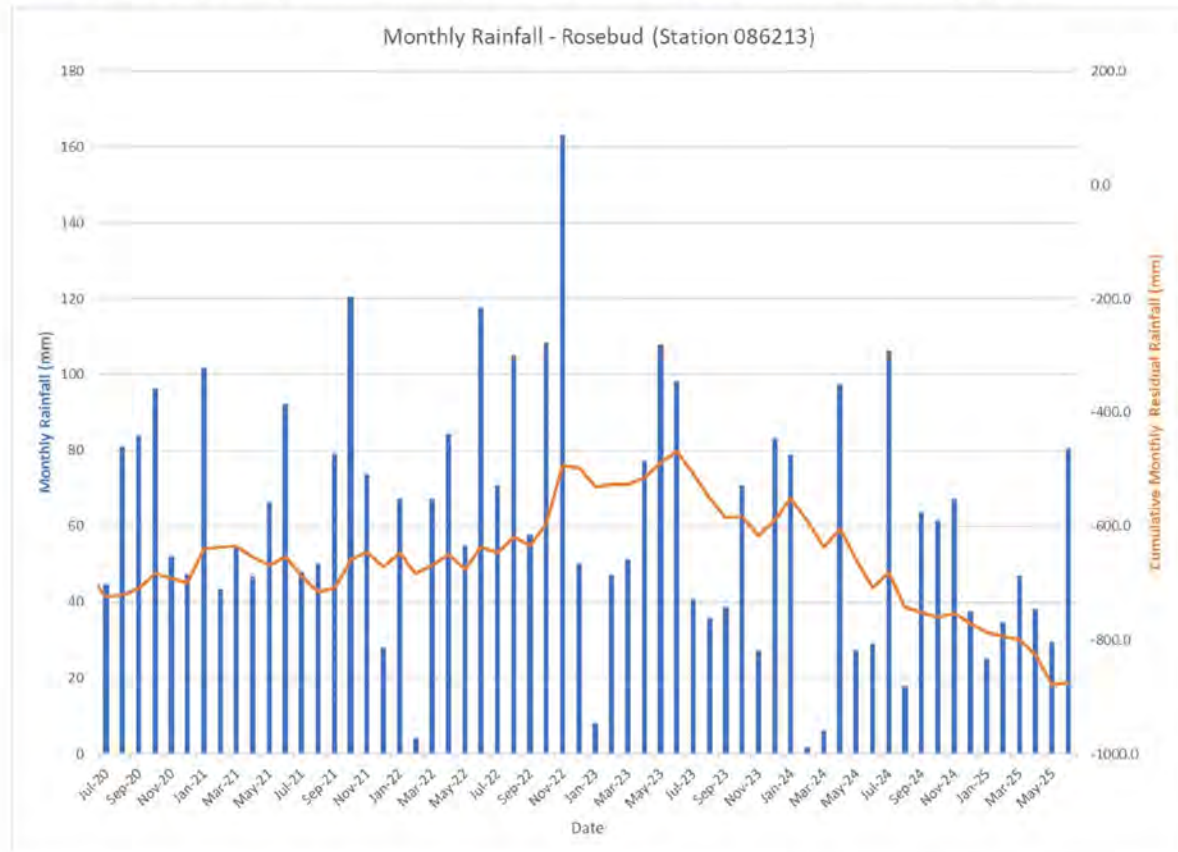
Figure 8: Cumulative Residual Monthly Rainfall for Rosebud rainfall station

The November 2024 monthly rainfall of 67.2mm is slightly higher than average monthly rainfall (60.2mm). However, is not outside the normal range of November rainfall events for the area. The cumulative residual monthly rainfall data from July 2024 to November 2024 in the lead up to the landslide shows a falling trend. Cumulative residual rainfall is a consecutive monthly accumulation of the deviation from average monthly rainfall. Therefore, a rising trend indicates a wetter period and a falling trend indicates a drying trend.

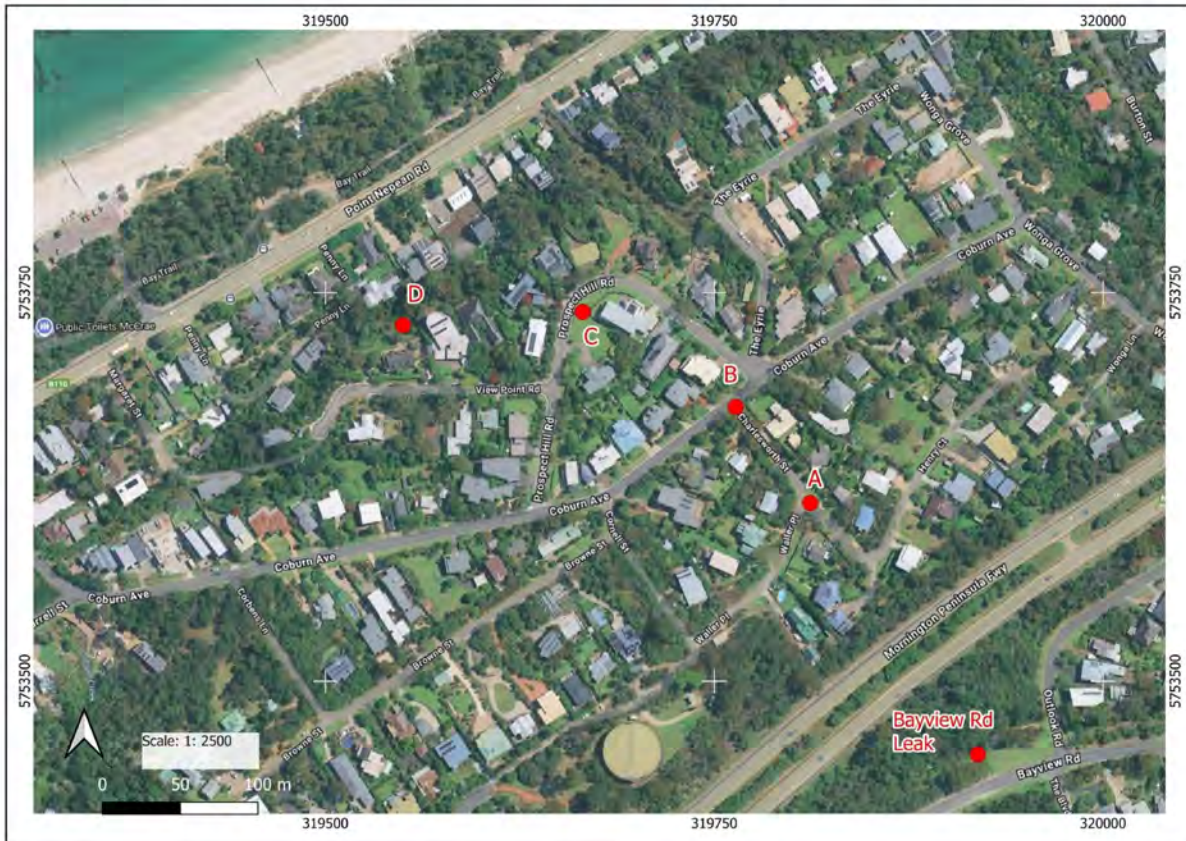
Figure 10 Location of sample sites referred to in Figure 11 and Figure 12

- Bayview Road Leak
- A – Waller Place and Charlesworth Street intersection where upwelling occurred
- B – Coburn Avenue and Charlesworth Street intersection where upwelling occurred
- C – 7 Prospect Hill where samples collected from building foundation drainage system
- D – Location of landslide where a water quality sample was taken on 6 January 2025

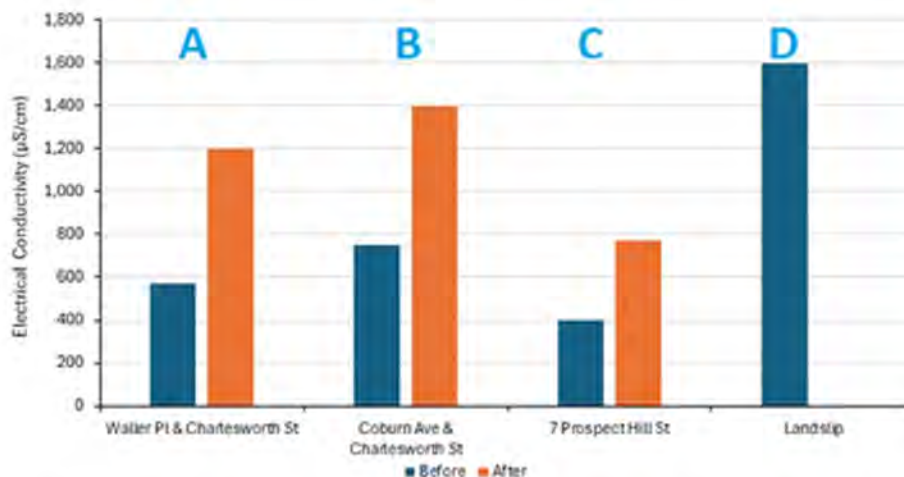
Figure 11: Summary of EC for selected sample locations showing Before and After Fix of Burst Pipe area

Figure 11 shows EC changes for the selected sample location shown in Figure 10 for EC values prior to / shortly after repairing the SEW burst compared to EC values post repair, which show a substantial increase in EC levels

as groundwater quality in the shallow perched aquifer returns to background water quality. In fact, it can be seen that in each case, the post-repair EC is almost exactly double the pre-repair value.

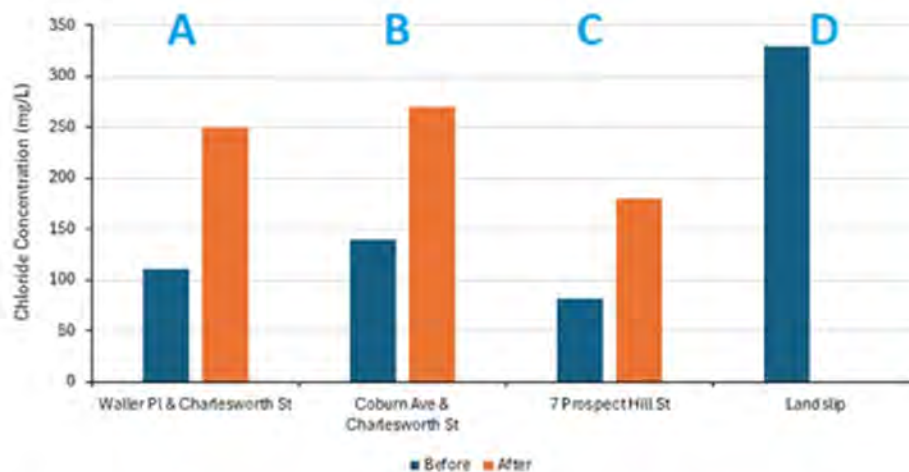
Figure 12: Summary of Chloride Concentration for selected sample locations showing Before and After Fix of Burst Pipe

A similar proportionate change in concentrations is also observed for chloride, as shown in Figure 12.

Overall, the increase in EC, and chloride, post repair of the burst pipe shows similar ratios.

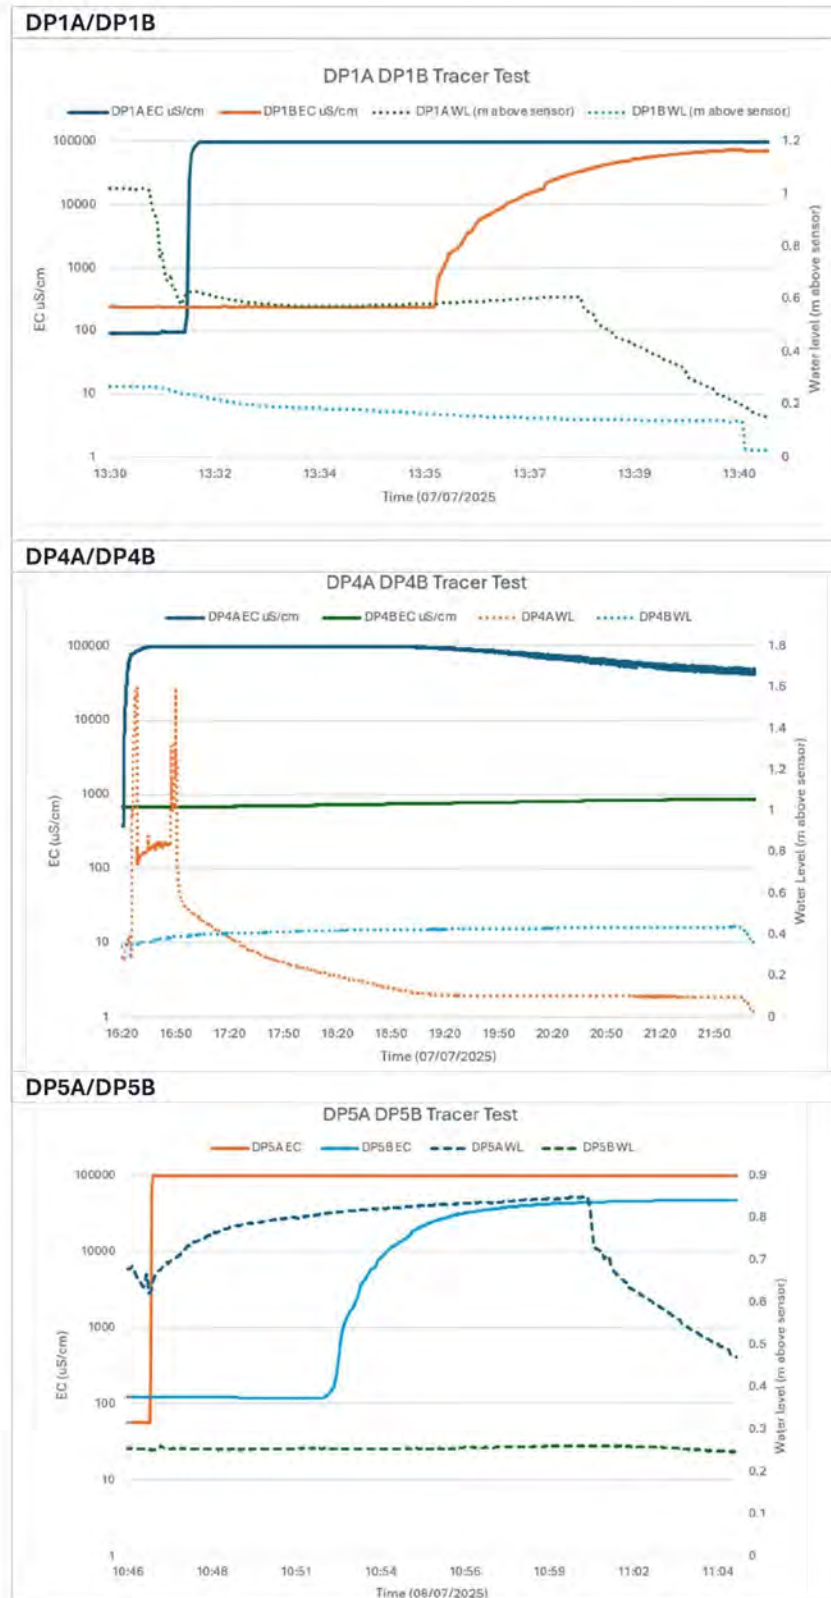
Figure 15: Tracer Test Plots

Tracer test results are present in Table 12 and graphically in Figure 15. Both DP1A/DP1B and DP5A/DP5B show clear responses indicating the ability of the embedment material to transmit water. It should be noted that the head differences that occurred during the test are higher than what would be experienced in reality therefore the travel times should be treated with this in mind.

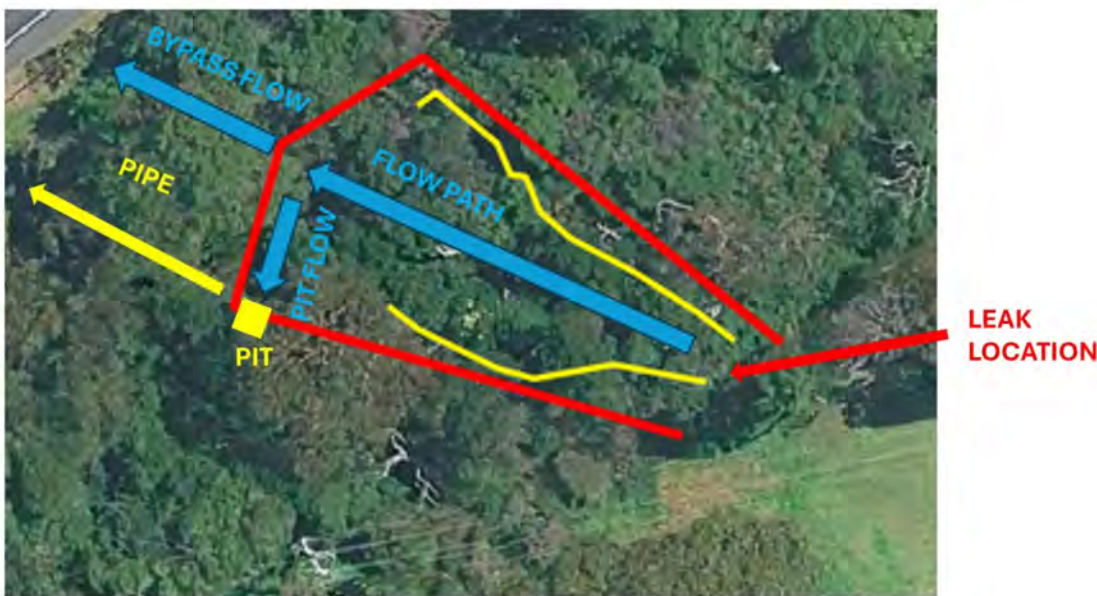
Figure 1: Estimated Sand Deposition Extent

The occurred through dense vegetation between Bayview Road and the Mornington Peninsula Freeway. The flows appear to have progressed downhill towards a shallow unlined surface drain running parallel to the Mornington Peninsula Freeway and terminating at an open grated pit. The pit is connected to a drainage line running underneath the freeway. Any flows which are not captured by the surface drain and pit would bypass the surface drain and continue downhill to the freeway.

The extent of the surface flows is estimated to be delineated by the extent of sandy materials deposited across the surface downstream of the leak location. The key features are shown on Figure 1.

The extent of sand deposition is delineated by the red lines in the above image. An example of the sand deposition area as viewed on the ground is presented in Figure 2.

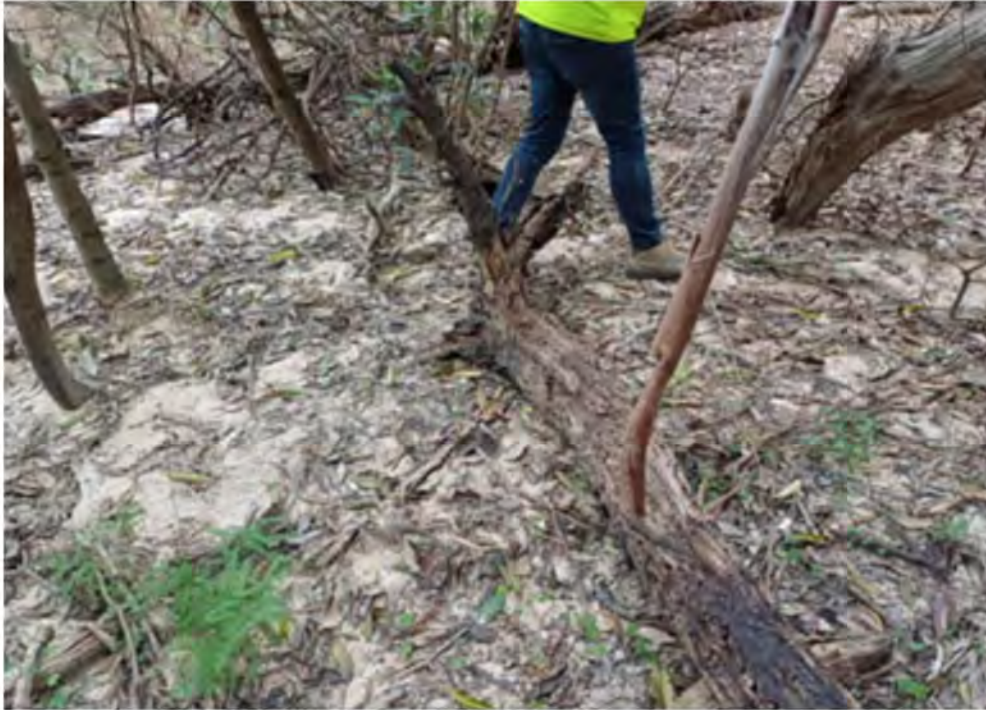
Figure 2: Example of Sand Deposition

The image presented above shows that the sand depositions area has a characteristic colour, overlies leaf litter and is largely free of vegetation. The appearance is different to that of adjoining regions which are characterised by a greater vegetative coverage, darker colour and a greater depth of leaf litter across the surface.

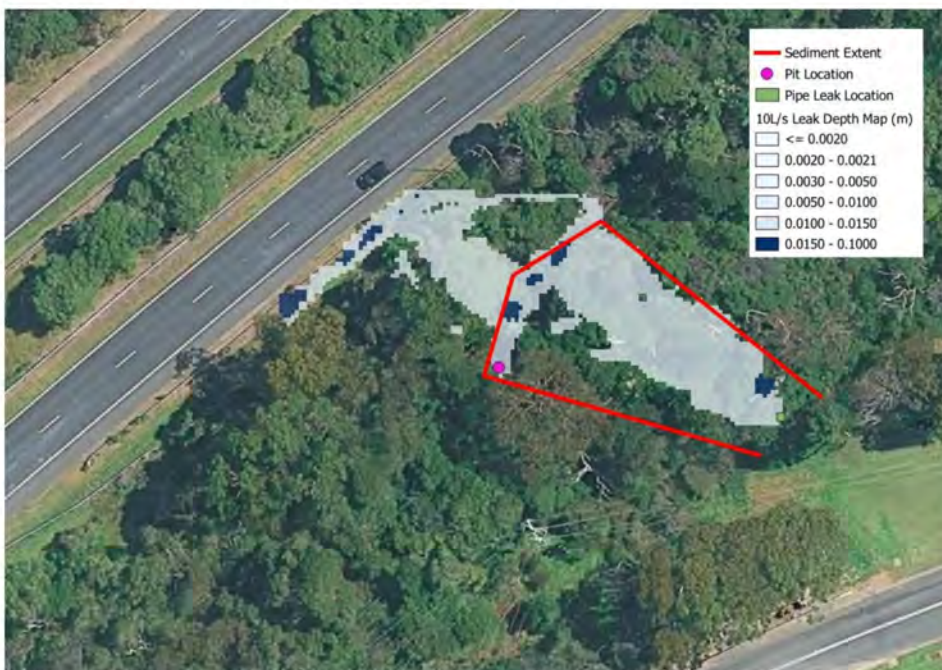
Figure 4: 10 L/s inundation extents

The outcomes indicate that the flood extent is similar to the observed extent of sediment deposition (red line). The outcomes indicate that the majority of the estimated outflow of 16 L/s would have travelled across the surface.

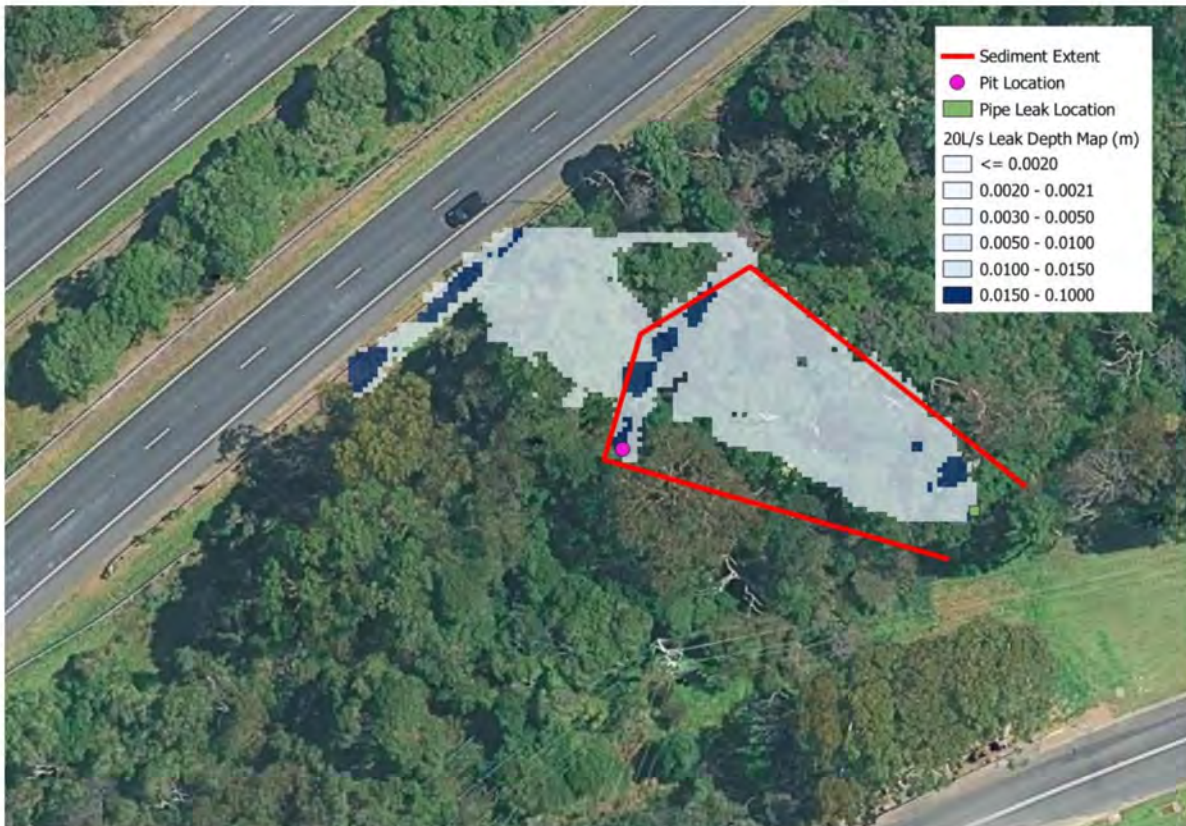
Figure 5: 20L/s inundation extents

The surface area of the inundation extent is estimated to be around 400 m². Applying an infiltration rate of 50 mm/hr suggests that an infiltration into the subsoil of up to 5 L/s could have occurred.

It is judged that the majority, or all, of the estimated peak leakage flow would be required to produce a sediment deposition pattern consistent with that observed at the site. The infiltration estimate indicates that around 25% of the 20 L/s flow could have entered the subsoils.

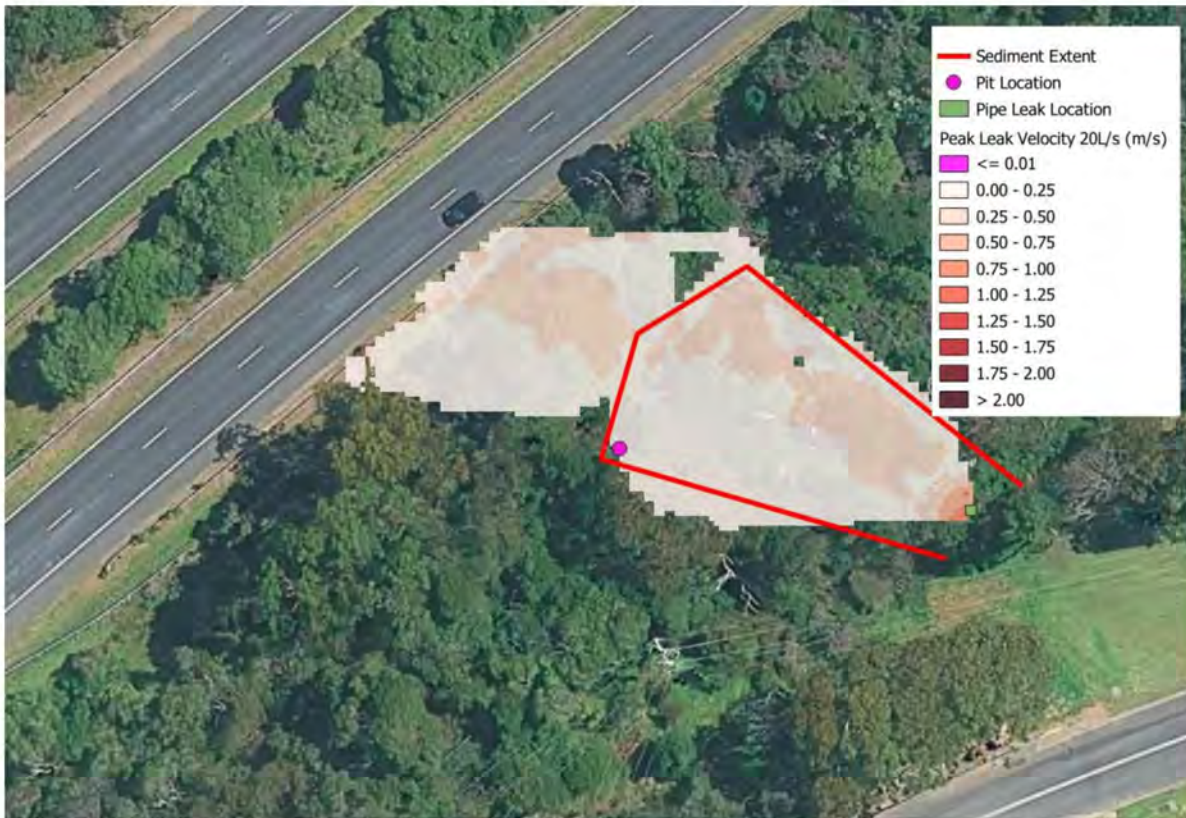
Figure 6: 20 l/s maximum velocities

Note that the velocities in the above figure cover a broader extent than that shown in the flood maps because velocities are shown for all depths, while the flood maps do not show depths less than 2 mm. The maximum velocities are around 0.5 m/s. This is consistent with a maximum diameter of around 1 mm for transported sediments.

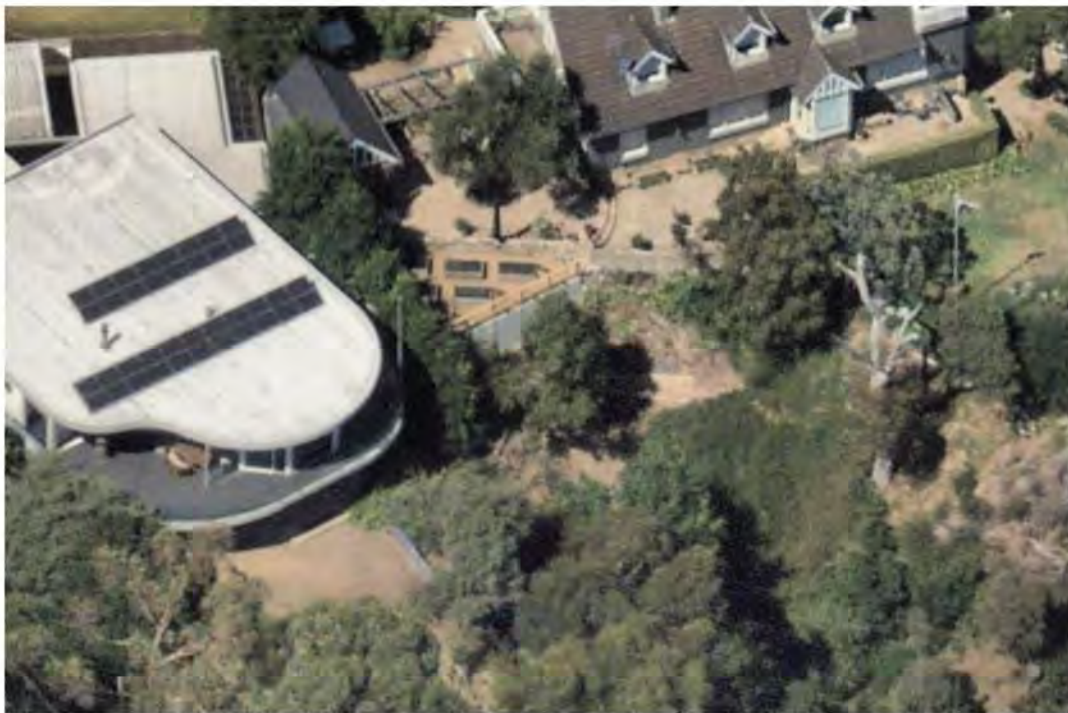
Figure 1: Aerial photo on 15 February 2024 (Nearmap 2024)

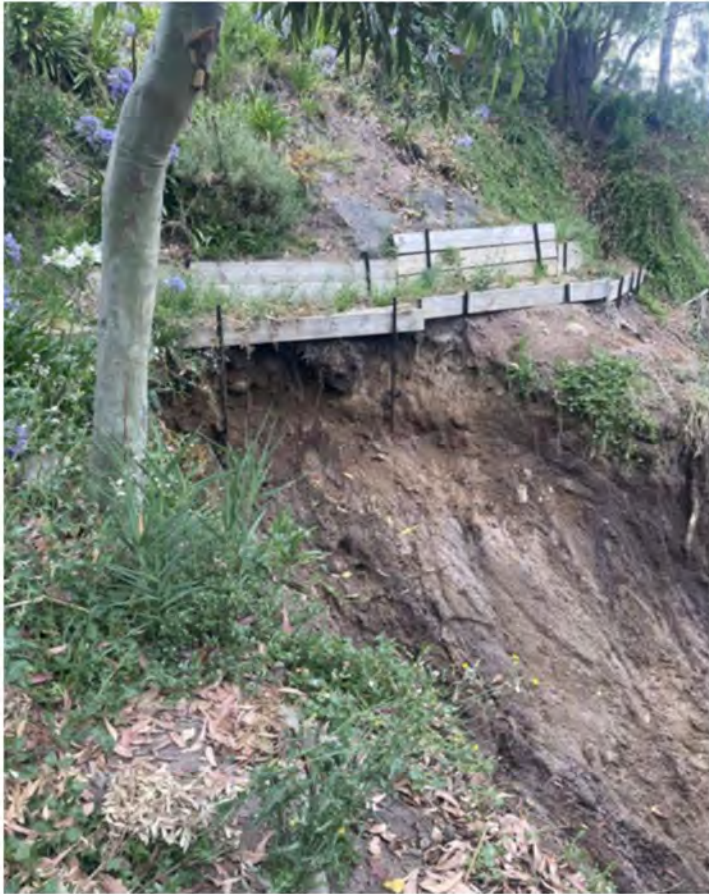
Figure 4: Photo taken by SEW personnel on 6 January 2025 showing detail of backscarp of landslide

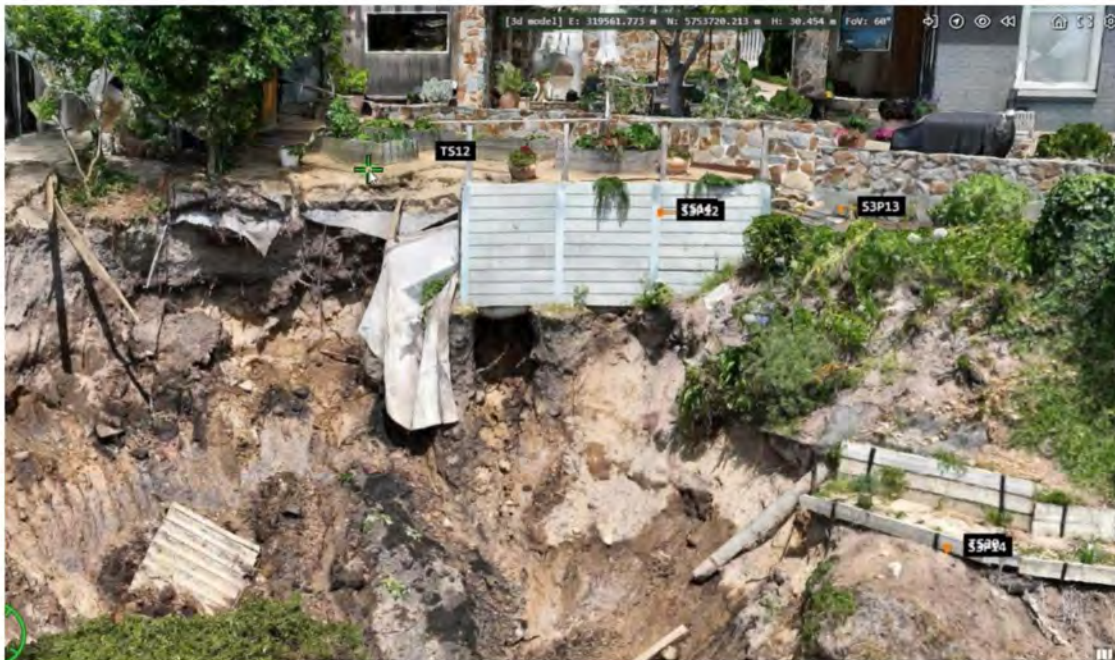
Figure 1 to Figure 5 show the site prior and after the 2025 landslide events. It can be seen that the retaining wall was not affected in the 5 January landslide (Figure 2), and the backscarp of this failure was approximately 3 m to 5 m below the toe of the retaining wall.

Figure 5: Drone footage of the retaining wall on 16 January 2025

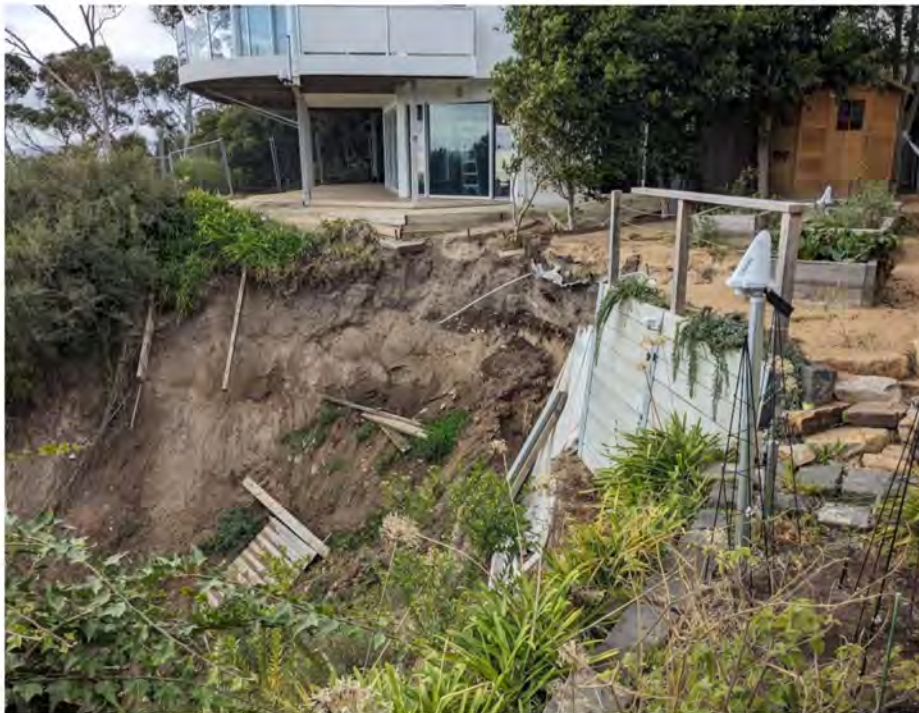
Based on BH01 and BH02 by PSM, the ground at 10 View Point Road comprised granular fill material overlying inferred granular colluvium material, underlain by residual granite recovered as Clayey SAND or Sandy CLAY and grading into XW granite as depth increases. Figure 7 and Figure 8 shows the post-failure condition of the slope. It can be seen that as surficial material (inferred colluvium soil) slipped down along the slope, weathered rock was daylighted under the retaining wall. Based on Figure 8 and site observations, the thickness of the inferred colluvium soil above weathered rock was approximately 1-2m.

Figure 7: Site photograph looking at backscarp facing 6 View Point Road

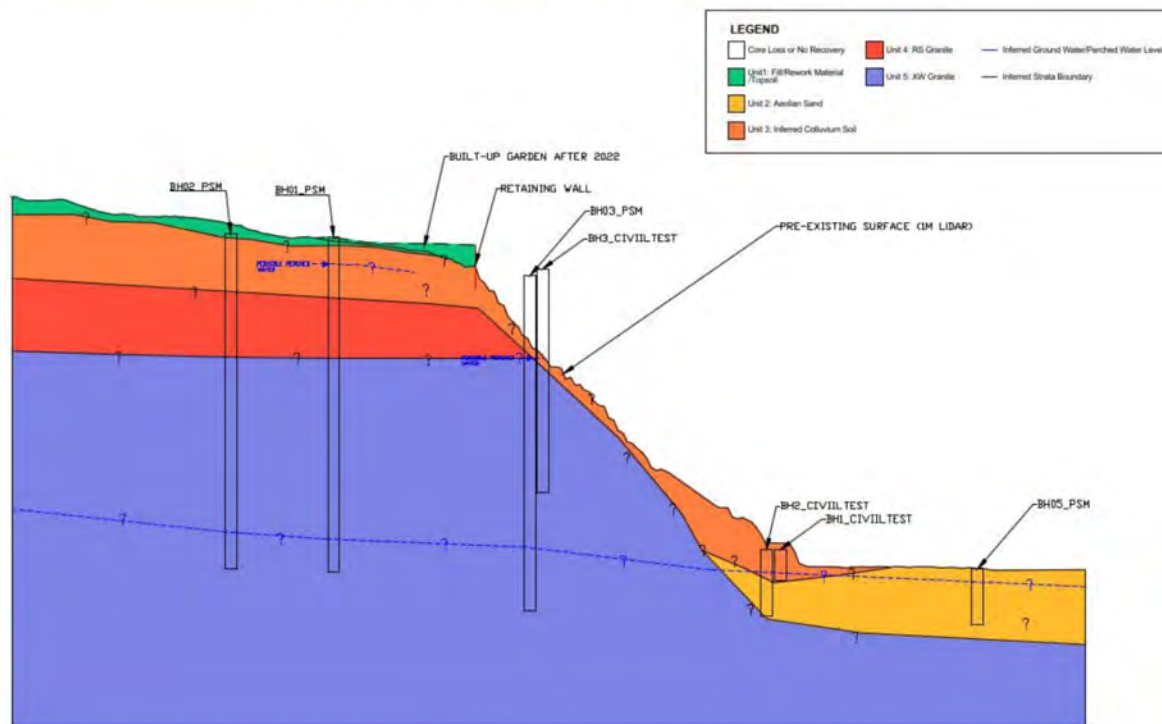
Figure 9: Ground model of assessed section (not to scale)

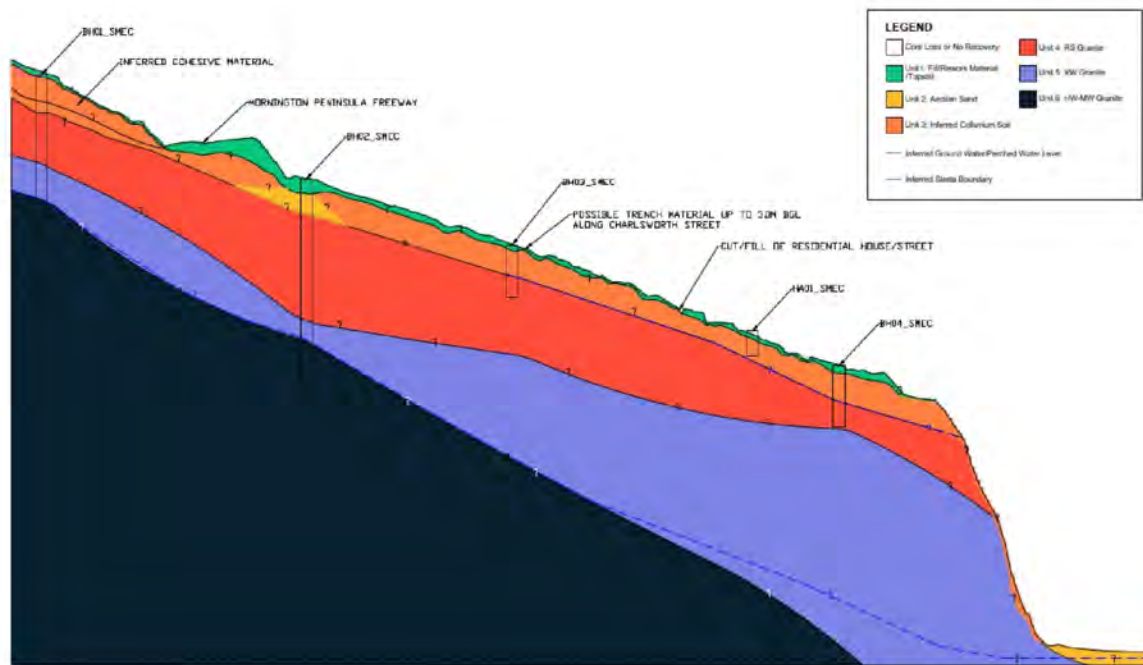
Figure 11: Ground model of site locality (not to scale)

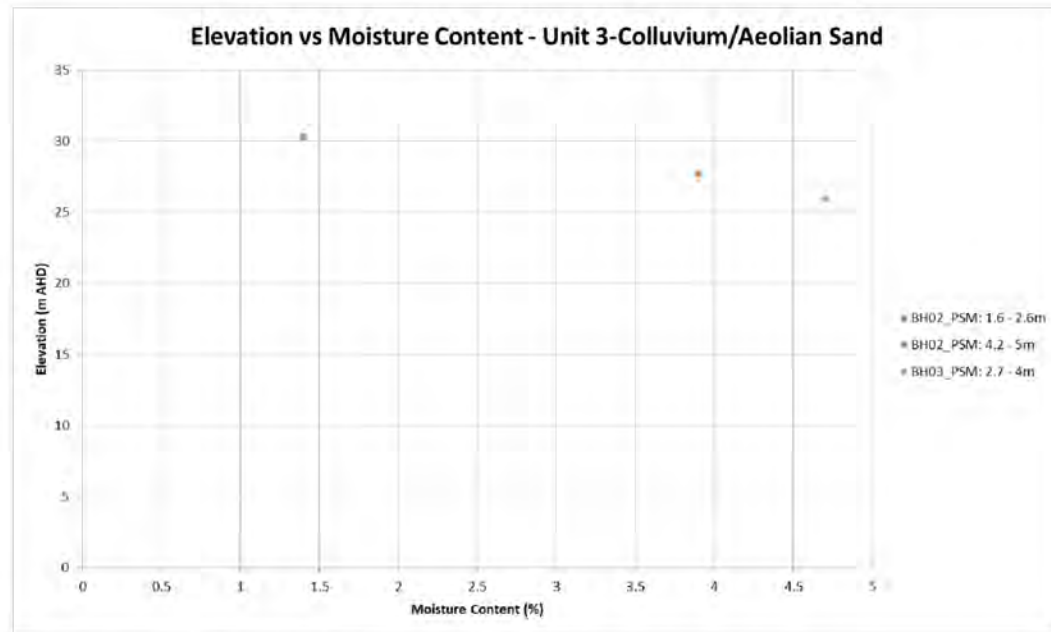
Only two moisture content tests were performed on Unit 3 materials, showing in Figure 12. It can be seen that the results of the tested samples had less than 5% moisture content. Note that material in BH03_PSM at 2.7 m was logged as wet soil.

Figure 12: Unit 3 moisture content plot
