Multidisciplinary Expert Supplementary Report

Board of Inquiry into McCrae Landslide

Prepared for: Thomson Geer

30 July 2025

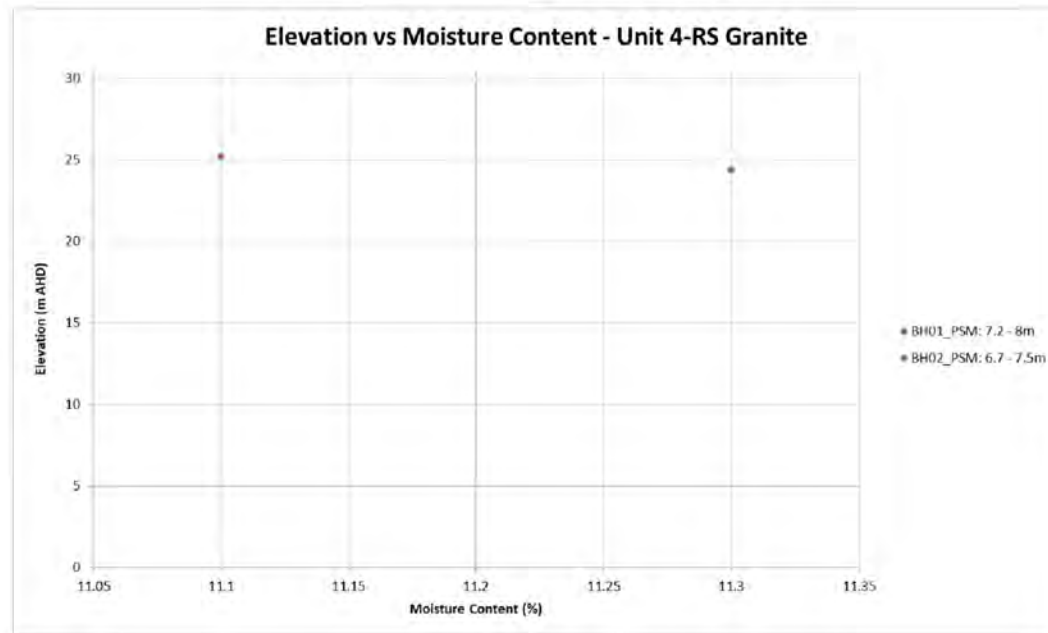
Only two moisture content tests were performed on Unit 4 materials, showing in Figure 13. It can be seen that the tested Unit 4 materials had less than 11.5% moisture content.

Figure 13: Unit 4 moisture content plot

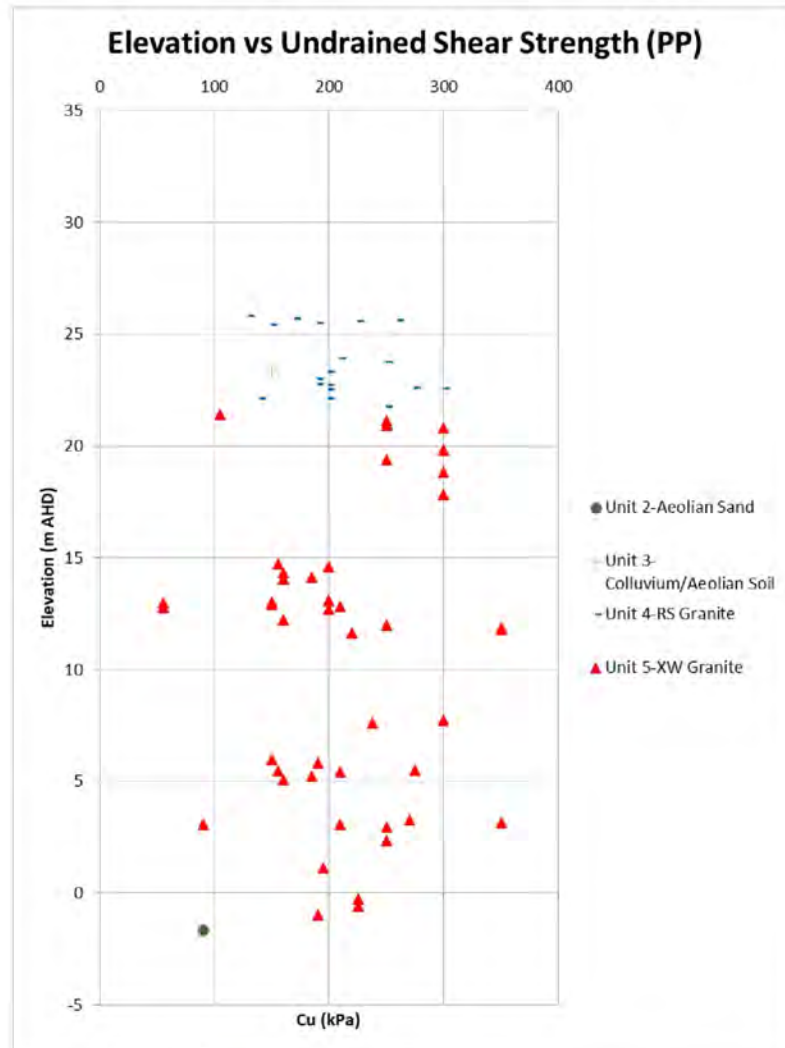
Figure 14: Pocket penetrometer result plot

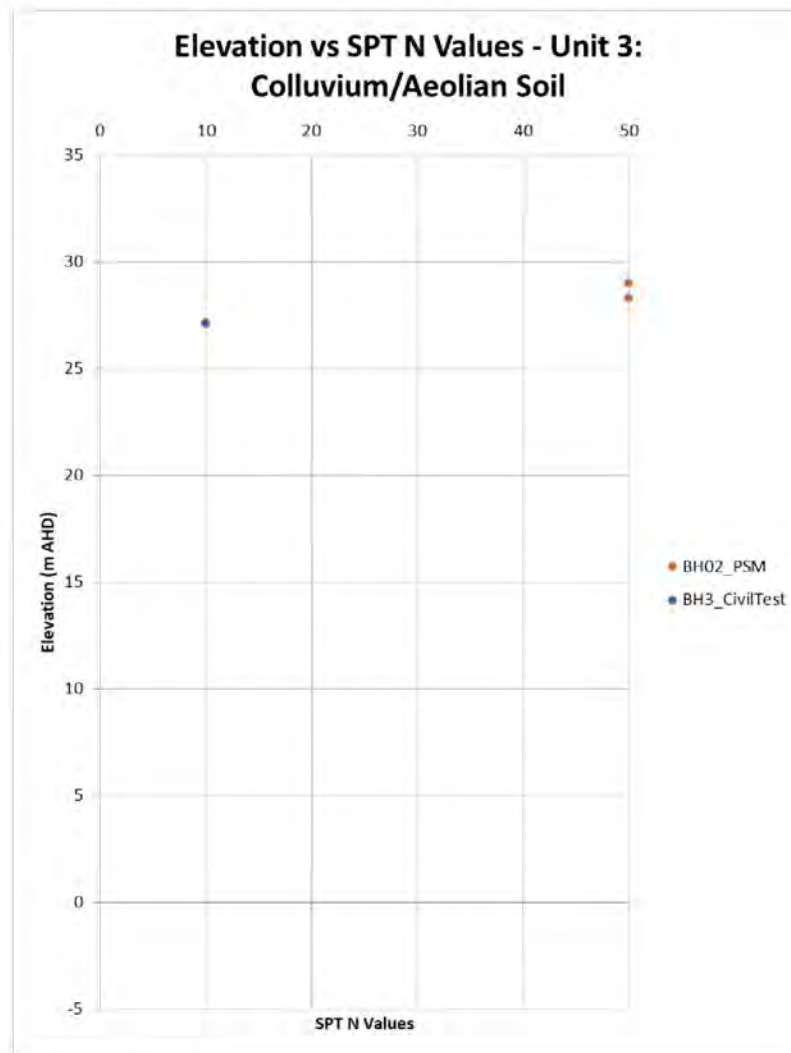
- All SPT in Unit 3 soil were conducted within granular material. SPT in BH02_PSM refused which was potentially due to the presence of gravel;
- Only one SPT in Unit 4 soil was conducted within cohesive material which had SPT N value of 12 indicating consistency of stiff. All other SPTs had N value of 25 to 33, indicating relative density of medium dense to dense;
- Due to the limited amount of data, it is difficult to derive soil parameters from SPT results.

Figure 15: Unit 3 SPT plot

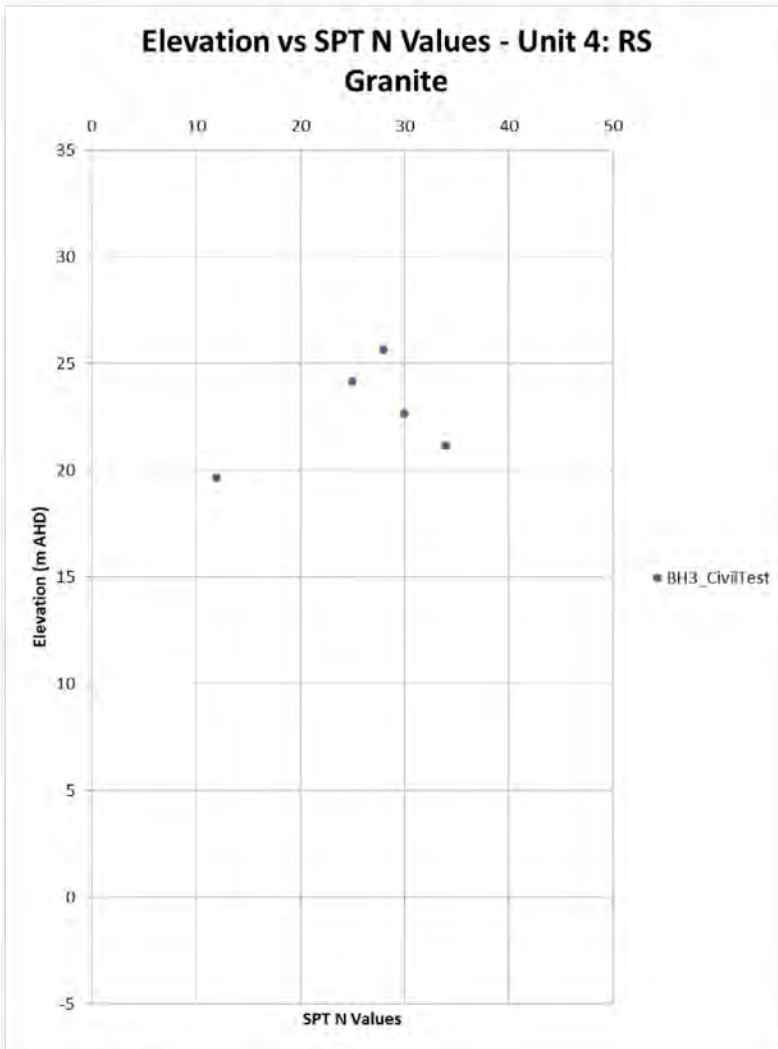
Figure 16: Unit 4 SPT plot

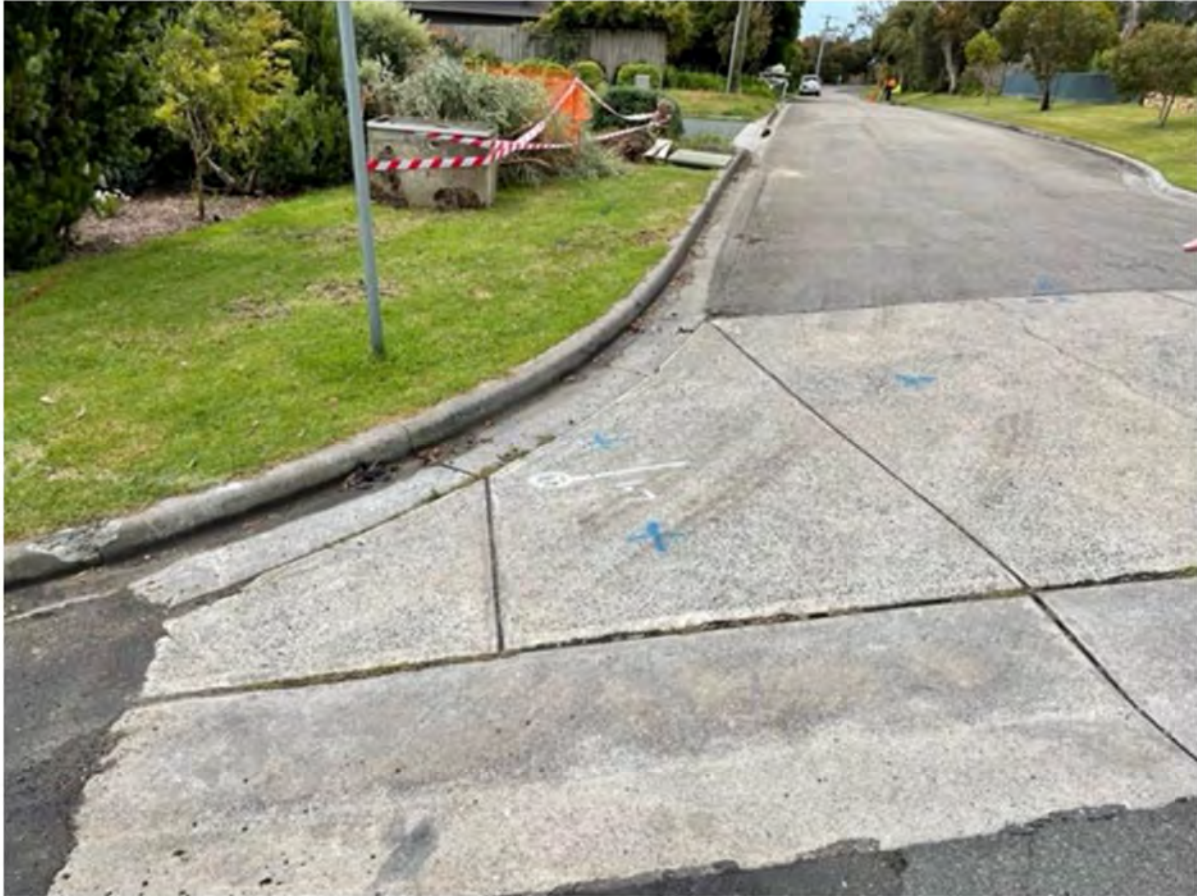
Figure 24: Photograph from email of 22 November 2022, looking north from Coburn Avenue towards Prospect Hill Road showing undulating concrete pavement construction.
