PSM5665 McCrae Landslide - Pile Testing Proposal

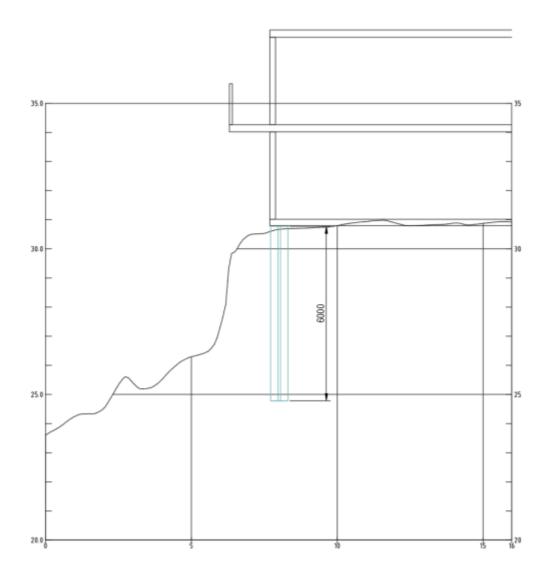
PSM have considered methods available to test the lengths of piles at the Site. A sectional sketch showing the proximity of pile to the rear scarp of the landslide is shown in inset below. The founding depth of the pile is a key control of stability and the pile lengths are not known with any confidence. The estimated range of pile depths is 4 to 8 m. There are approximately 3 to 4 piles in close proximity to the rear of the Landslide.
