Leak Report

19 Highfield Road McCrae Victoria 3938 Australia

📁 South East Water

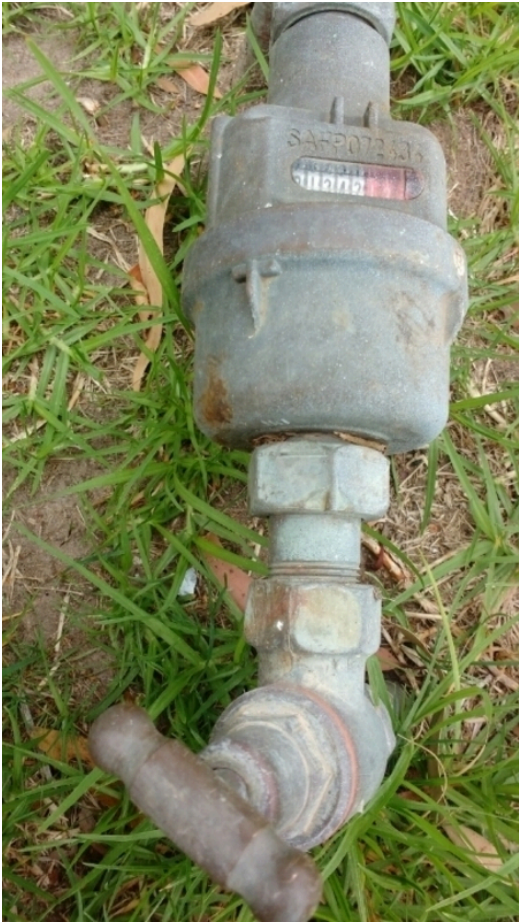
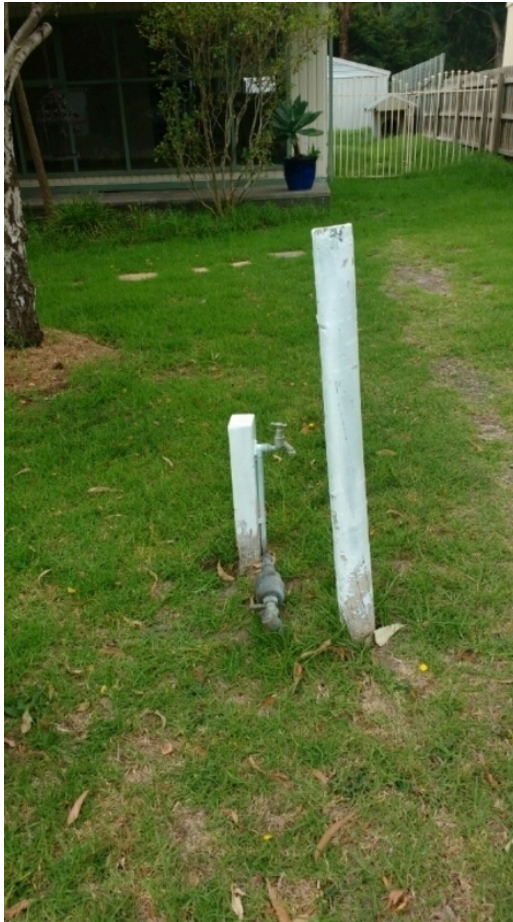
Photo

Stop Tap

0.6

Found meter shut-off. Water passing through meter. Cannot fully shut off meter. Recommend replacing meter tap.
vacant building
