Leak Report

121 Bayview Road McCrae Victoria 3938 Australia

PROJECT
📁 South East Water

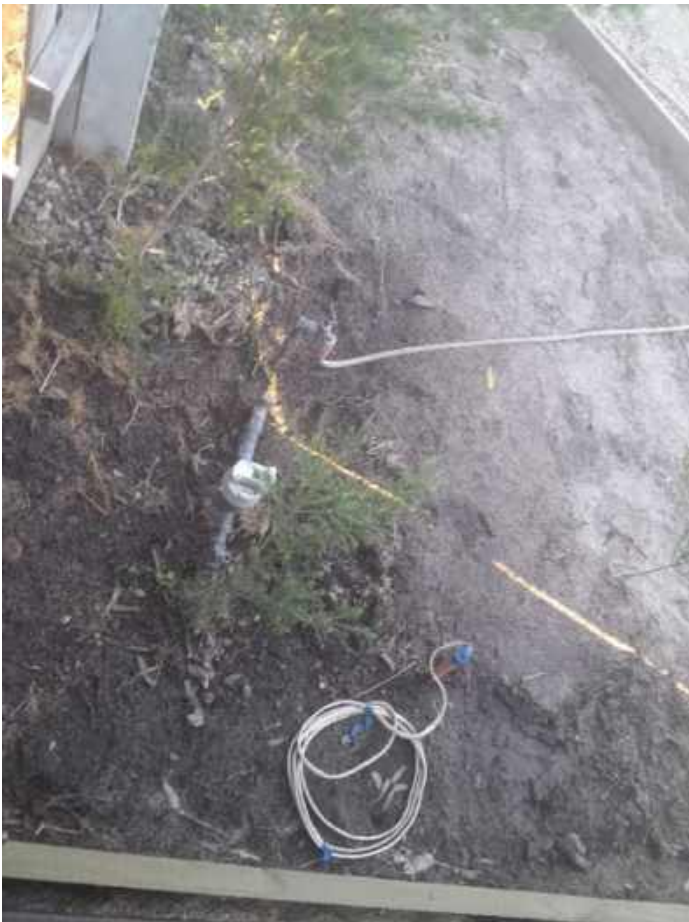
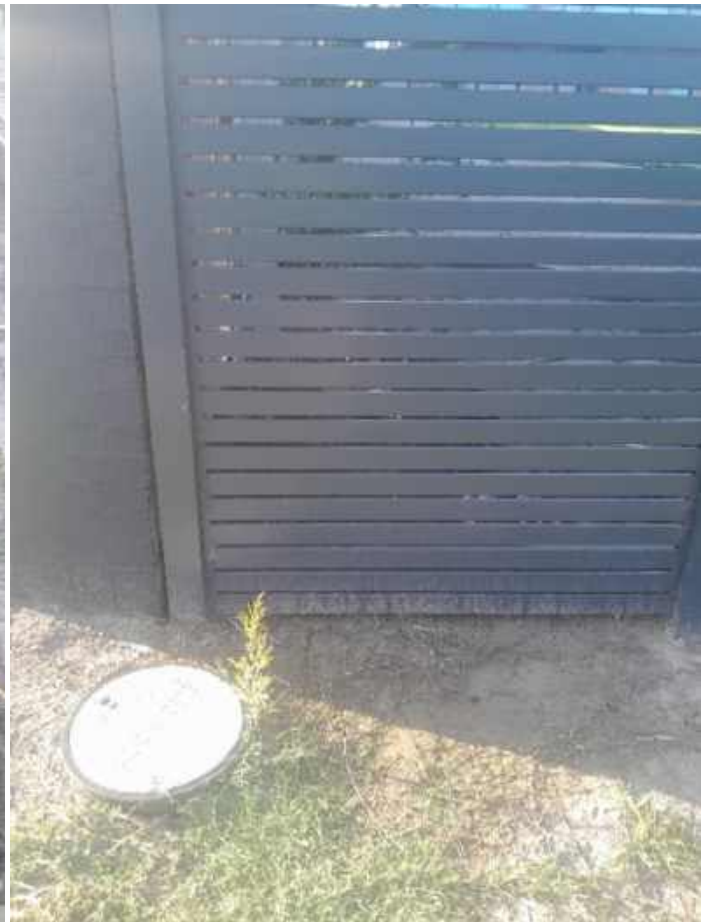
Photo

Leak Address	121 Bayview Road McCrae Victoria 3938 Australia
Zone	South East Water ► Parkes St Tank Zone
Leak Asset Type	possible leak
Flow Rate (L/min)	3
Has the leak been called in by DS Technician?	No
Leak Visible	No
Comments	Good noise on meter, cannot access meter to confirm, sounds louder on service side . Noticed ground looks damp around meter & fence. Watering garden? Suggest gaining access to meter & shutting of meter to confirm if customer leak, service side leak or no leaks are present .
