Leak Report

14 Poole Street McCrae Victoria 3938 Australia

PROJECT
📁 Service Stream

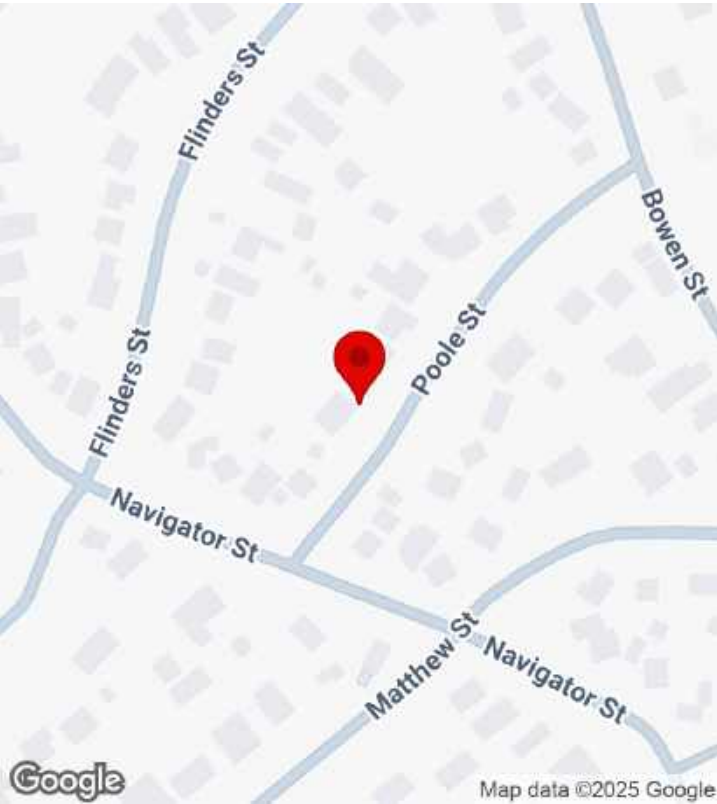
Leak Address	14 Poole Street McCrae Victoria 3938 Australia
Zone	South East Water ► Parkes St Tank Zone
Leak Asset Type	customer leak & meter tap
Flow Rate (L/min)	1
Has the leak been called in by DS Technician?	No
Leak Visible	Yes
Comments	Leak on sprinkler head next to driveway. Water running down driveway. Cannot shut off Meter. Recommend replacing meter tap & notifying customer of leak on sprinkler system
