Leak Report

17 Cook Street McCrae Victoria 3938 Australia

PROJECT
📁 Service Stream

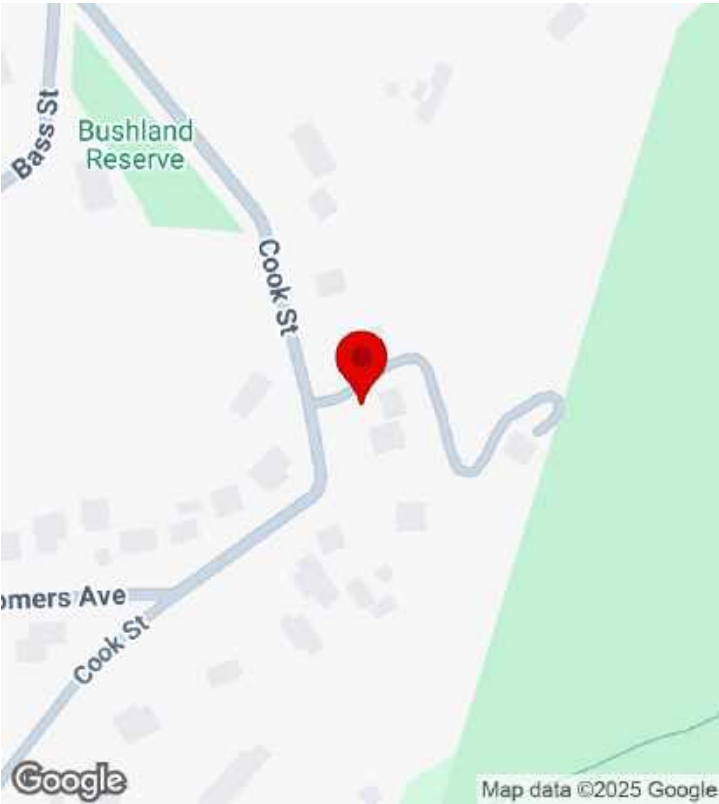
Turned meter on & it started spinning over. Walked up very steep long driveway & noticed water running down steep slope near top of driveway.
Walked around to corner footing of house & noticed water pushing through ground at stone footing of building. Near where telstra cable enters building.

Couldn't probe onto service line. Hard ground.

Suspect that leak may be on service outside building or inside behind stone footing.

Turned meter off as requested

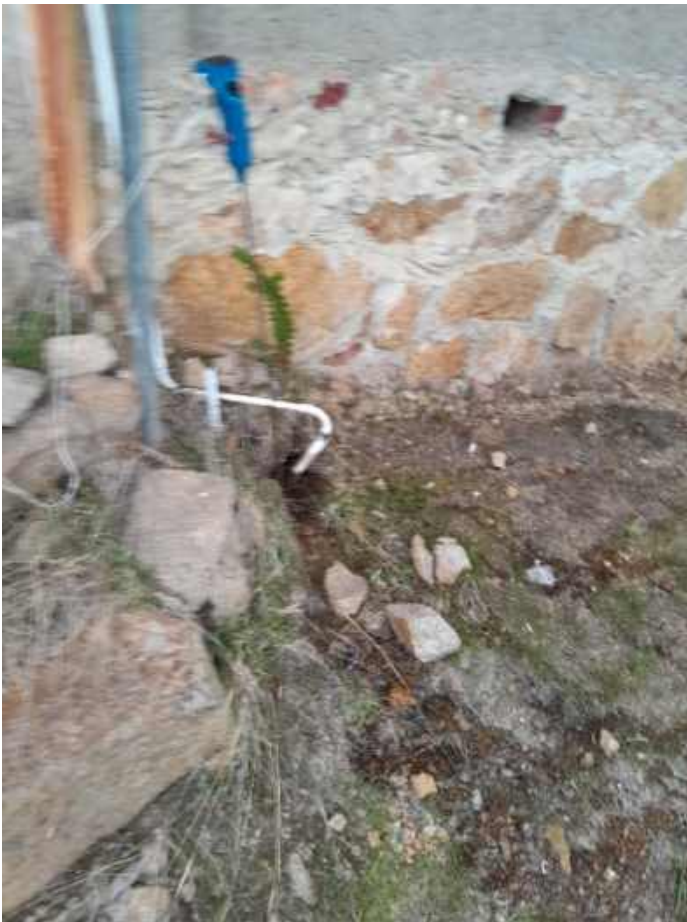
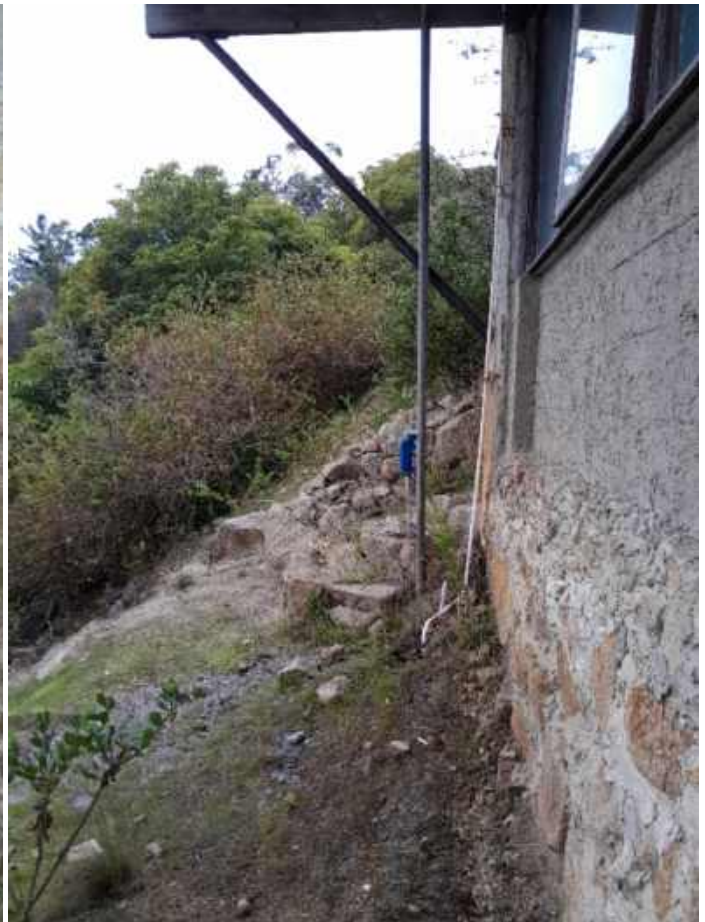
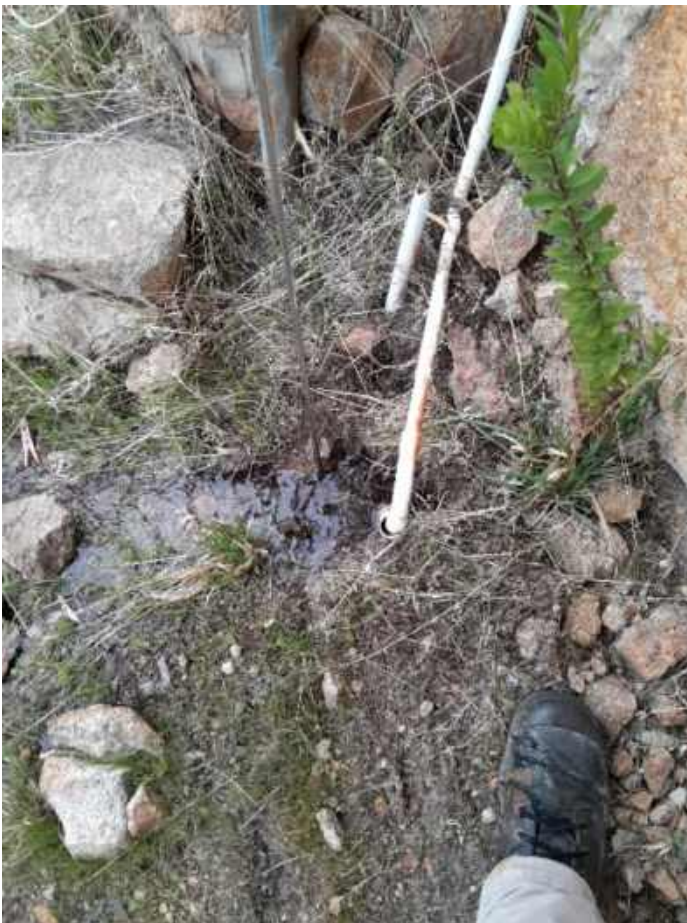
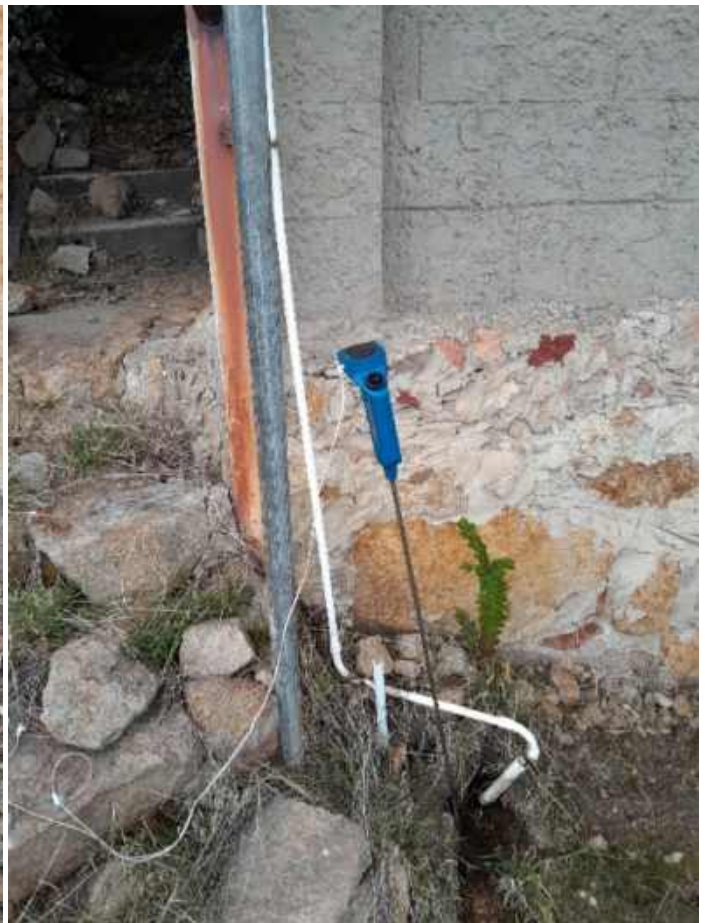
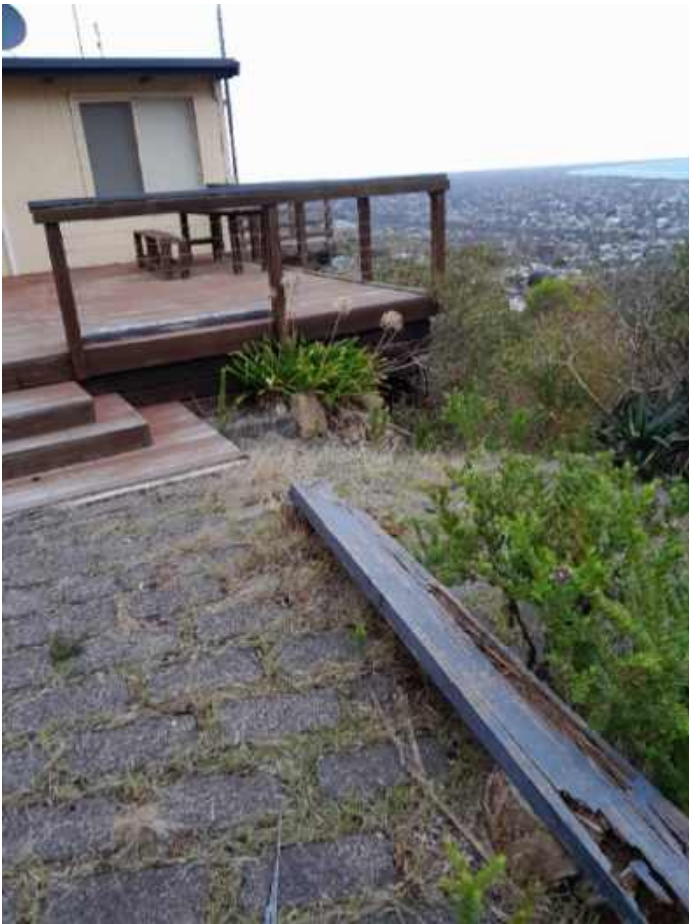
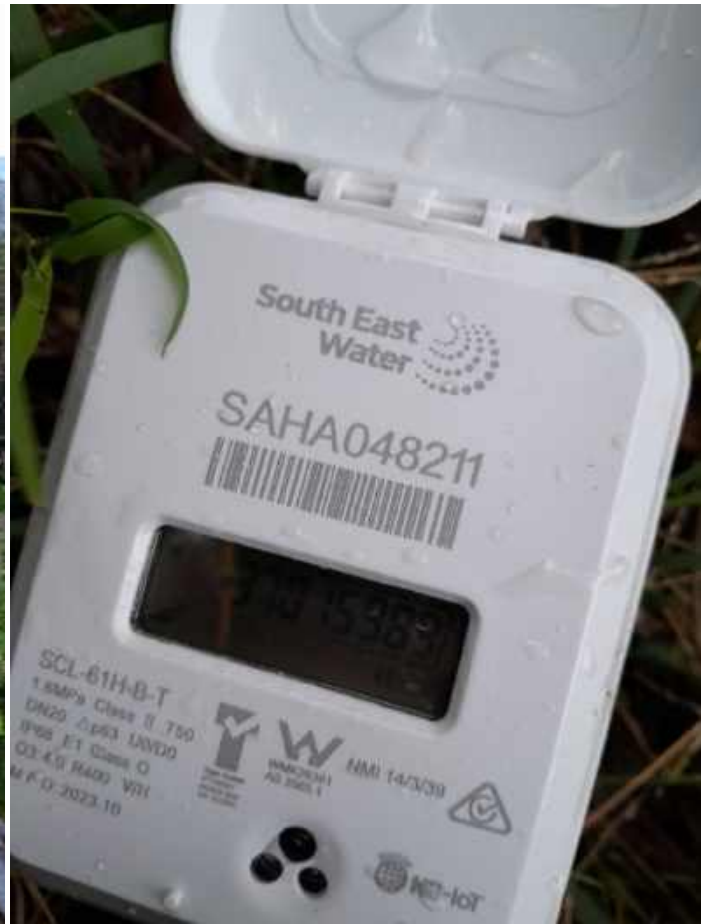
Photo

1200/hr
