# Leak Report

21 Charles Street McCrae Victoria 3938 Australia

South East Water

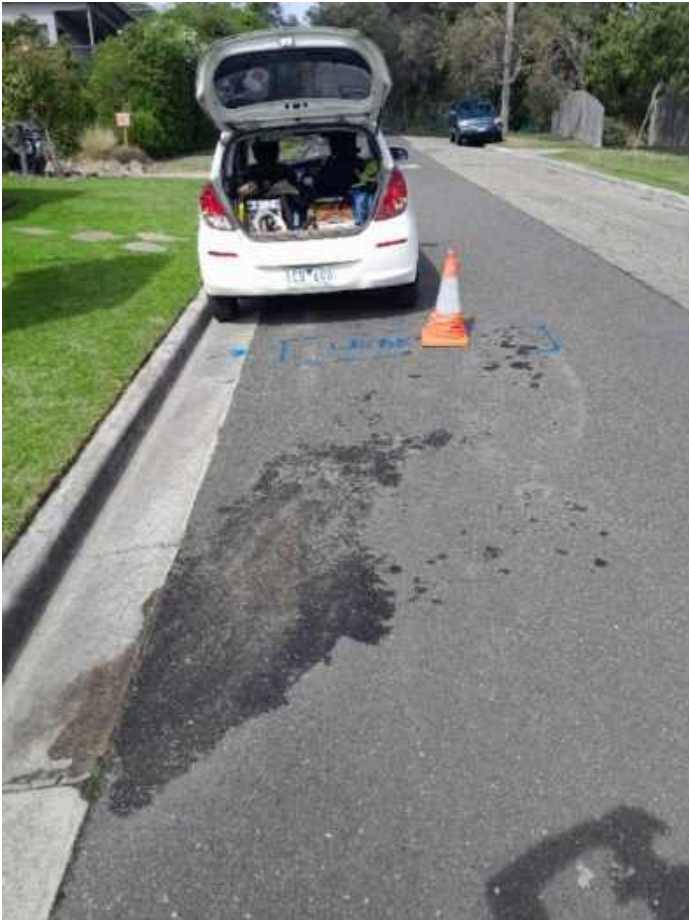
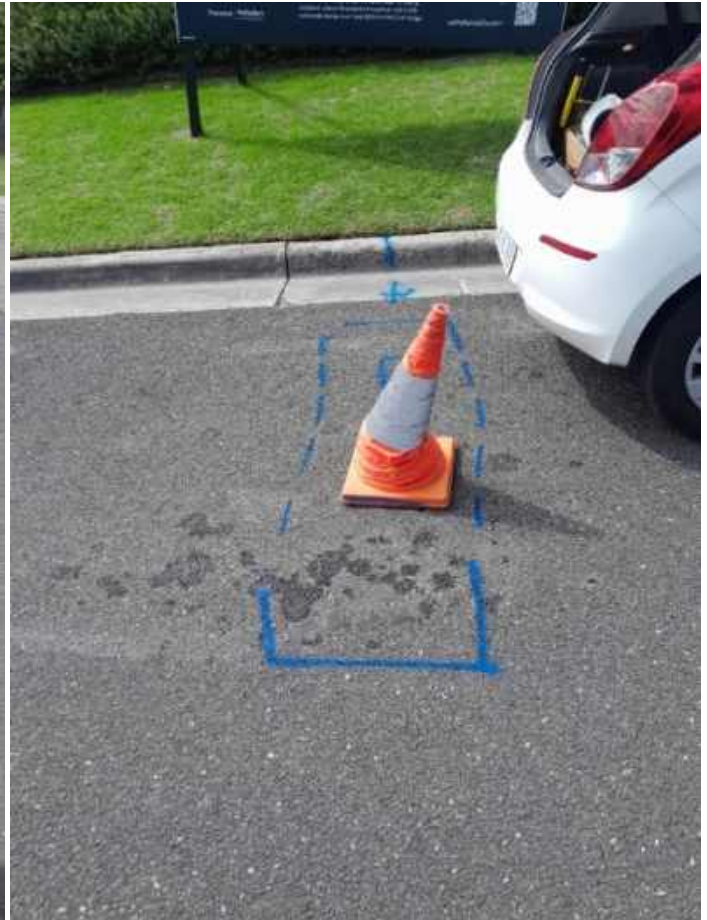
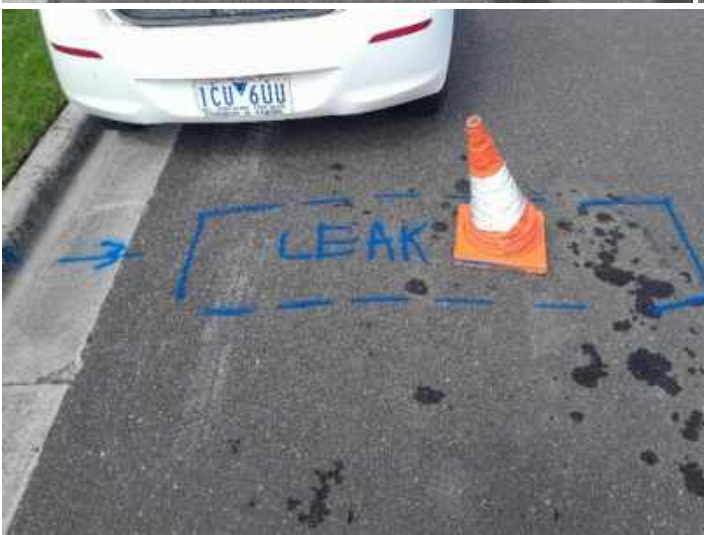
Photo

Leak Address	21 Charles Street McCrae Victoria 3938 Australia
Zone	South East Water ► Waller Place
Leak Asset Type	Main to Meter Line
Flow Rate (L/min)	2
Has the leak been called in by DS Technician?	No
Leak Visible	Yes
Comments	Noticed sweat patch on road, sponged dry & water slowly weeping through  Noticed previous tracer marks on road.  Sounded along tracer marks & found noise.  Leak on service line under road, approximately 1m from gutter
