# Leak Report

## 2 Bowen Street McCrae Victoria 3938 Australia

**LOCATION**-38.351715, 144.935884**PROJECT**South East Water

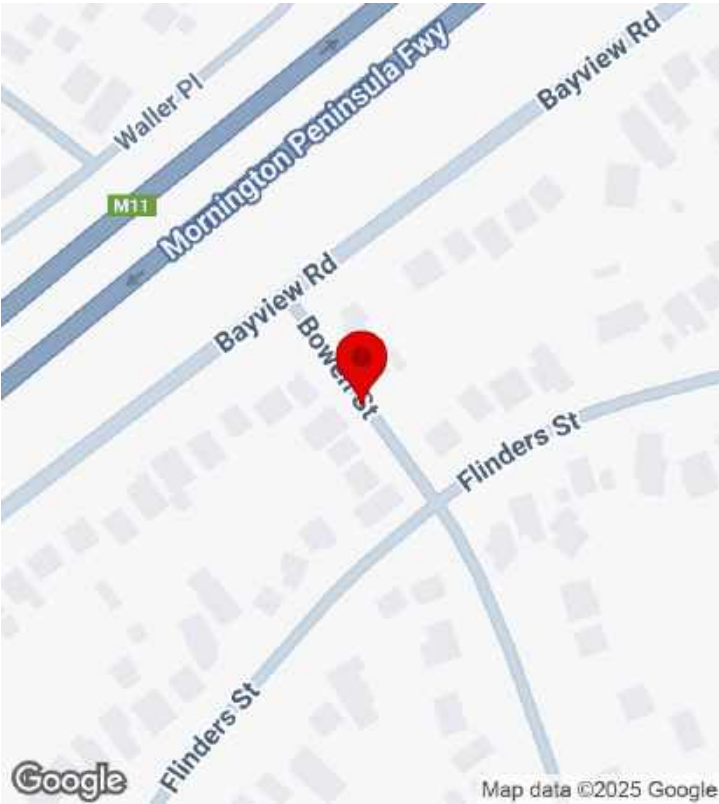
Leak Address	2 Bowen Street McCrae Victoria 3938 Australia
Zone	South East Water ► Parkes St Tank Zone
Leak Asset Type	Ferrule
Flow Rate (L/min)	5
Has the leak been called in by DS Technician?	No
Leak Visible	No
Comments	Leak on ferrule Traced out service line which runs at angle & straightens out along naturestrip Probed onto main/ferrule which is 1m deep & 1.4m behind gutter. Wet ground  Small noise on meter  Owner of 4 says there was a leak on ferrule 2 previously. Ferrule may have gone again.
