Leak Report

2 Grandview Court McCrae Victoria 3938 Australia

PROJECT
📁 South East Water

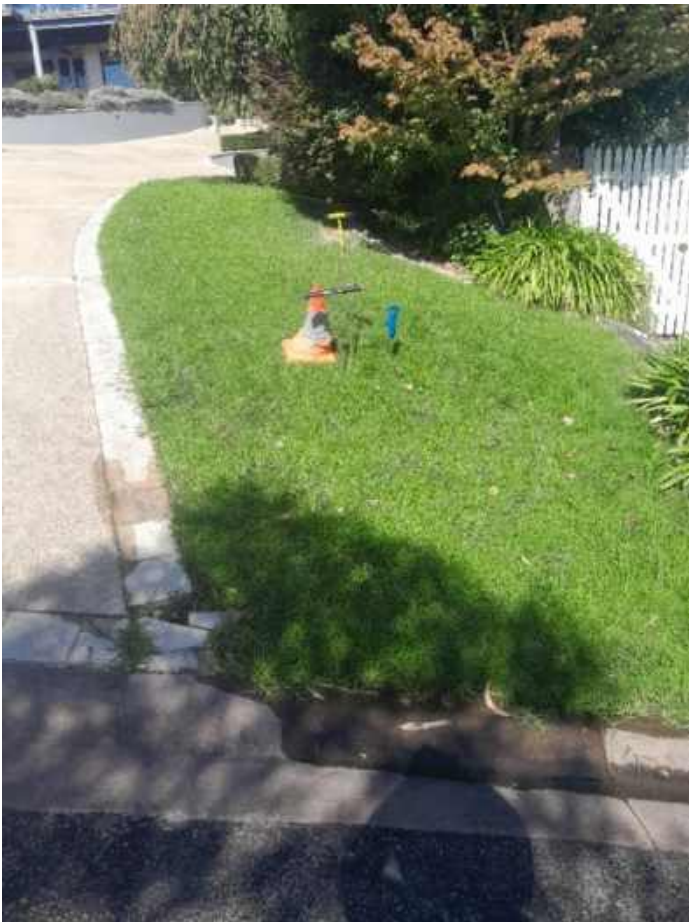
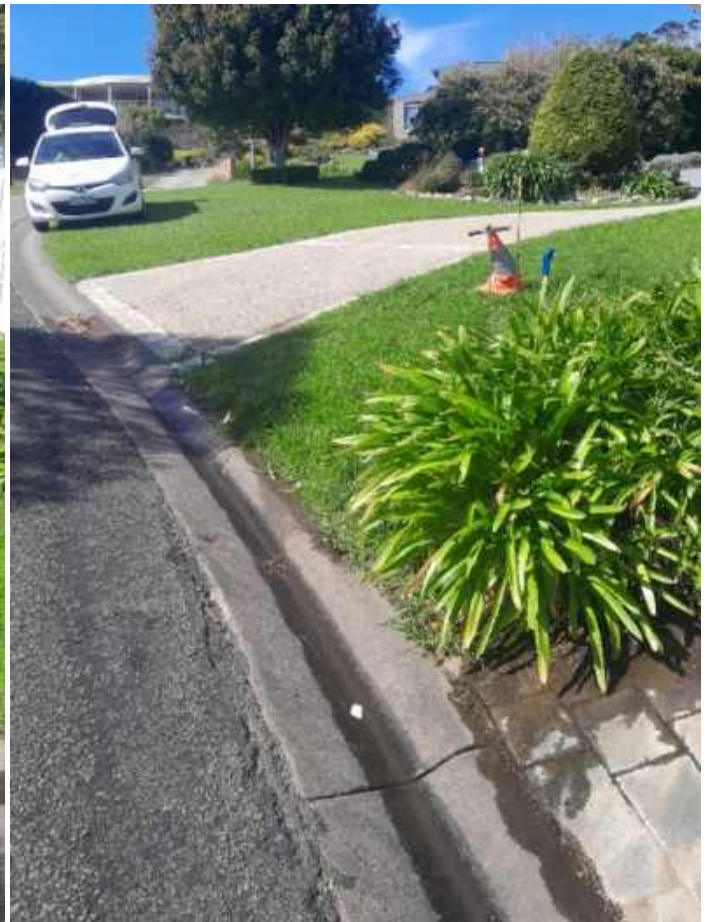
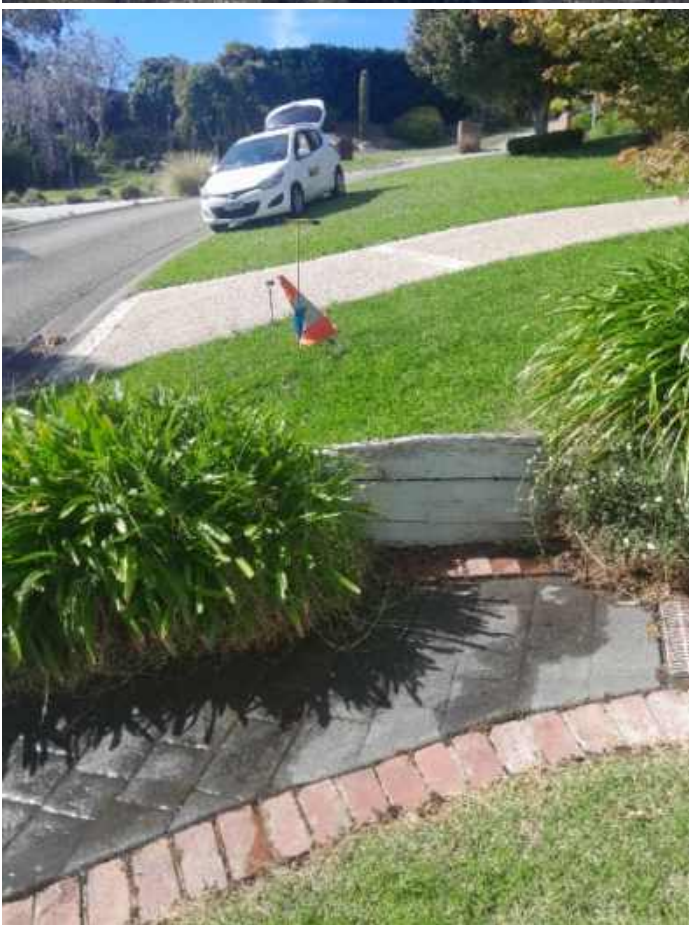
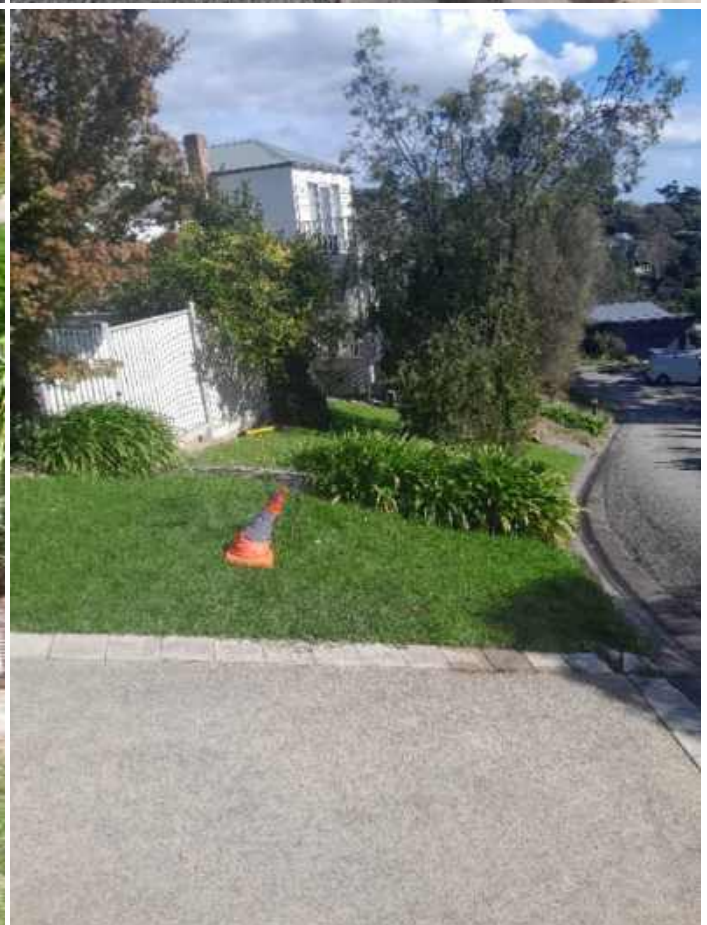
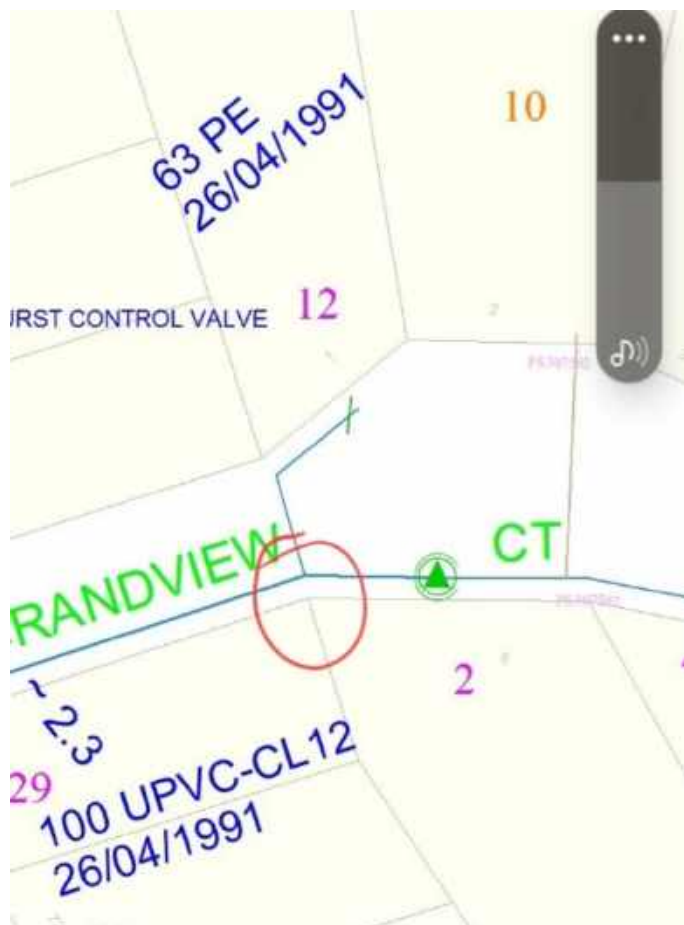
Photo

Possible leak on main, between driveway & sleeper wall.

Ground soft , wet & boggy, couldn't probe onto main, unknown location

Distant noise on hydrant

Leak Possibly on T Junction of 100upvc & 63pe.

Sewer runs Parralel to main

May need to excavate/vacuum to locate main & chase water to leak
