Leak Report

3 Somers Close McCrae Victoria 3938 Australia

PROJECT
📁 South East Water

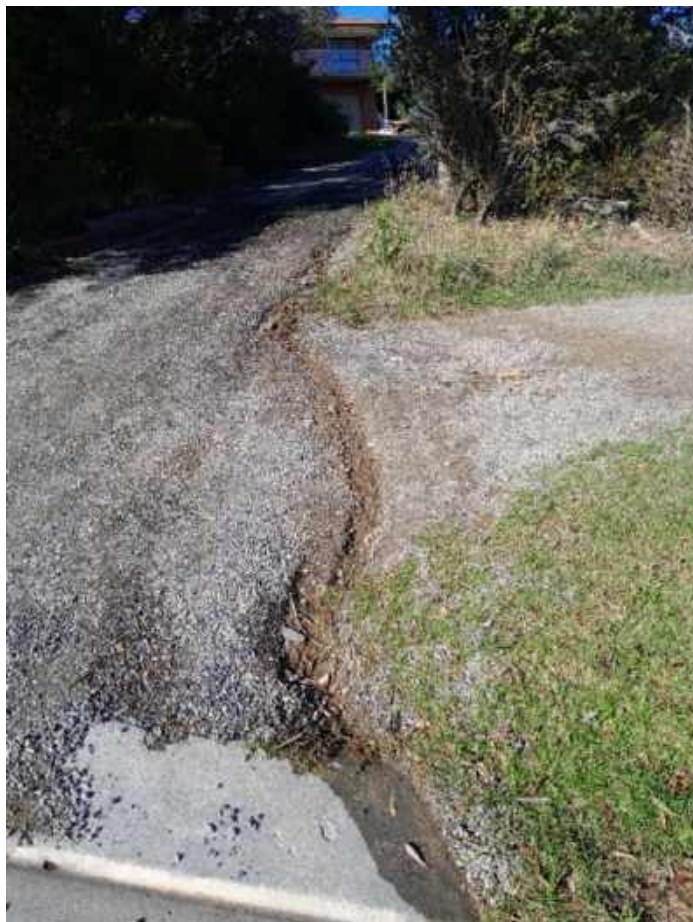
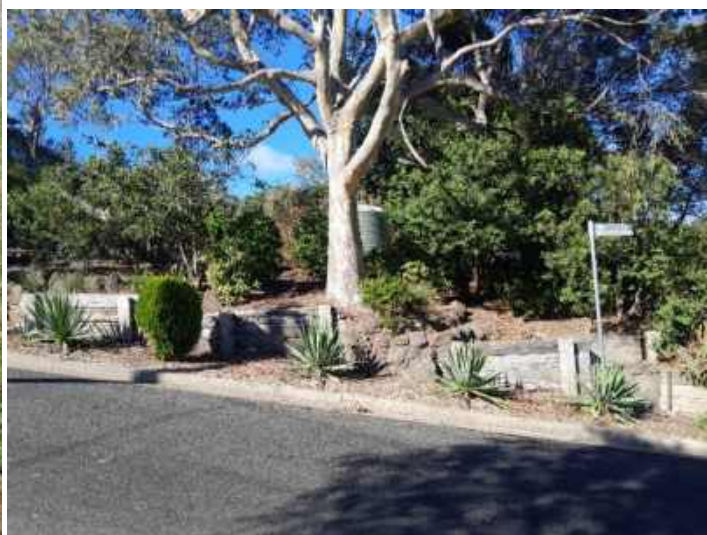
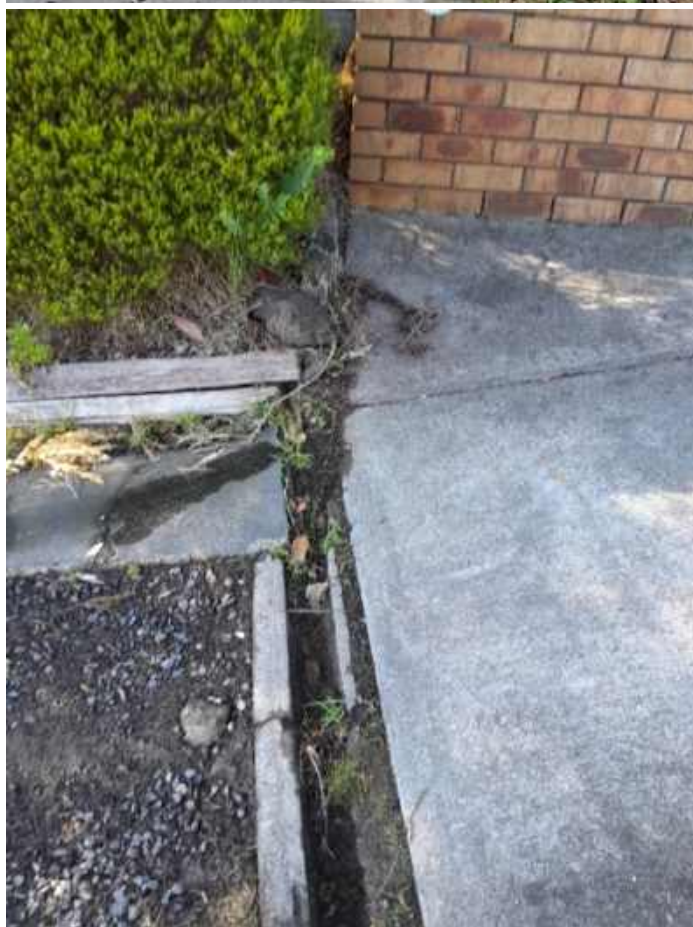
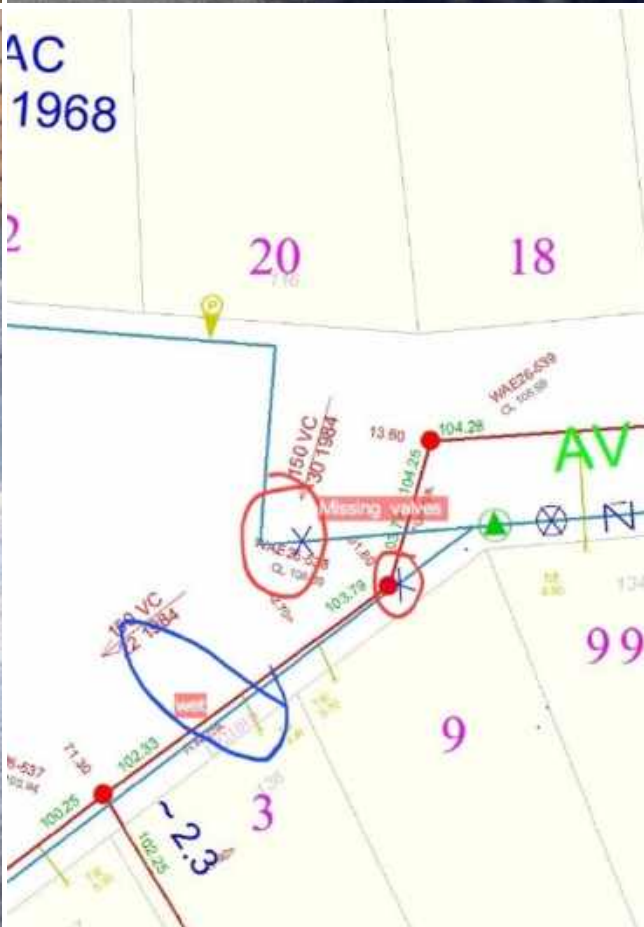
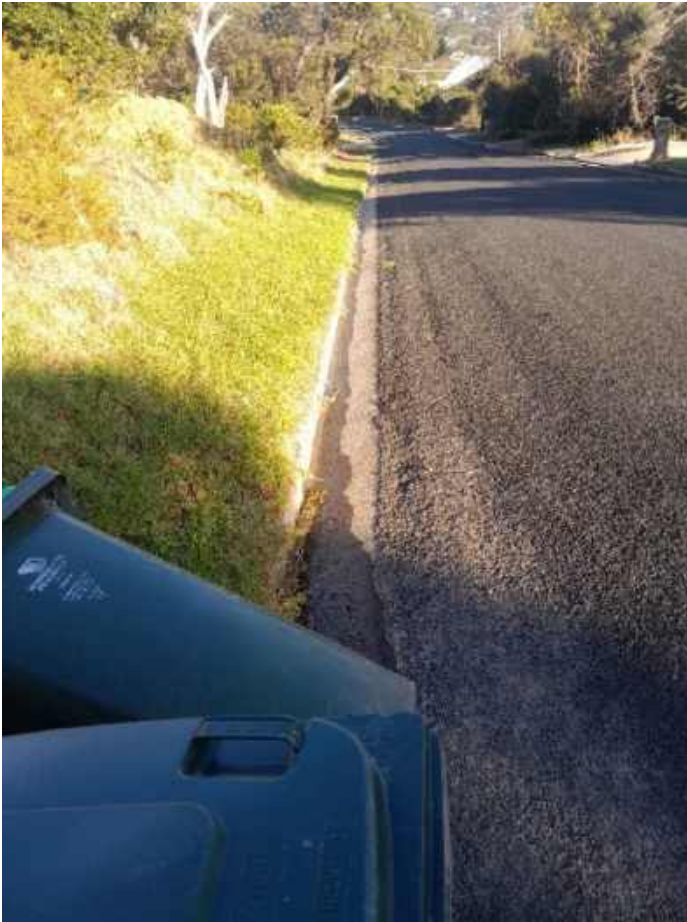
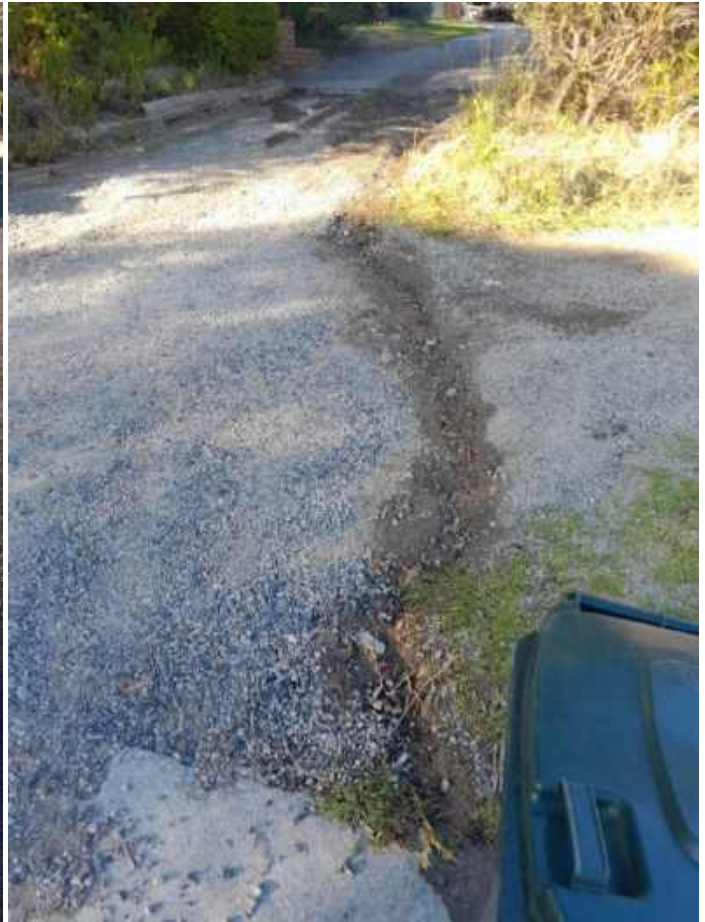
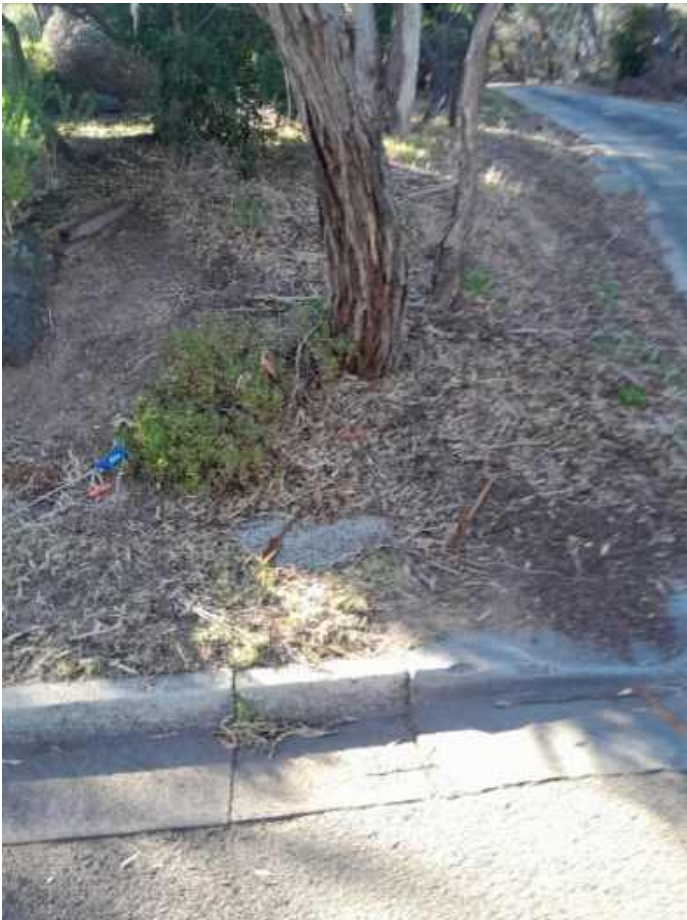
Photo

Noticed consistent flow of water across driveway 3, running across gravel road(Somers cl) & into gutter along Somers av

Chased water to pvc pipe behind letterbox & lost sight of it.

Plan shows 2x valves after hydrant which I could not locate, suspect it has been buried/taken over by garden beds.

One valve feeds dead end pvc main Sussopedly next to sewer manhole cover...could not locate & other valve heads downhill on Somers av

Water still flowing. No rain for several days.

...although did notice that scour/overflow drain next to access driveway to watertank 90% full of water, but not flowing

Not sure Wether this is rainwater from recent rain, overflow water from watertank or leak on main somewhere. Suggest locating & exposing these 2 valves & sounding for leaks
