Leak Report

4 Outlook Road McCrae Victoria 3938 Australia

PROJECT
📁 South East Water

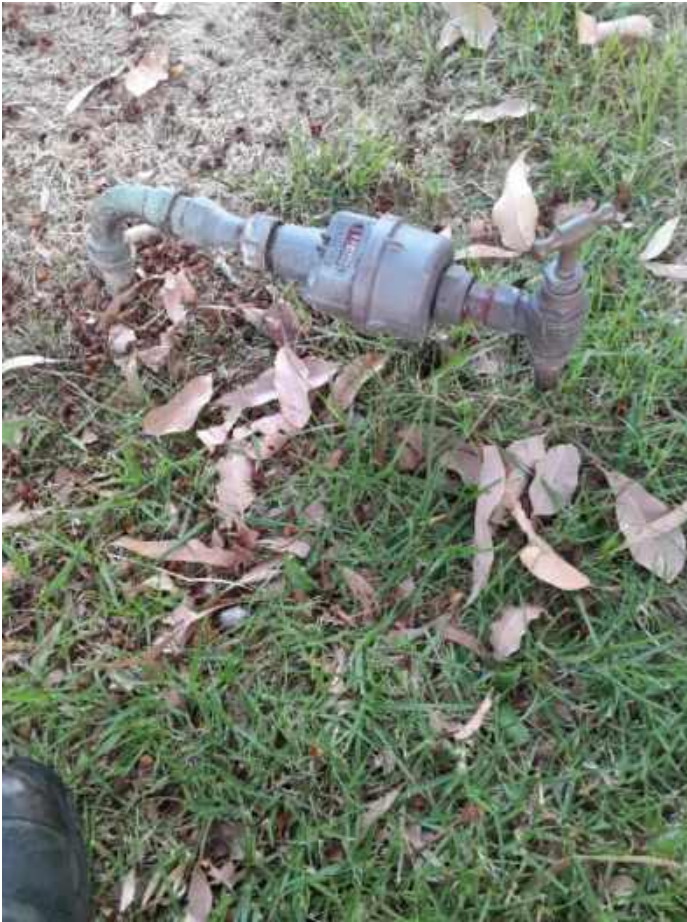
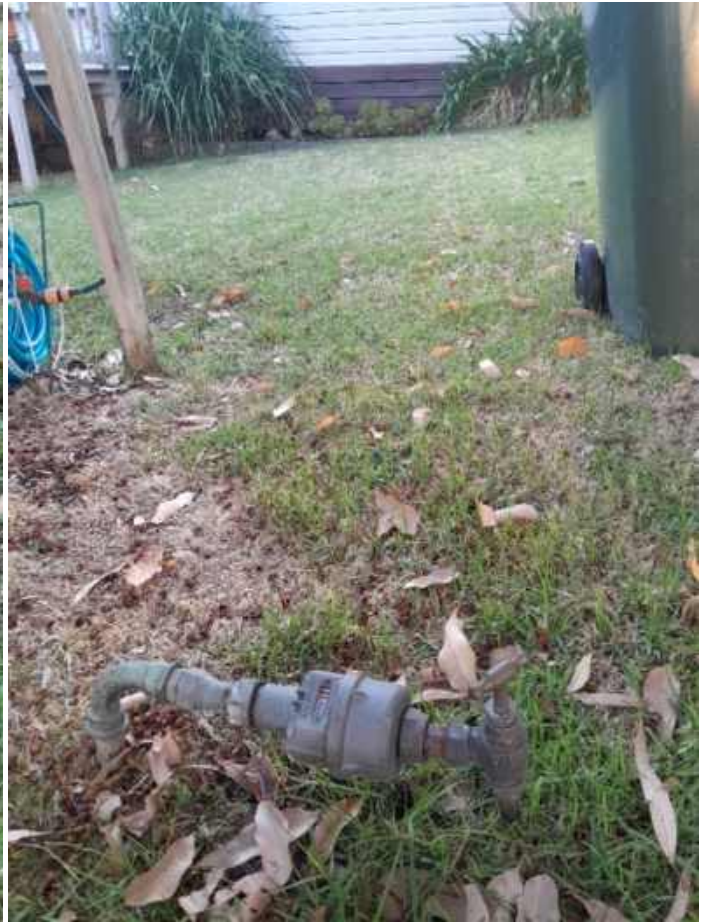
Leak Address	4 Outlook Road McCrae Victoria 3938 Australia
Zone	South East Water ► Parkes St Tank Zone
Leak Asset Type	Meter
Flow Rate (L/min)	0.4
Has the leak been called in by DS Technician?	No
Leak Visible	No
Comments	Leaking from both sides of meter connection
Photo
