# Leak Report

## 4 Waller Place McCrae Victoria 3938 Australia

**PROJECT**  
📁 South East Water

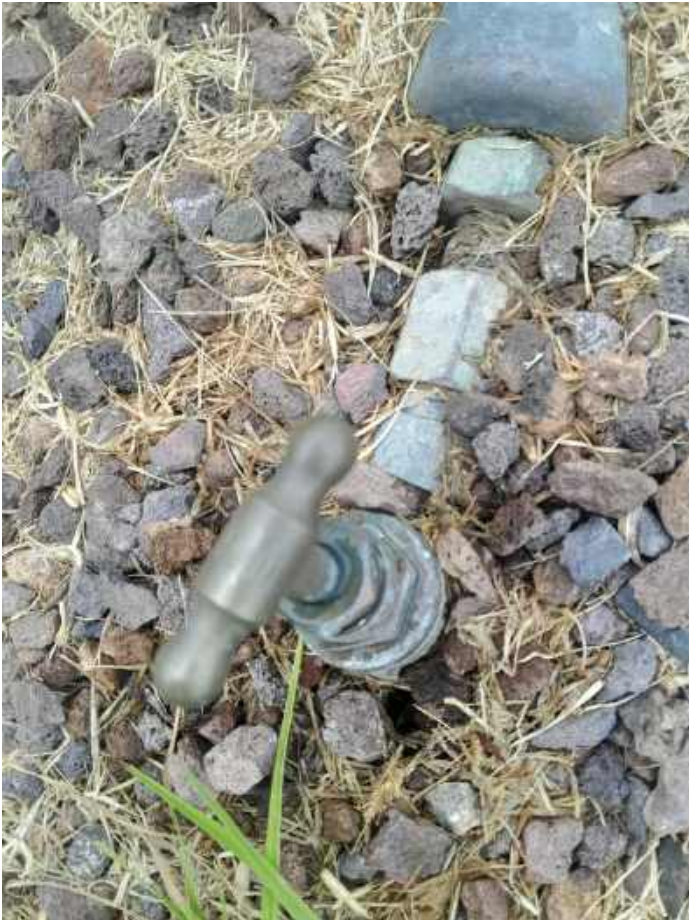
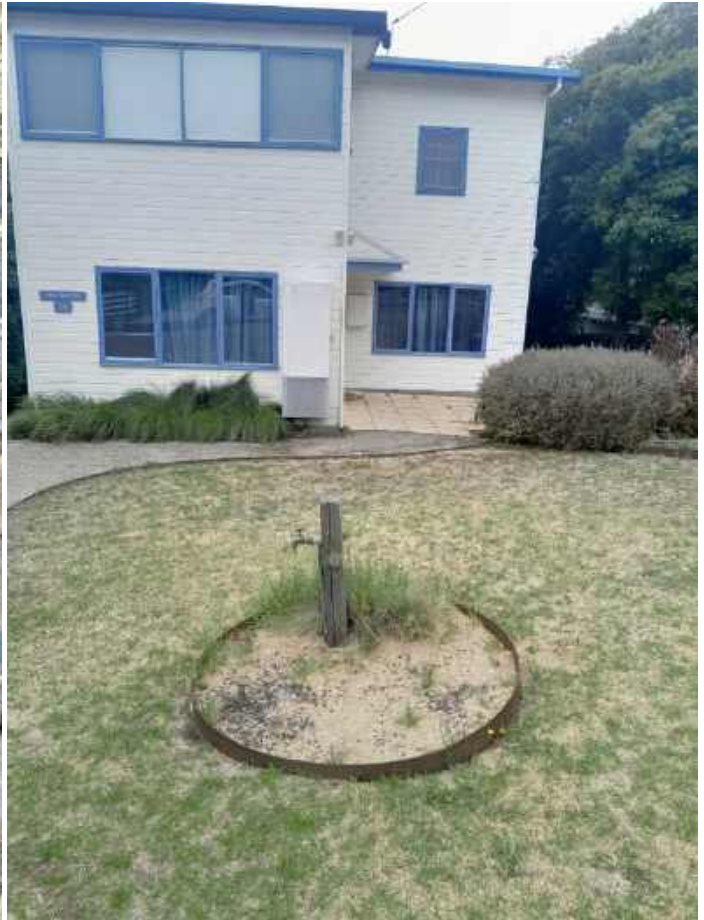
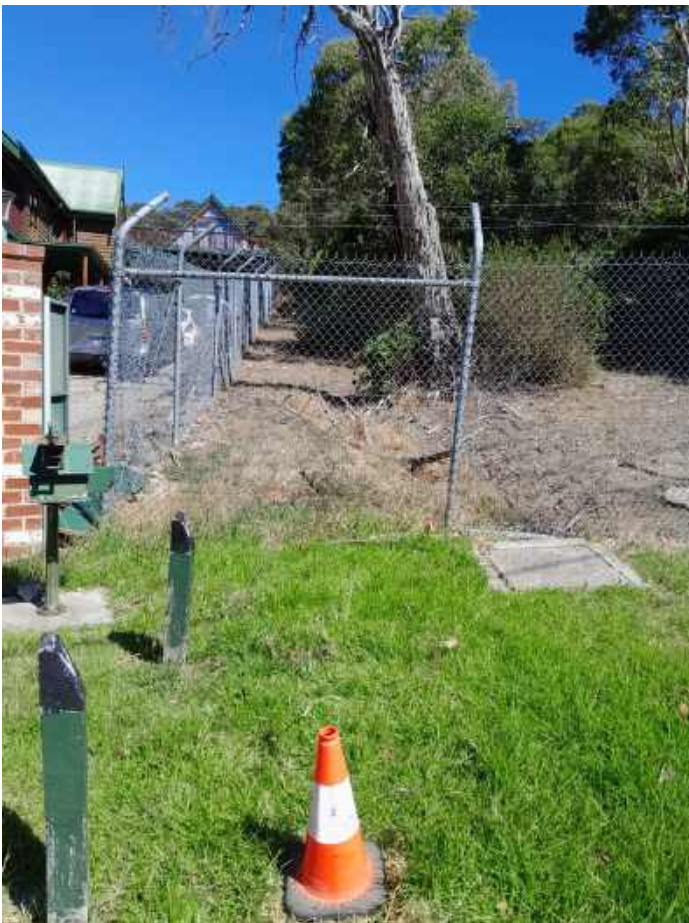
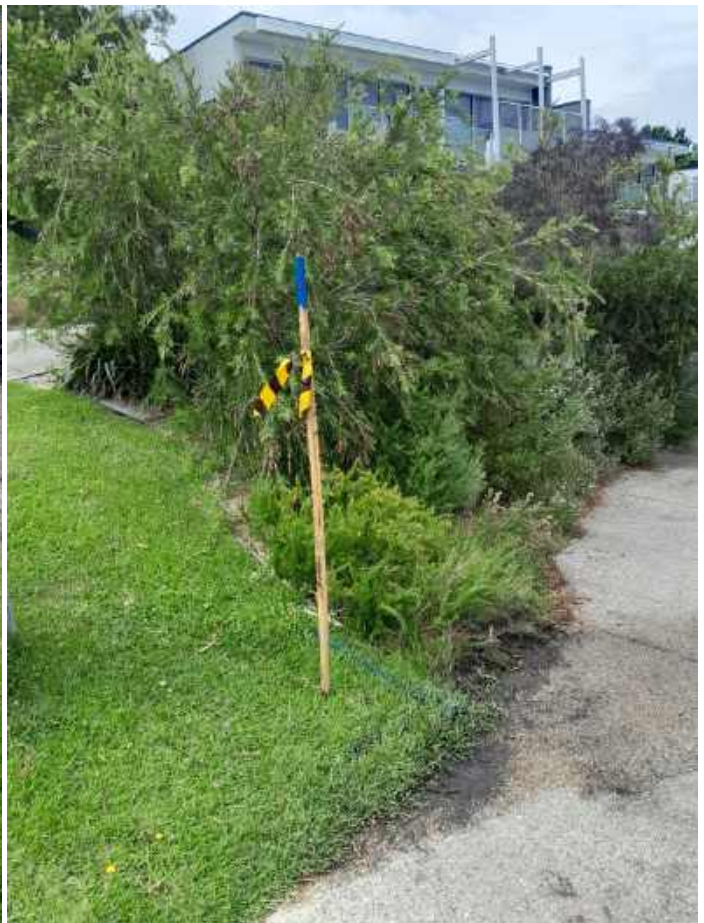
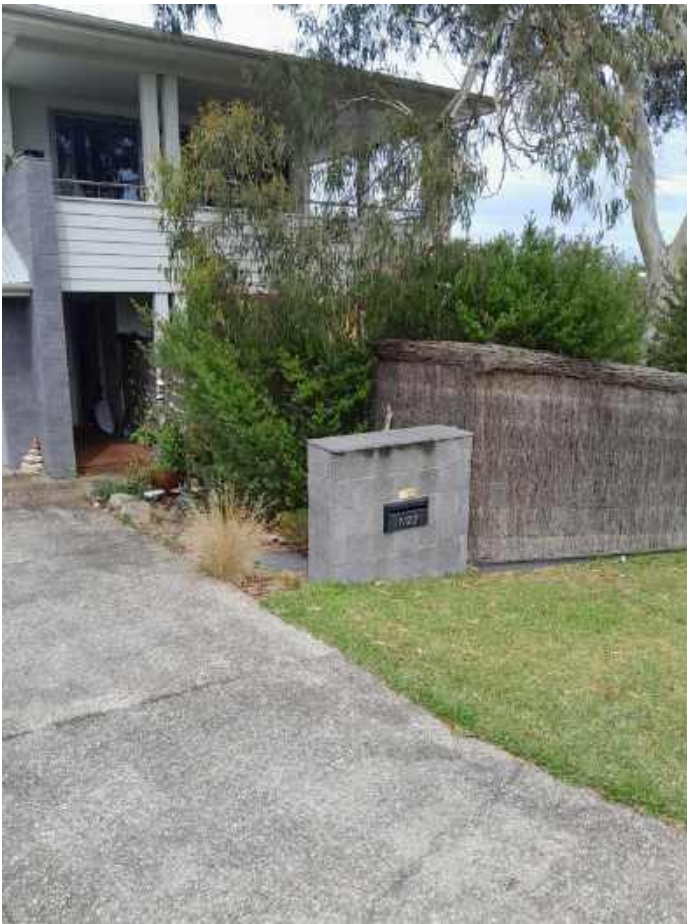
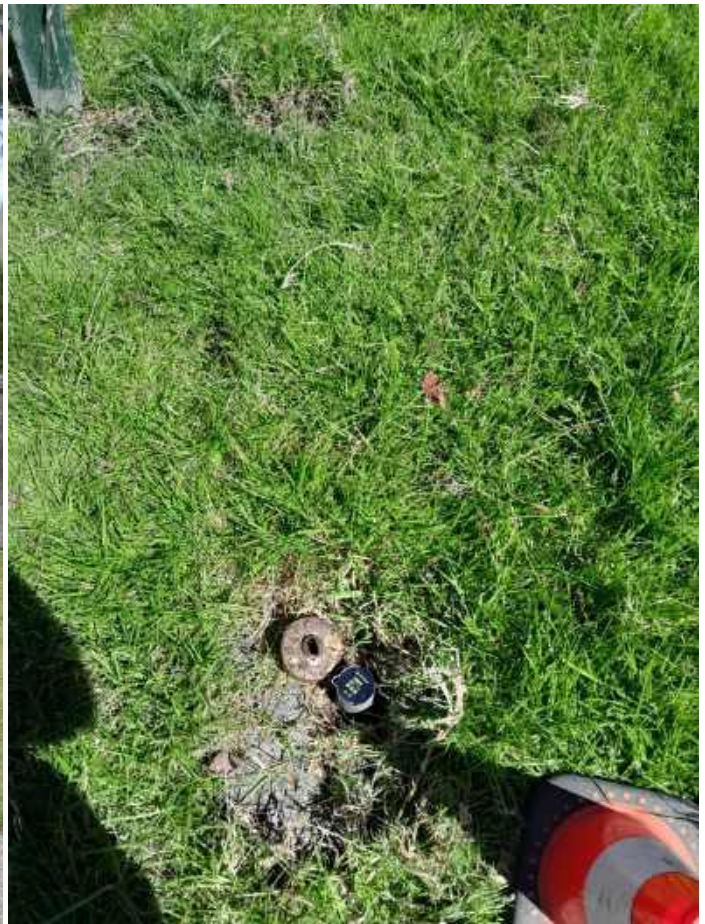
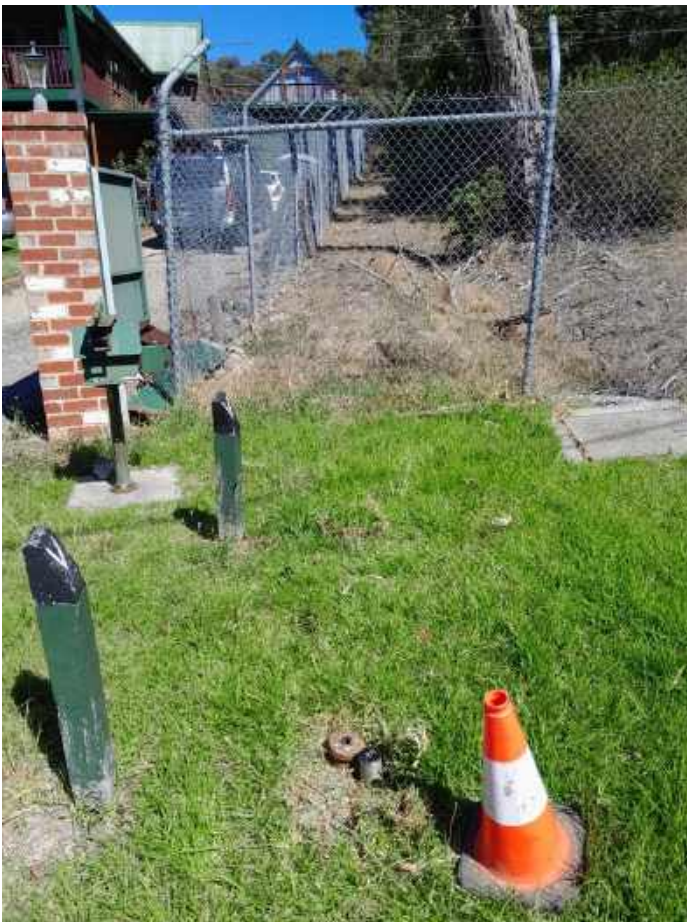
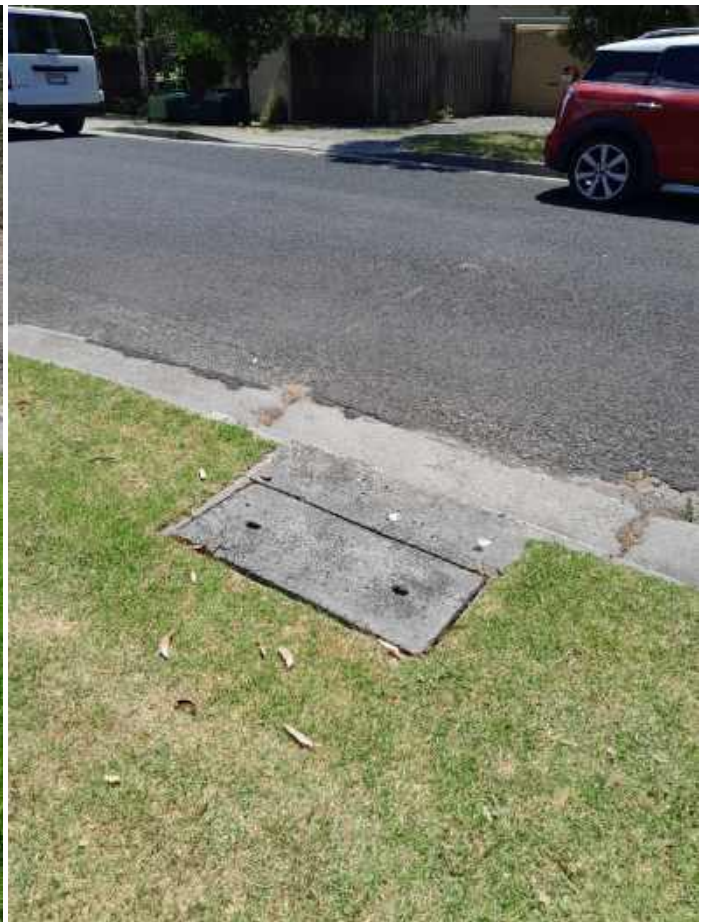
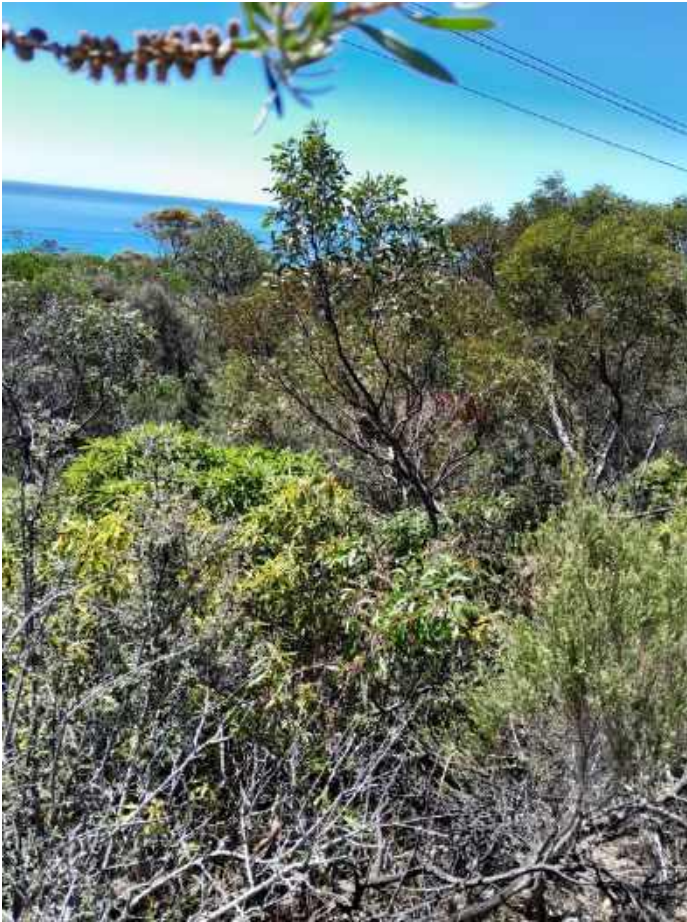
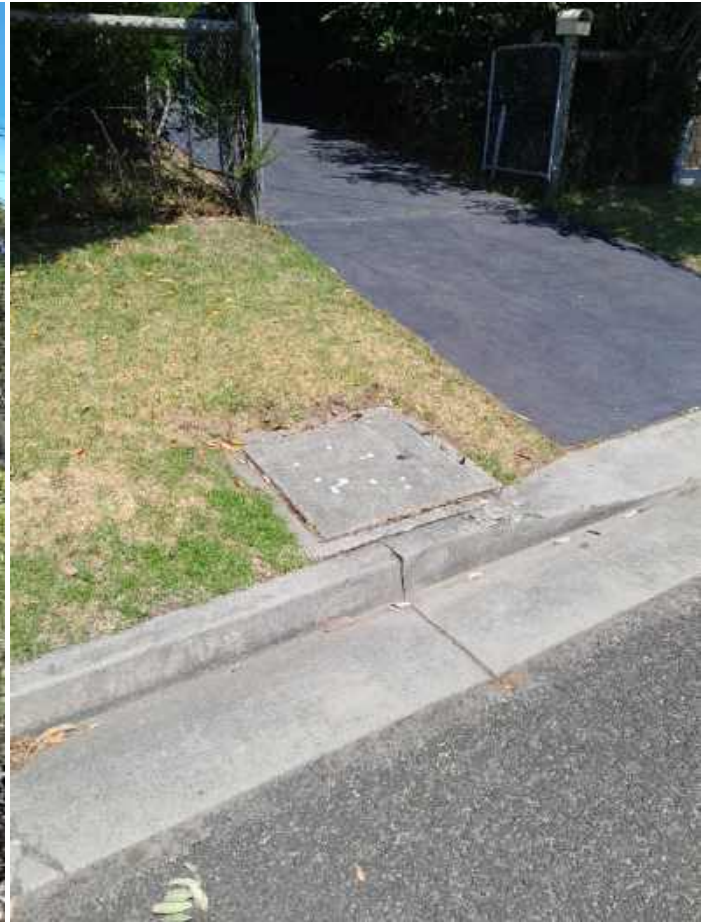
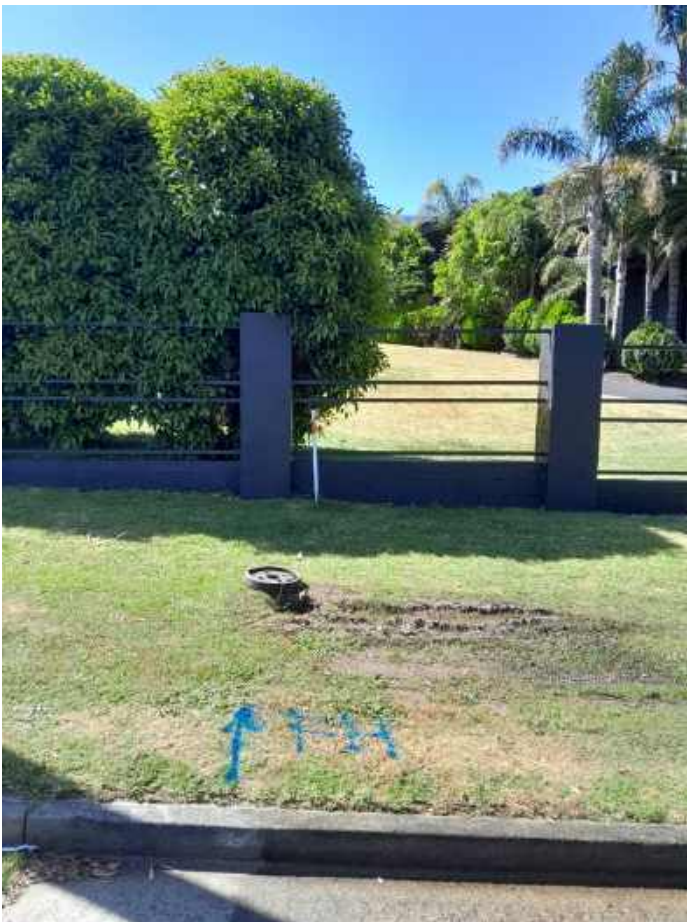
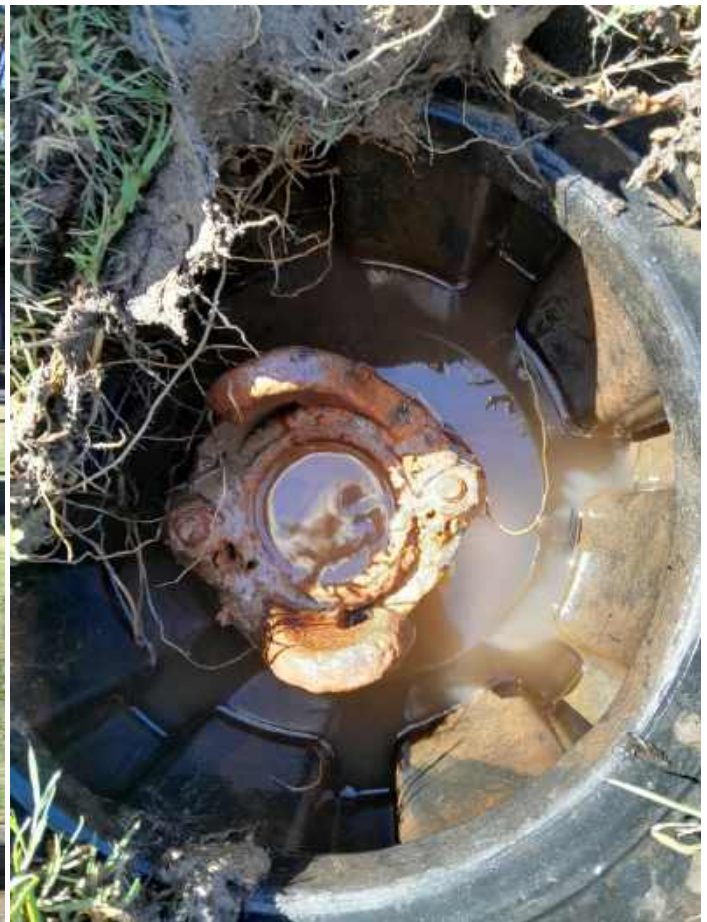
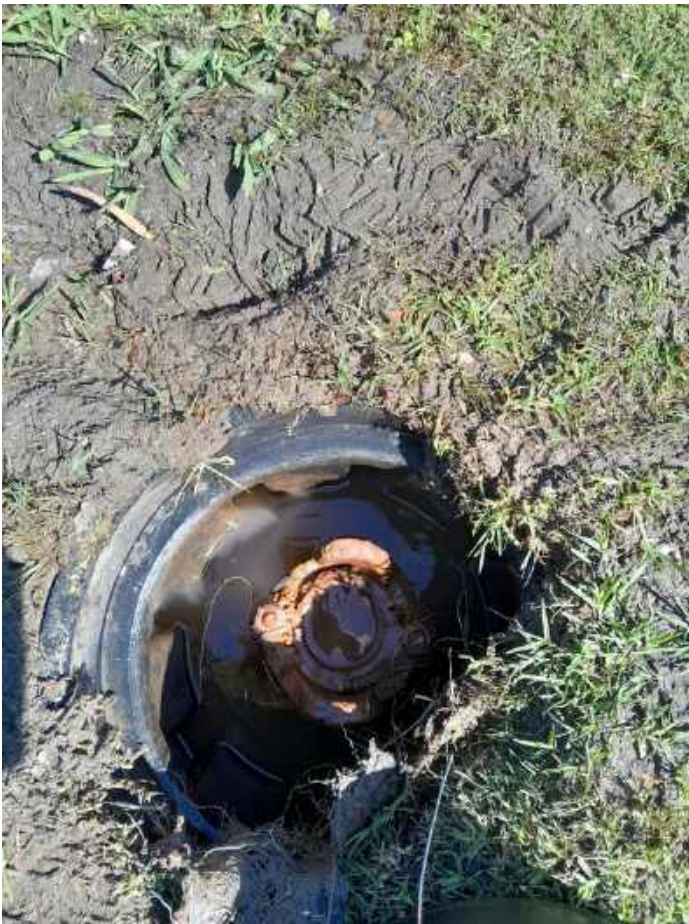
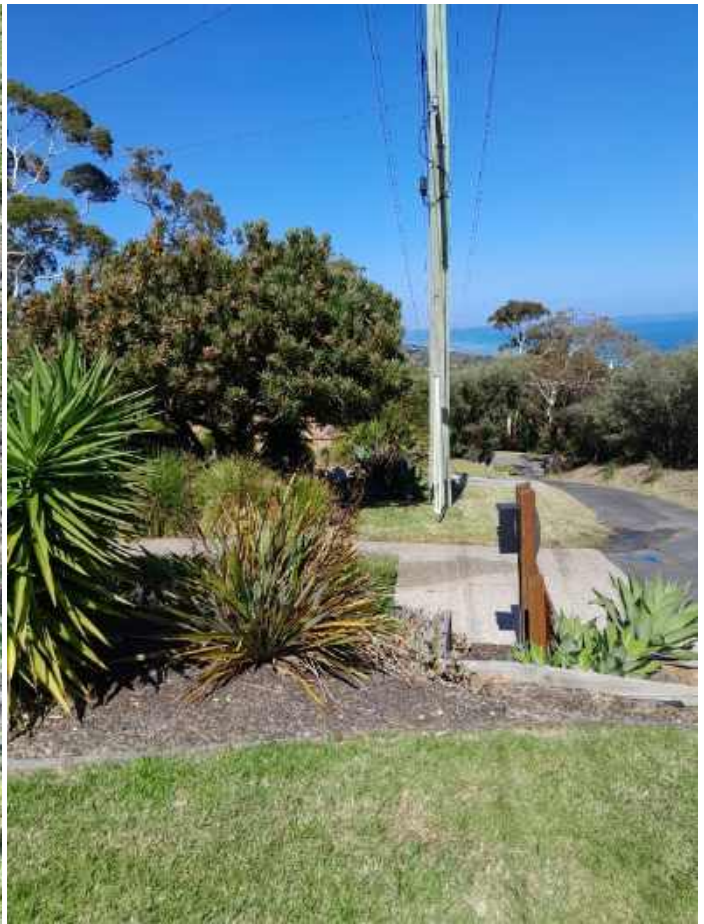
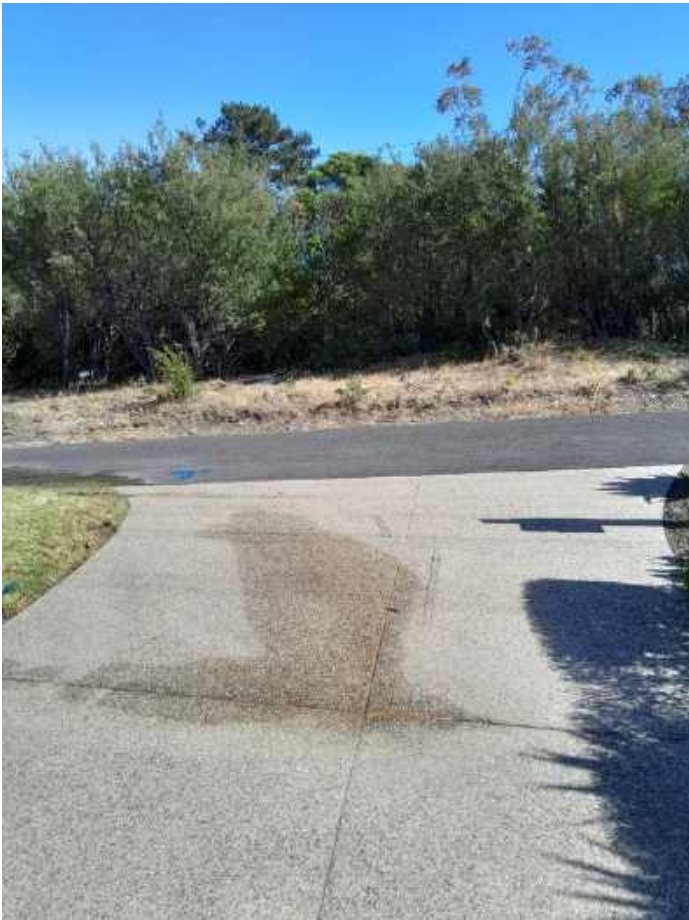
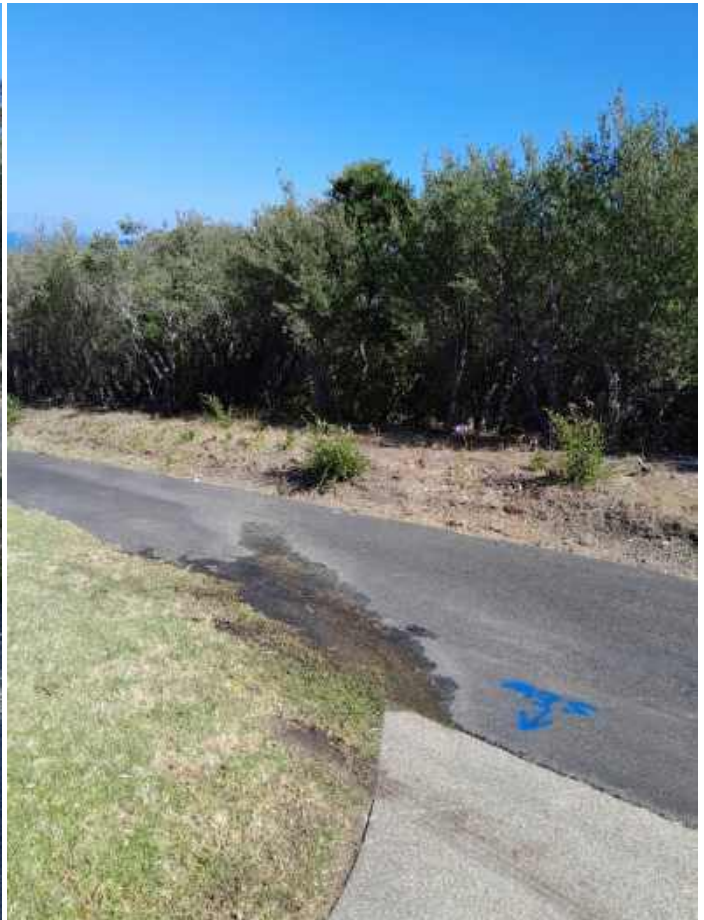
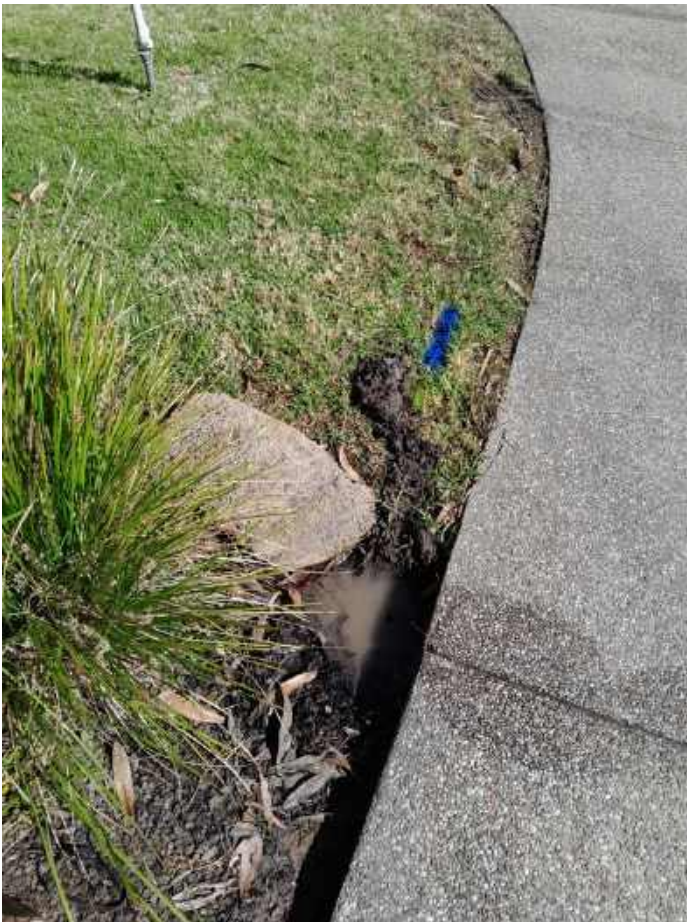
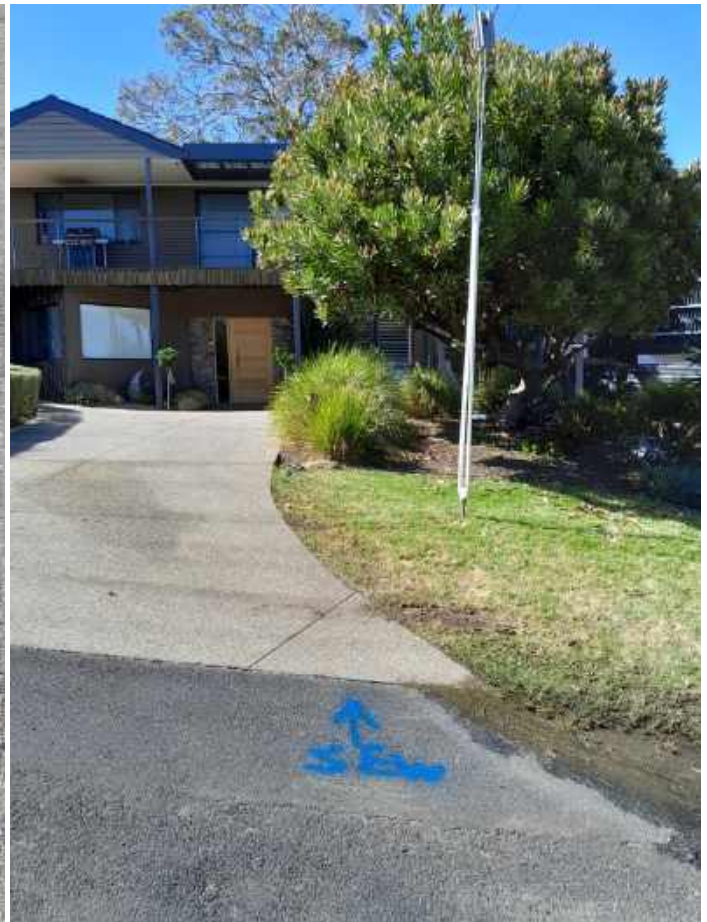
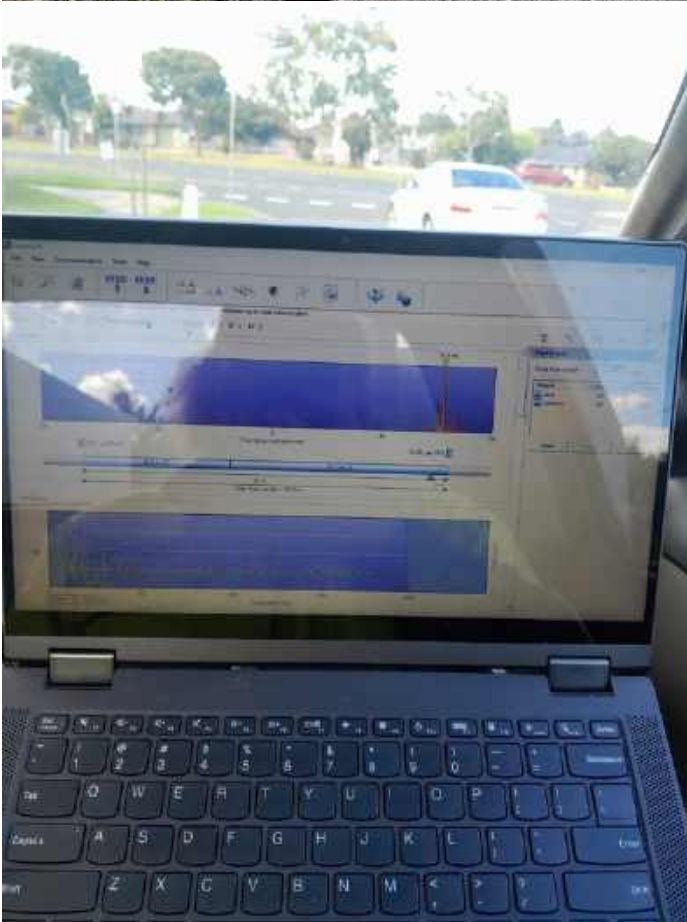
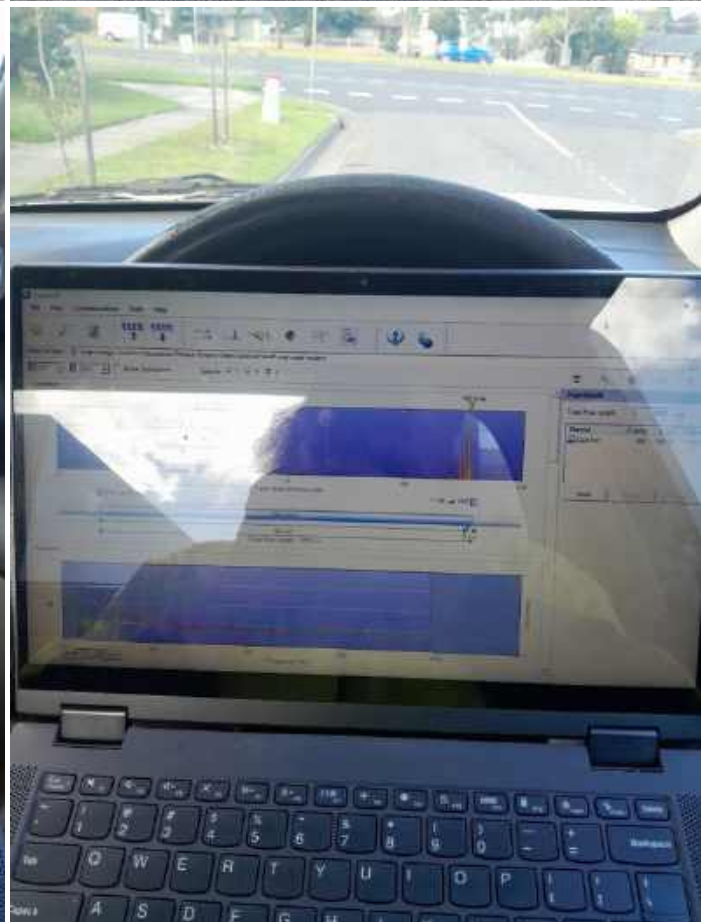
Photo

The new owners at 4 Waller and the owner Bret of number 5 (has lived here for the past 20 years) let us at the back of his block where he has an old Water style lid cover (see attached photos) it houses the 14" main elbow, it's very deep approx 4m and is not on his property, although it's fencing inside his property, we just popped the lid and sounded it directly, no noise at all. Apparently the drains run all year round, but the water has got a lot worse and it's affected on the roadways and two locations bubbling up and damaging the road.

There is now a blue marker post here and I've sounded in naturestrip and u can pick up slight noise here but unable to locate meter for property so could be a service line leak but please see photos down below.

I met Hayden onsite around 12ish and he gave me measurements so I can run the correlations. As you can see in the photos down below, we are getting two different peaks, but I believe they are just picking up the noise from the pumps. The peak on logger 3 has pinned me directly in the pumping station ground, so I would ignore this and the other peak is around 6m from hydrant in bushland where they had the other Burst main. A suggestion here would be to have a vac truck onsite to expose the main as I can't probe down onto it to listen. But I think this is most likely picking up the pumps.

Still water here and it's showing on driveway, I would need job notes from crew to see what they did but I would get a vac truck up here again and expose main on the other side of the driveway as it's also wet here when probing, also suggest I'm onsite for this as well.
