Leak Report

4 Waller Place McCrae Victoria 3938 Australia

Leak Address	4 Waller Place McCrae Victoria 3938 Australia
Zone	South East Water ► Reactive Leaks
Leak Asset Type	Mains
Flow Rate (L/min)	120
Has the leak been called in by DS Technician?	Yes
Job Ref	1295094/003
Leak Visible	No

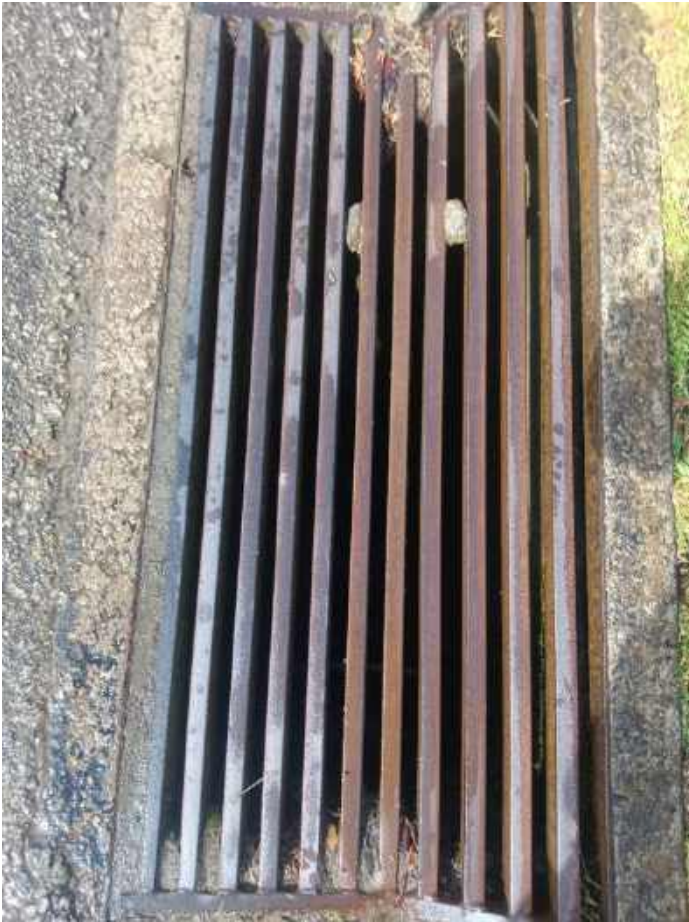
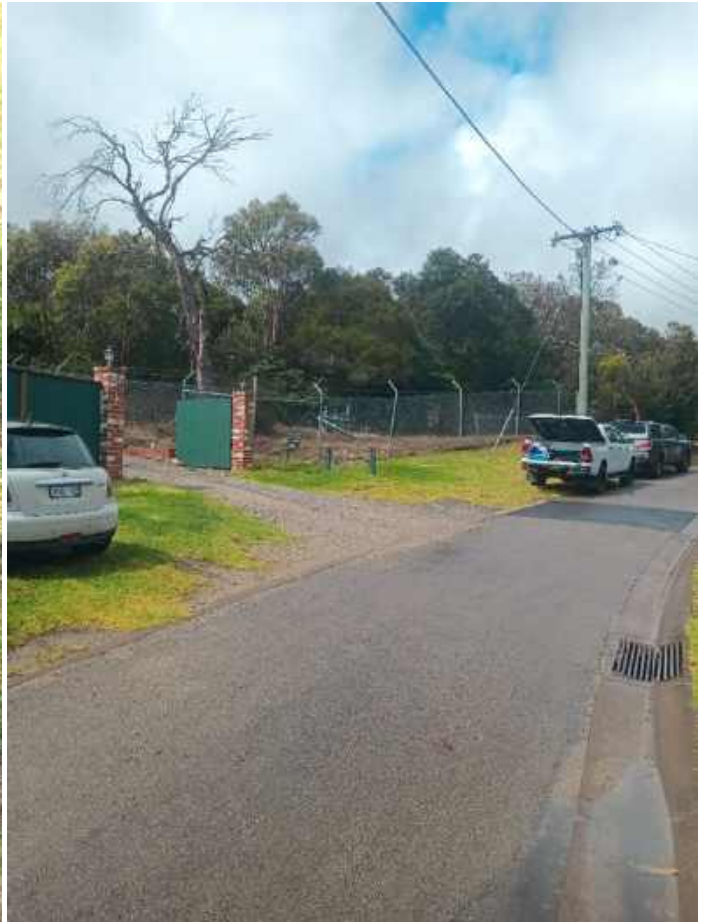
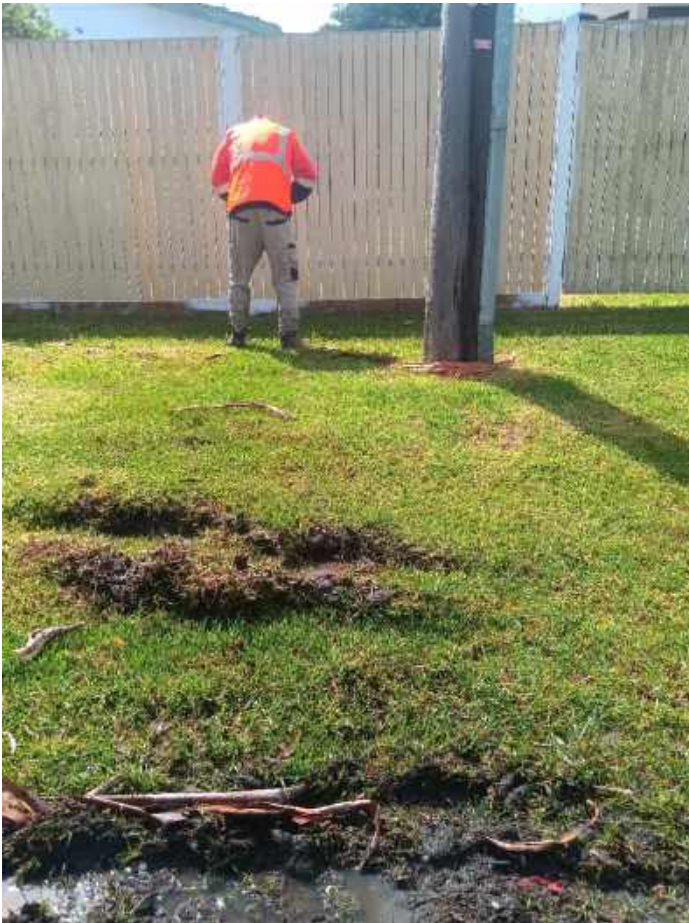
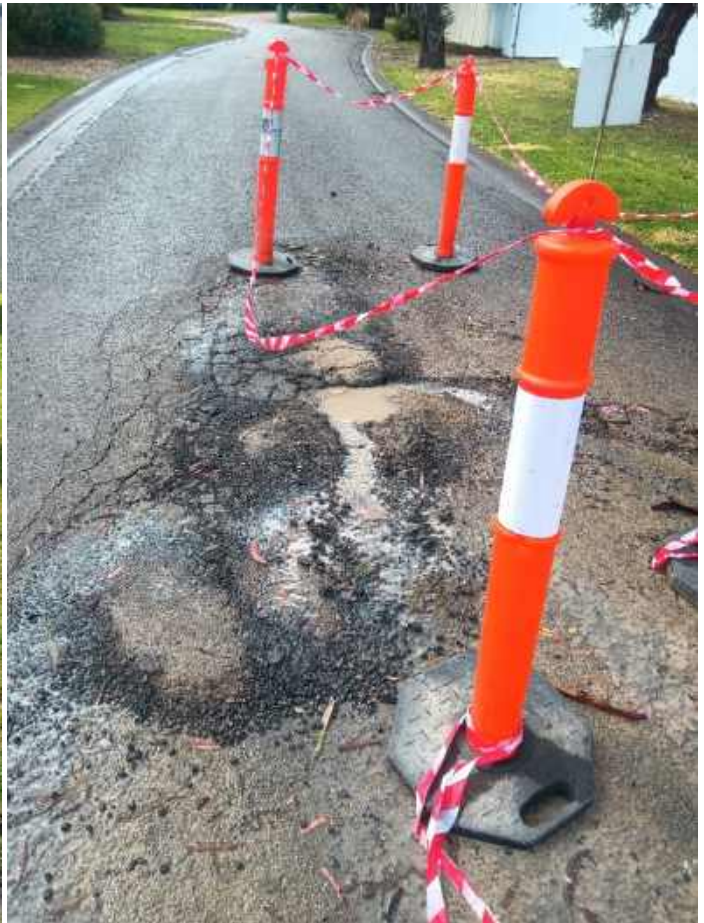
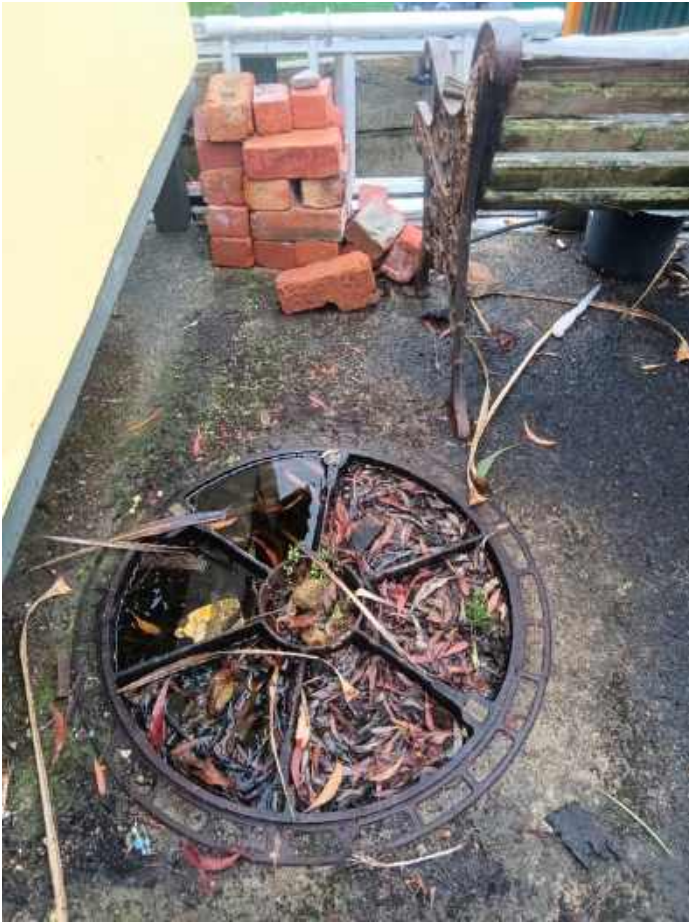
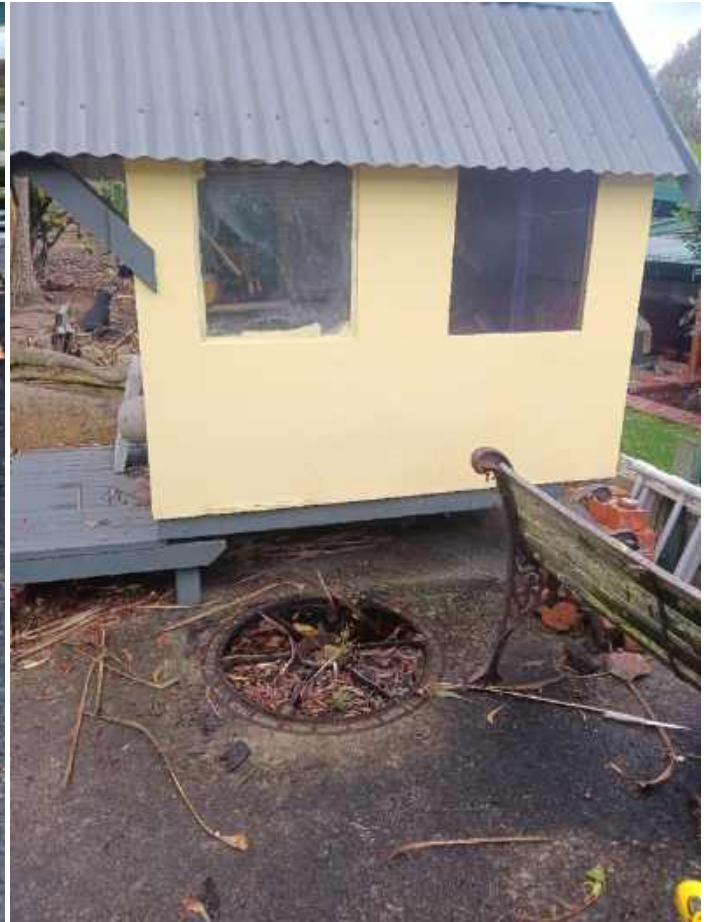
Photo

Sounded all assets in the area, followed suspect 300mm main and no leaks were detected. Chlorine sample needs to be taken when rain stops.

The new owners at 4 Waller and the owner Bret of number 5 (has lived here for the past 20 years) has let us at the back of his block where he has an old Water style lid cover (see attached photos) it houses the 14" main elbow it's very deep 4m is actually not on his property, although it's fencing inside his property, we just popped the and sounded it directly, no noise at all. Apparently the drains run all year round, but the water has got a lot worse and it's affected on the roadways and two locations bubbling up and damaging the road. It been partially barricaded of.

I don't believe there's any leaks on the mains but still some of the smaller pipes really haven't checked out. Jason Marsh will return take samples when it's not raining for a few days.
