Leak Report

711 Point Nepean Road McCrae Victoria 3938 Australia

PROJECT
📁 Service Stream

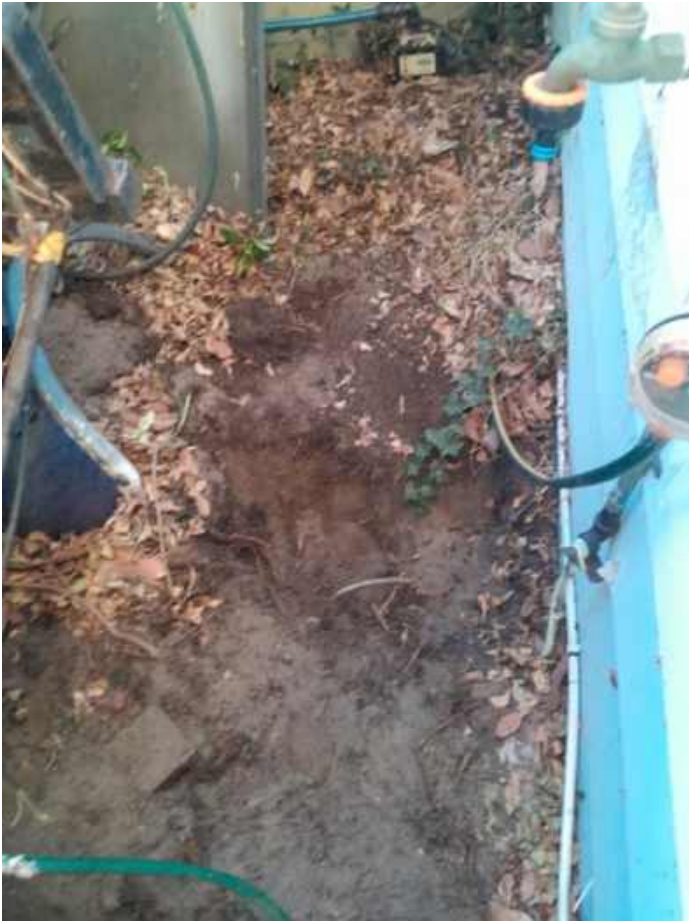
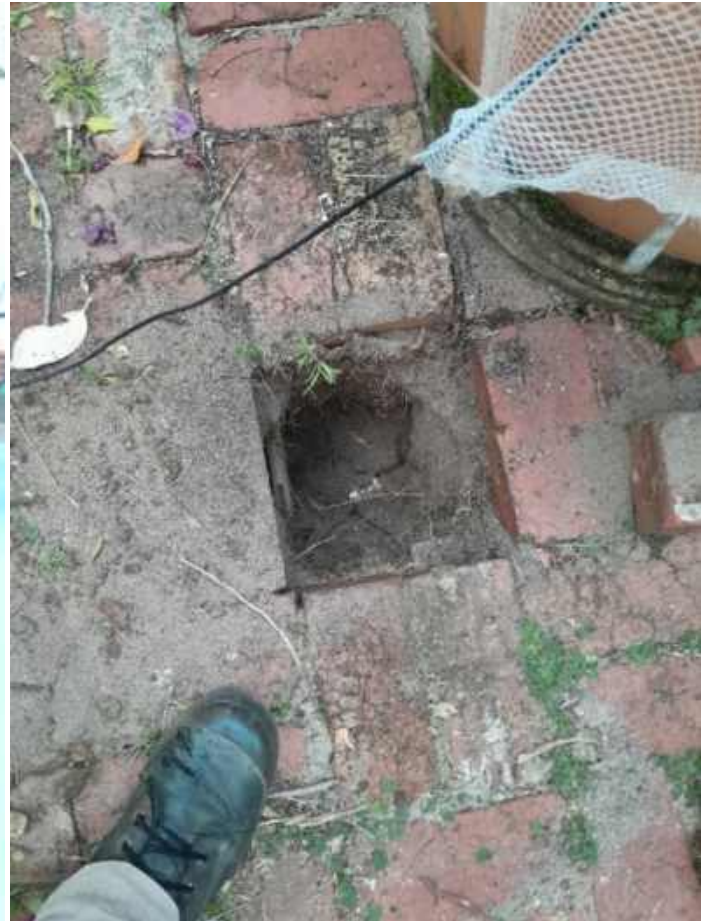
Photo

0.8l/m (50l/h)

Sounded outside taps, back tap dead quiet, front tap slight noise

Service stream arrived, dug a few holes both sides of front garage & in Front garden, with no luck, although I am picking up noise in pot holes.
Discovered that service is pvc

Sounded with ground phone across garage slab & also picking up noise across garage floor, one half of concrete slab slightly louder.

Service stream will install some stop taps both sides of garage to narrow leak down at a future date.

& if leak is under concrete slab they may re-route service line
