Leak Report

75 Bayview Road McCrae Victoria 3938 Australia

South East Water

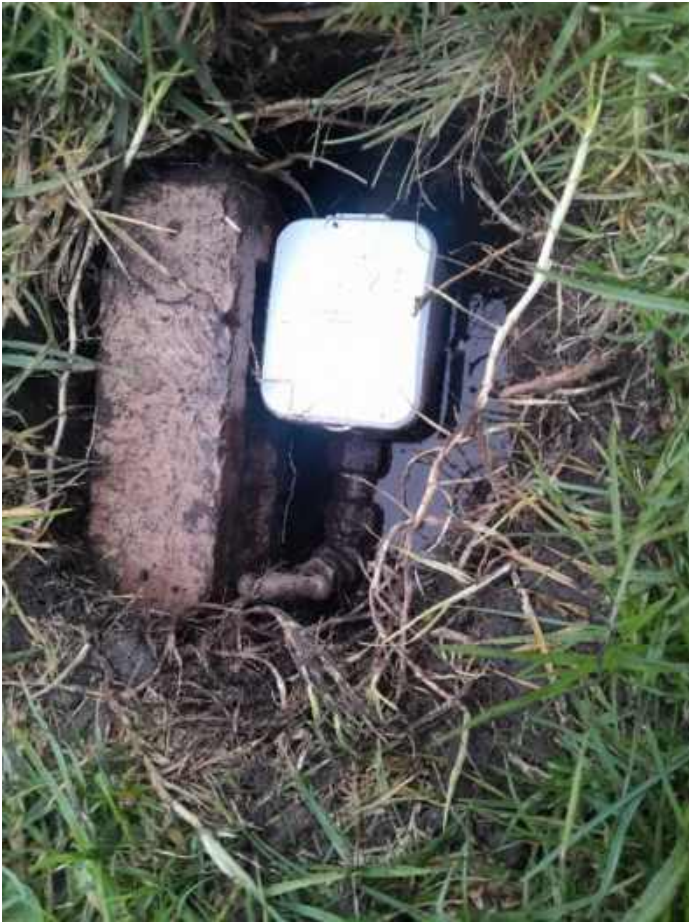
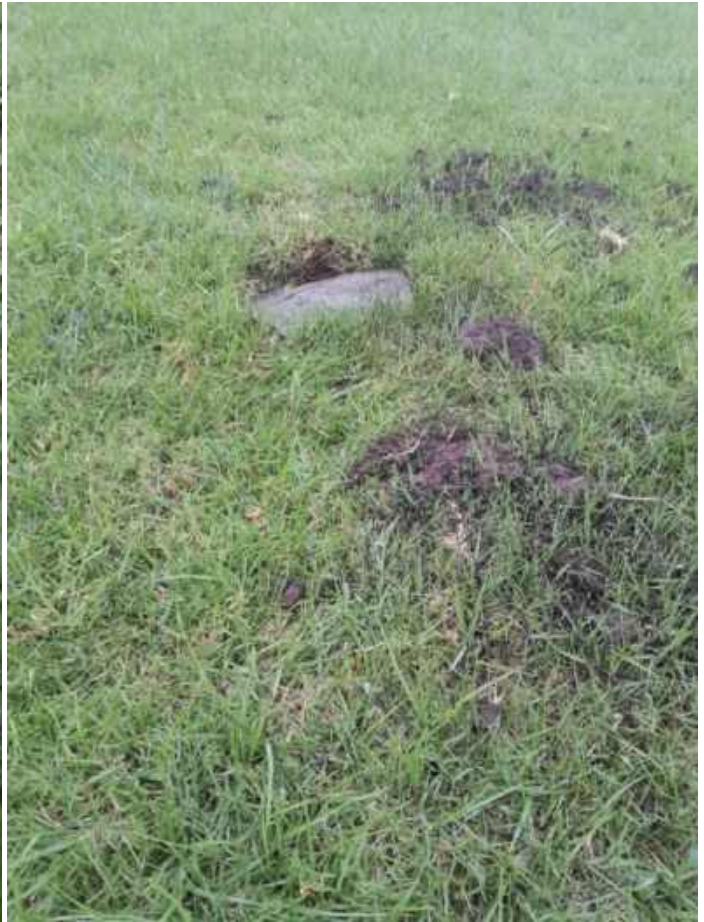
Photo

Leak Address	75 Bayview Road McCrae Victoria 3938 Australia
Zone	South East Water ► Parkes St Tank Zone
Leak Asset Type	Meter
Flow Rate (L/min)	0.3
Has the leak been called in by DS Technician?	No
Leak Visible	No
Comments	Leaking from meter connection?. Small noise on meter, meter pit full of water. Louder on service side Meter recently upgraded to digital meter
