Leak Report

88 Cinerama Crescent McCrae Victoria 3938 Australia

PROJECT
📁 South East Water

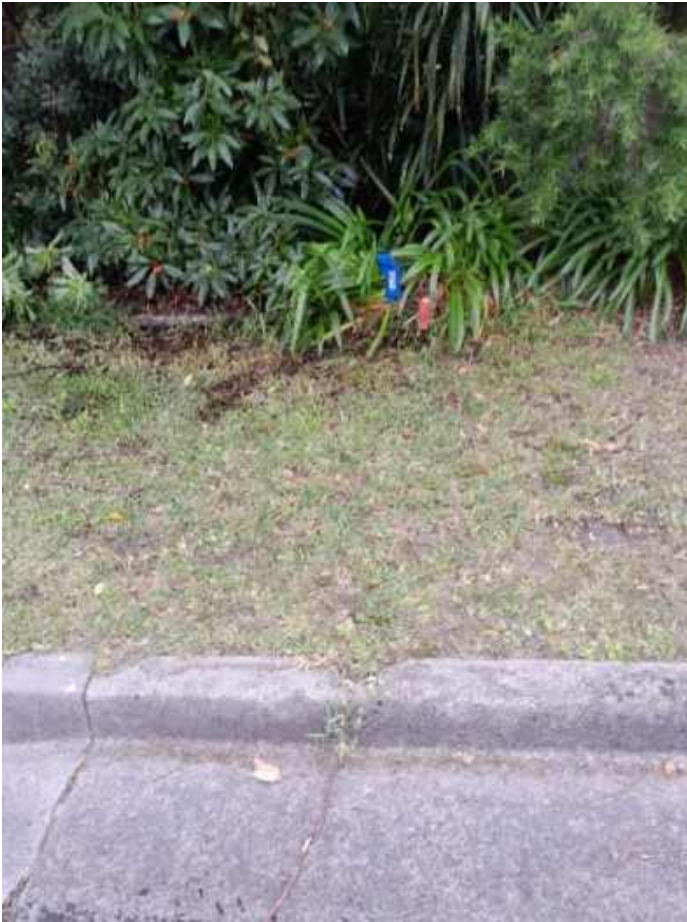
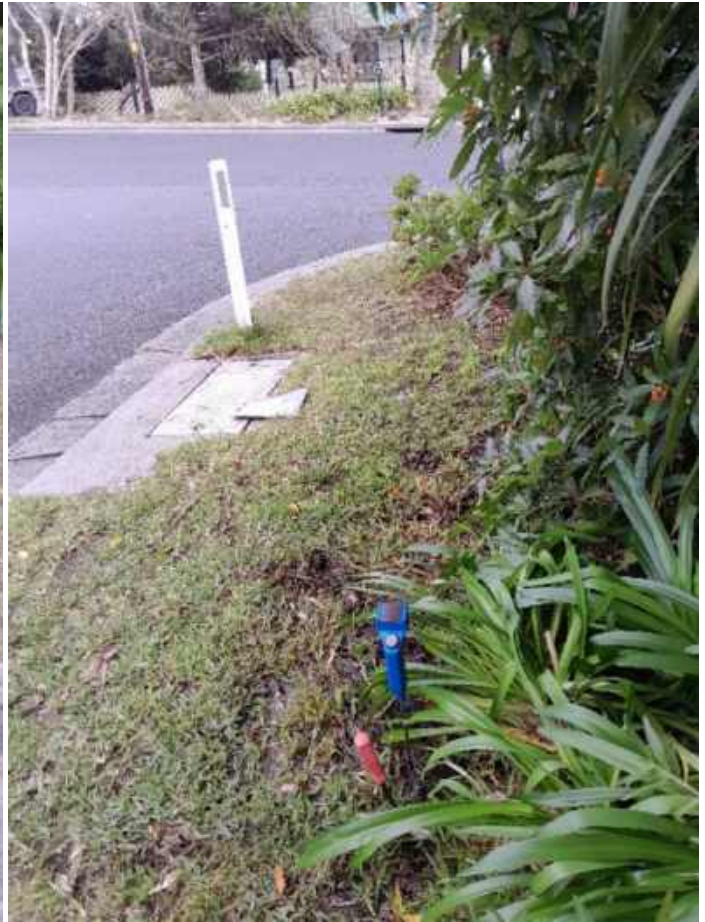
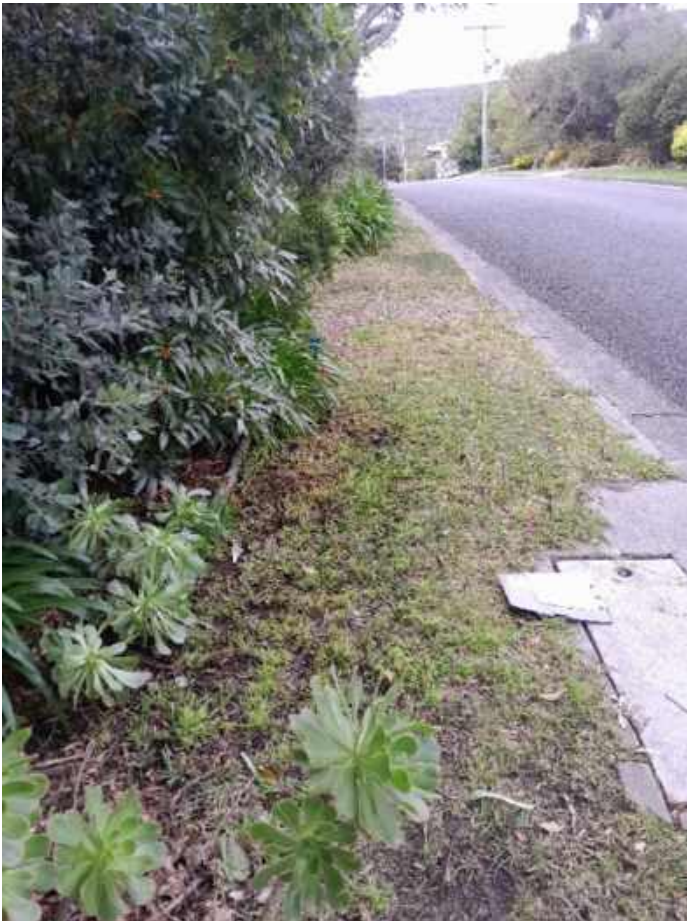
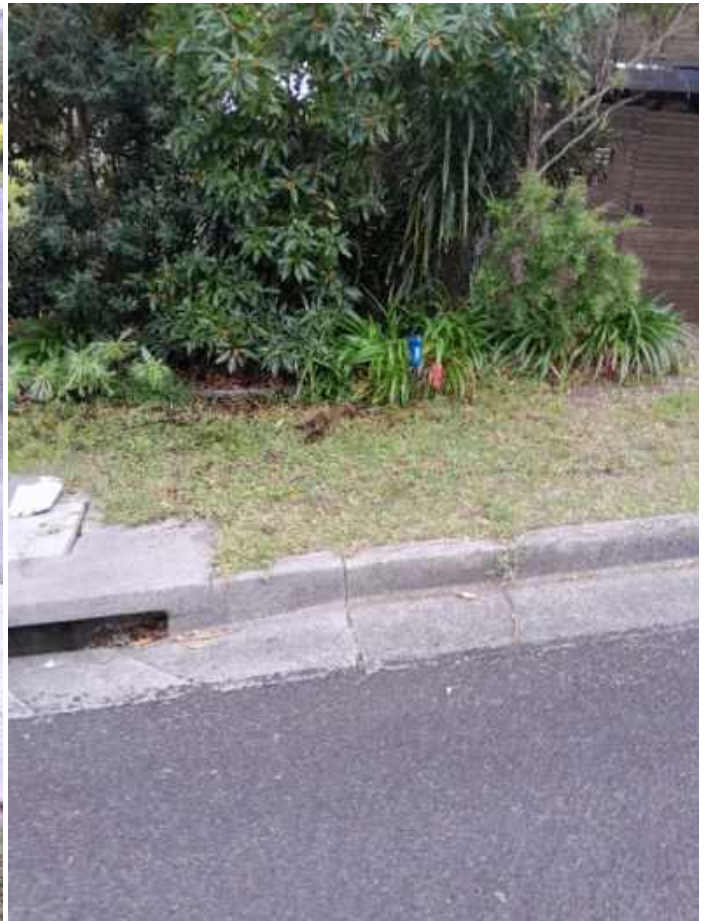
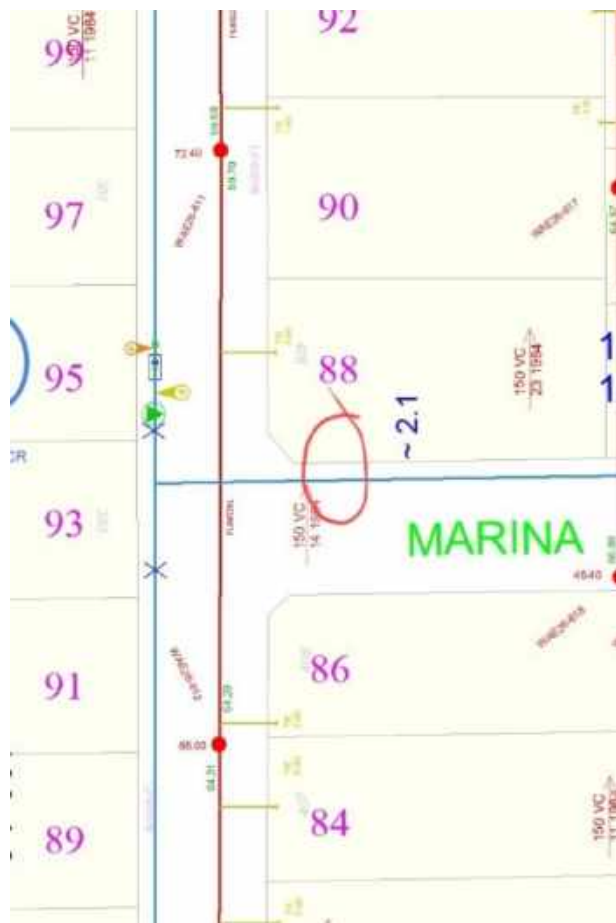
Photo

Leak Address	88 Cinerama Crescent McCrae Victoria 3938 Australia
Zone	South East Water ► Parkes St Tank Zone
Leak Asset Type	Mains
Flow Rate (L/min)	20
Has the leak been called in by DS Technician?	No
Leak Visible	Yes
Comments	Corner Marina av. Next to agapanthus bushes & stormwater drain Water pushing through ground & running along naturestrip. Probed onto main, good noise, next to agapanthus bush Possibly on ferrule, couldn't locate meter 88
