# Leak Report

## 8 Bass Street McCrae Victoria 3938 Australia

South East Water

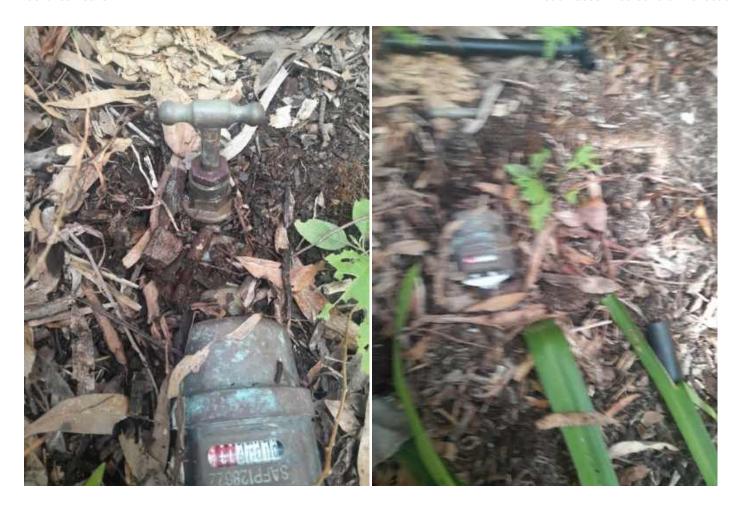
Photo

Leak Address	8 Bass Street McCrae Victoria 3938 Australia
Zone	South East Water ► Cook St Tank Zone
Leak Asset Type	Stop Tap
Flow Rate (L/min)	0.3
Has the leak been called in by DS Technician?	No
Leak Visible	Yes
Comments	Found meter tap leaking again. Tightened meter tap, still leaking 0.1. Suggest replacing meter tap with gate valve meter tap. As this is the second time meter Tap has been leaking.
