Leak Report

8 Bass Street McCrae Victoria 3938 Australia

PROJECT
📁 South East Water

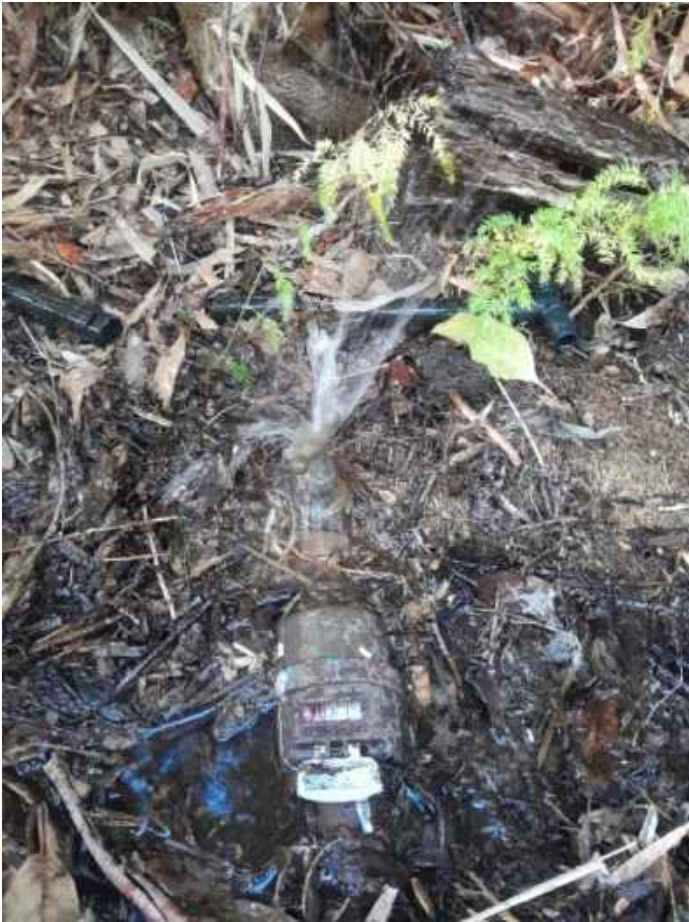
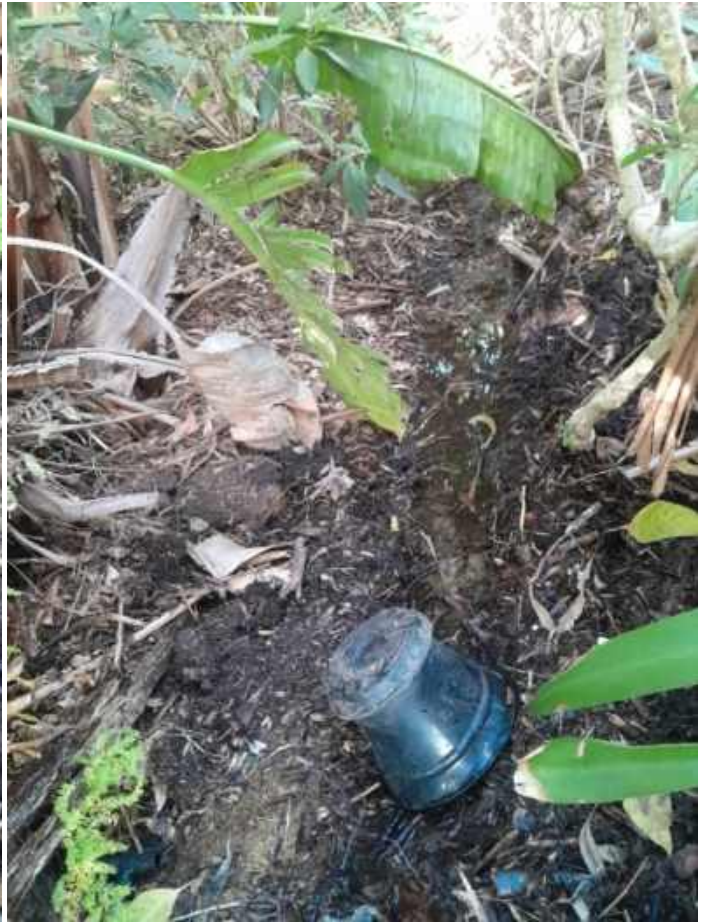
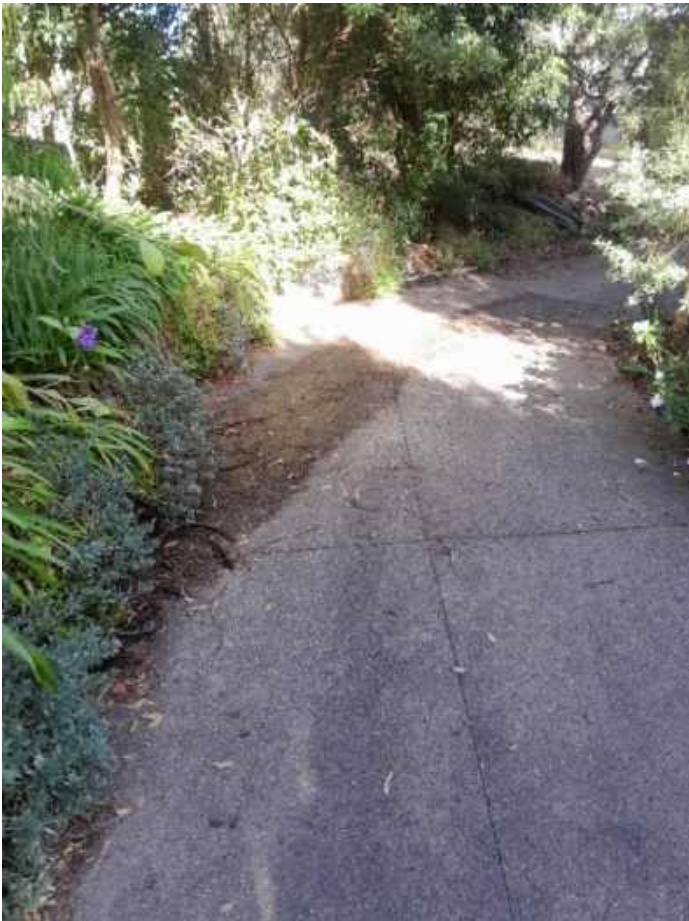
Photo

Leak Address	8 Bass Street McCrae Victoria 3938 Australia
Zone	South East Water ► Cook St Tank Zone
Leak Asset Type	Stop Tap
Flow Rate (L/min)	5
Has the leak been called in by DS Technician?	No
Leak Visible	Yes
Comments	Leaking from meter tap. Water shooting out everywhere. Cannot tighten. Owner knows of leak & has dug ditch next to meter. Water running down driveway & potentially affecting properties downhill Leak creating fair bit of noise, can be heard on surrounding assets
