Leak Report

Unit 3, 48 Armstrong Road McCrae Victoria 3938 Australia

PROJECT
📁 Service Stream

| Job Ref | LD022 |

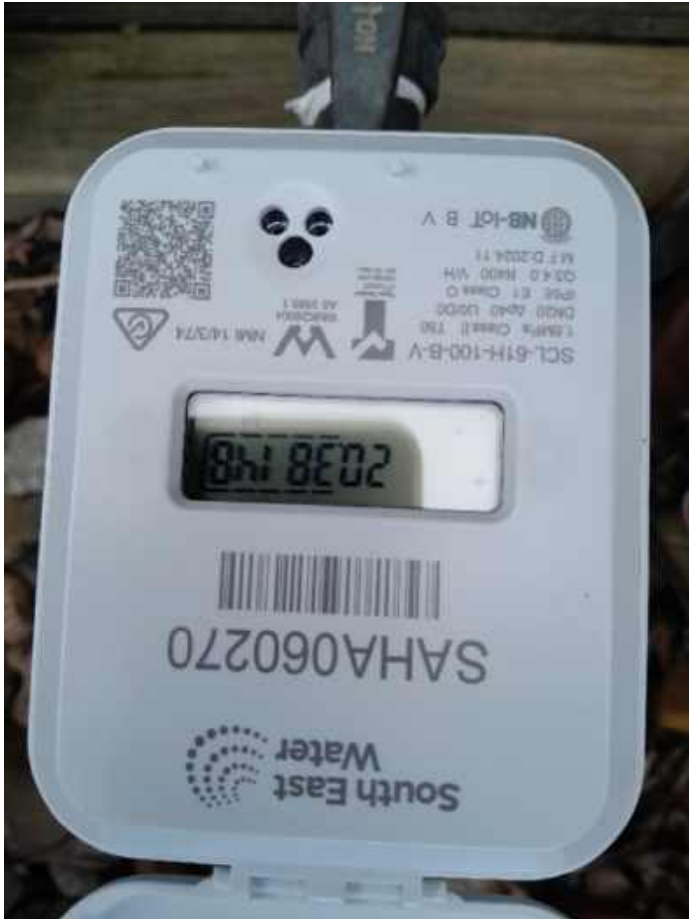
Photo

Arrived onsite, no one home. Meter spinning around, sounded garden tap at front of unit 3, no noise.

Called **I&S** . **I&S** Arrived gained access to rear of property, sounded rear garden tap, picked up small noise. Tightened tap & noise stopped. Sounded fittings up sideways..no other noises.

Checked meter again & meter stopped spinning...no noise.

Informed **I&S** of my findings & that rear garden tap may have been used & not turned off fully/left o g for a long period of time .
