# LAND STABILITY ASSESSMENT

## 14-16 VIEW POINT ROAD

## McCRAE

**Report No: 1140220E**

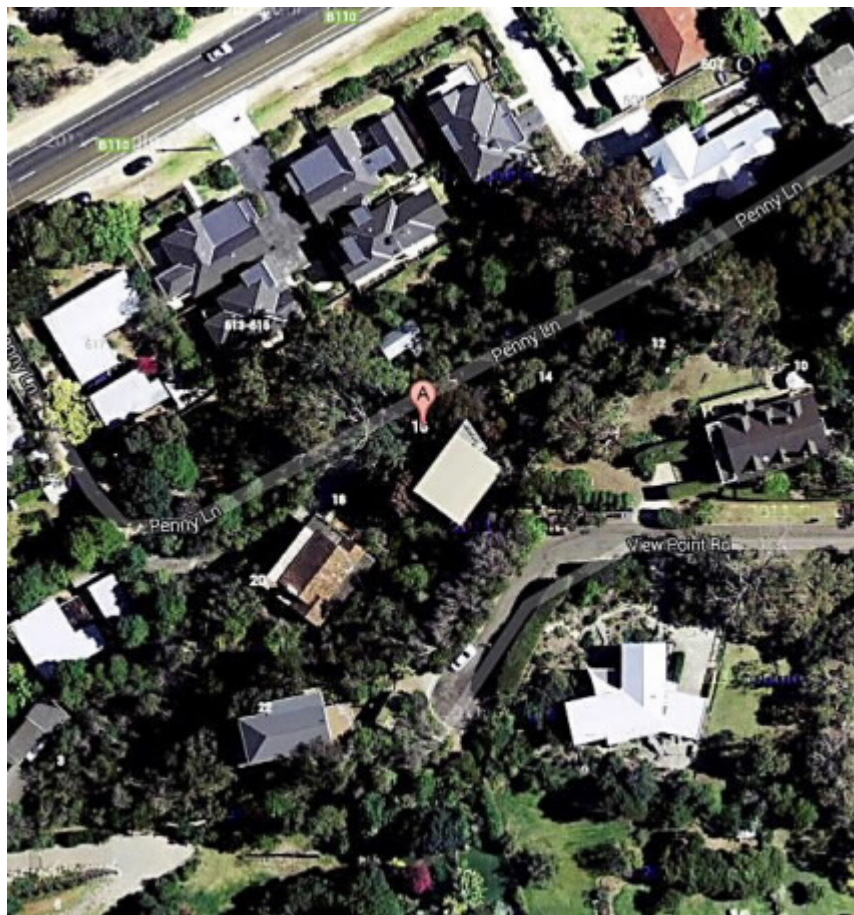
**Figure 2:** Google Aerial View of 14-16 View Point Road, MCCRAE

There is an existing single storey timber and fibro sheet clad dwelling near the upper slope end of the allotment and a timber cottage at the downslope end of the allotment – see Figure 2. The existing dwelling is on steel H columns that are founded on what appears to be shallow concrete piles. It is understood the existing structures will be demolished to give way to the construction of the proposed building. No visible defects were observed on the existing dwelling.

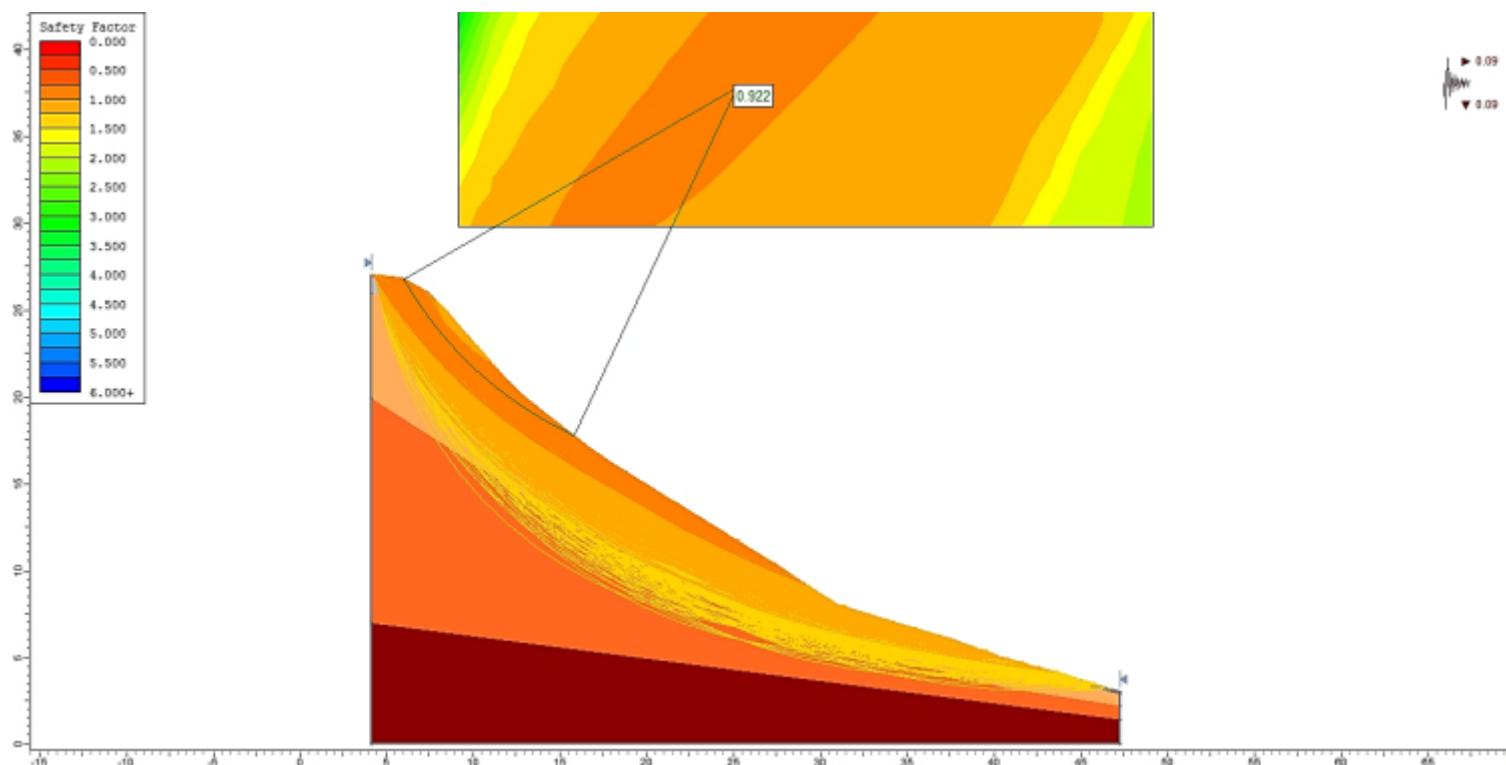
## 6.2 Model - Existing Site Conditions with Seismic Loading

Model 6.2 shows the present soil stratigraphy based on the site investigation and the latest contour map provided to Civiltest. This model considers the effects of earthquake loading. It shows a minimum Factor of Safety (FOS) equalling 0.922 for a failure surface. This would indicate that the slope would have collapsed under earthquake loading. The existing slope has been stable for at least the age of the existing dwelling on site. The model does not consider the effect of vegetation. The roots of existing vegetation over the site are contributing to the stability of the upper SAND. In addition, it is the author's opinion that the shear strength of the indurated SAND applied in the stability analysis for this site could be conservative.

All possible failure circles with a FOS of less than 1.5 are also shown in the above model. These failure circles are within the loose colluvium materials and the upper silty SAND layers. The depth of the failure circle is shown to be 5.0 metres from the existing surface level and this is highly unlikely. The failure surface would be shallow as the underlying SANDS are indurated. Collins, B.D. and Sitar, N. (2009) in an ASCE publication report cohesion values of 25kPa for indurated SAND. The modelling has adopted a cohesion of 1kPa because of the unknown depth of soil disturbance and weathering.

Model 6.2 indicates that under existing conditions, the possible failure surfaces with a FOS less than 1.5 could extend to a depth of up to 5.0 metres from the existing ground surface, and this is very dependent on the degree of weathering and disturbance of the surface soils.

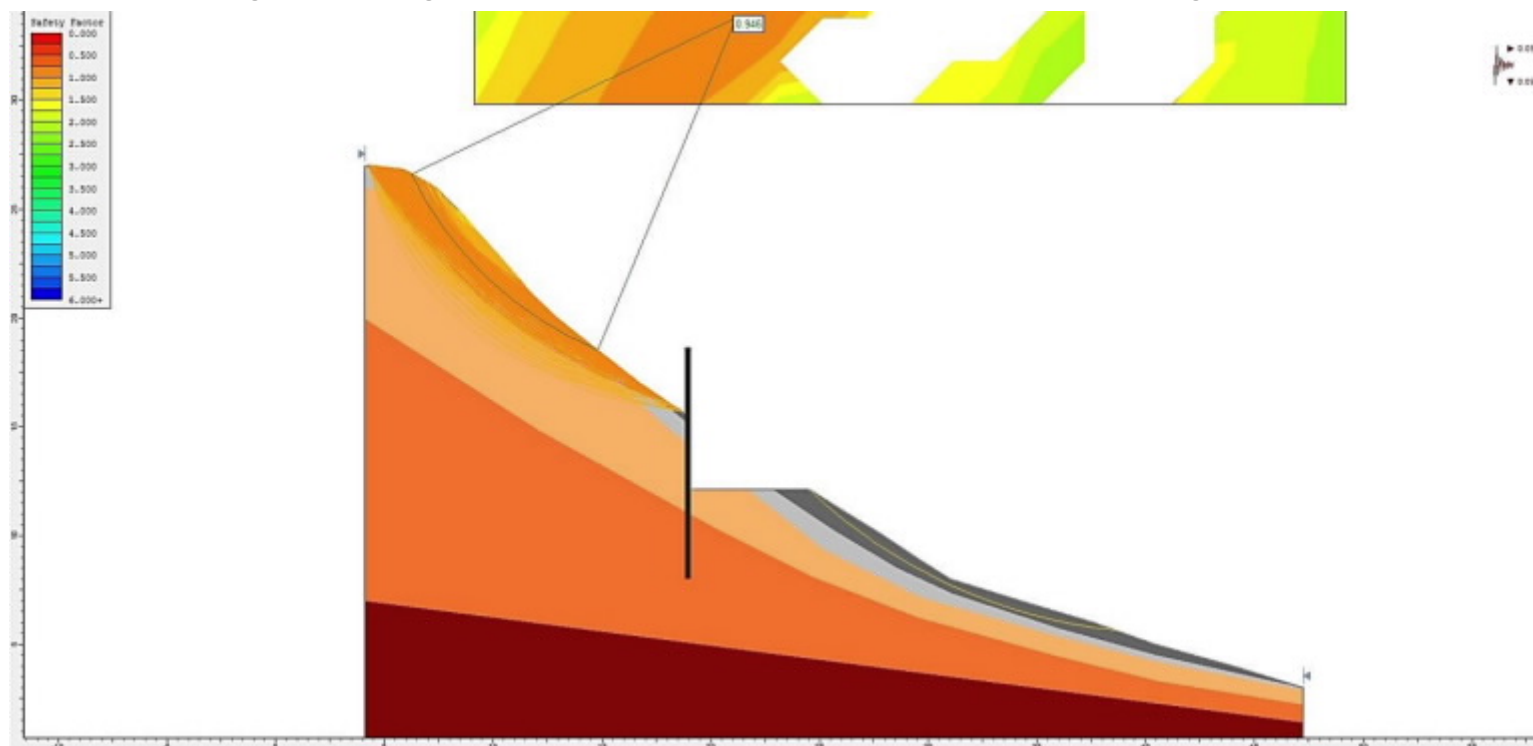
### 6.3 Model – Stage 1 Including the Installation of the Upper Line of Piers as a Retaining Structure

Model 6.3 demonstrates the effect of the proposed installation of the upper row of piers as a retaining wall. The modelling assumes that the proposed construction will entail constructing the upper row of piles followed by excavation of benches on the downslope side. This mode of construction is believed to minimise and stop any upslope disturbed material fallout and movement of the disturbed material down slope. Including the earthquake loading, the minimum FOS is 0.944. The location of the failure surface with the minimum FOS is at the steepest section of the site. Again the failure surface is within the indurated SAND layer and the depth is depicted to be a couple of metres at the most. The existing good vegetation cover and the indurated SAND soils at the exposed escarpment are contributing to the stability of the steep slope face.

The retaining wall, assumed to be steel and concrete, was added to the model at the vertical cut locations. It has been assumed that the retaining walls will consist of closely spaced piles no more than a horizontal distance of 2.5d centre to centre spacing. (Where d = diameter of the pier). The piers and wall will be structurally engineered and have sufficient strength to resist the lateral earth pressures, as well as static and dynamic design actions.

The failure surfaces (circles) with a minimum FOS of 1.082 indicated in models 6.3 and 6.4 at the steeper section of the slope (escarpment) indicate that the stability of the site is not altered significantly and also the risk of any fall-out of material is minimised if the site works are undertaken commencing at the centre of the site and working downslope. That is, on the upper line of piles and working downhill.

Model 6.3 and 6.4 indicate that if the upslope retaining walls at the proposed cuts are engineered and constructed properly, the stability of the slope in general would be maintained. It is recommended that a bored pier wall with capping beam should be provided at the upslope side of the proposed building before any construction procedures commence. Measures for stabilisation against shallow surface ravelling and erosion can be done together with bored pier wall or immediately after.

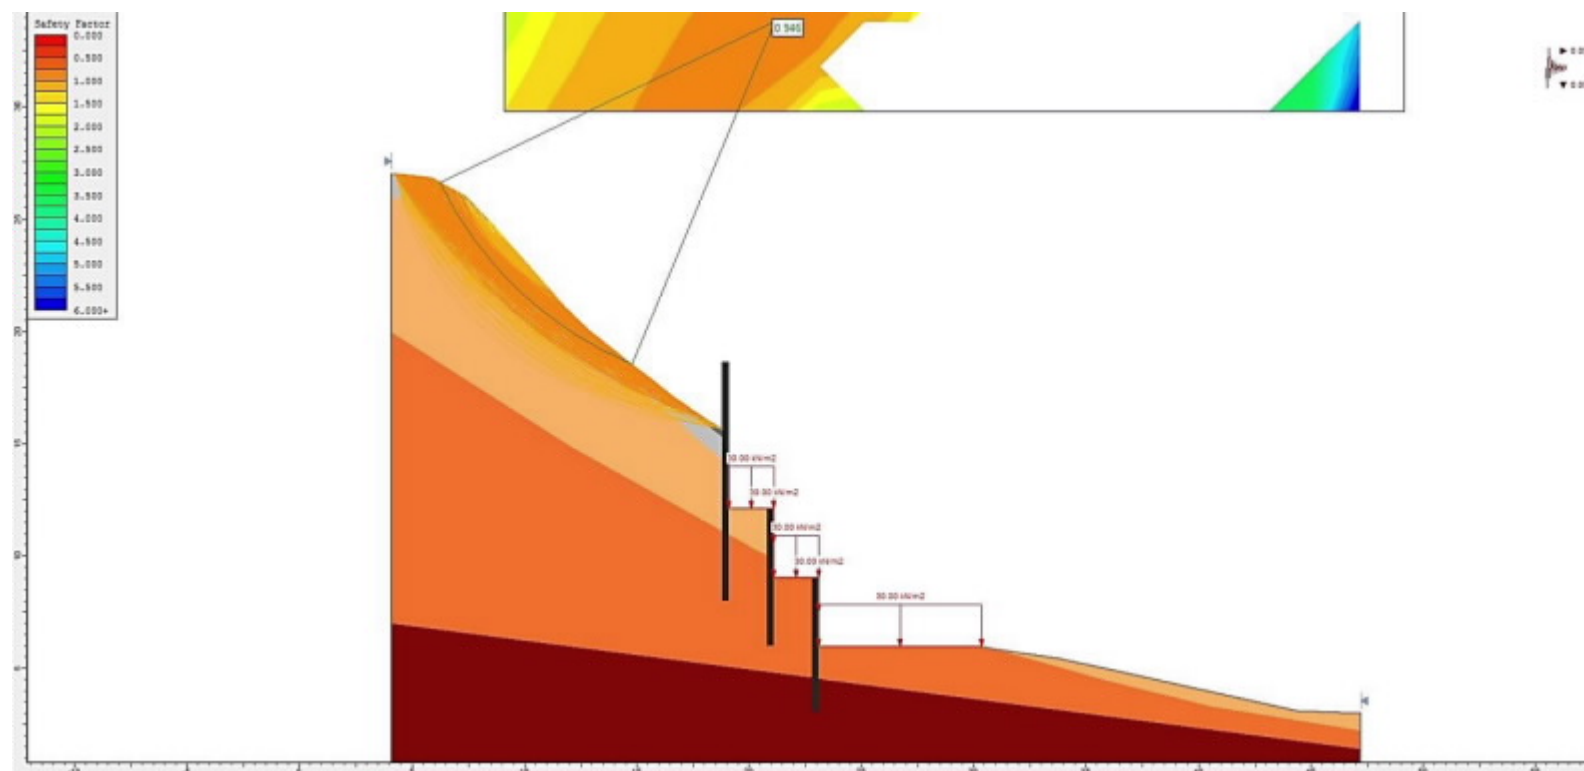
#### 6.4 Model – Proposed Building Loads with the Retaining Walls where Cuts are Proposed.

Model 6.4 demonstrates the effect of the proposed dwelling and the soil retaining walls as benched construction along the hillside. The minimum FOS is noted to remain at approximately the same location and the same value of 0.944 as per Model 6.3. Again the failure surface is within the indurated SAND layer and the depth is depicted to be a couple of metres at most. The existing good vegetation cover and the indurated SAND soils at the exposed escarpment are contributing to the stability of the steep slope face. To verify the existing stable conditions at this site based on the soil's material properties is made difficult because undisturbed sampling in sands is near to impossible.

It is the author's opinion that the shear strength of the indurated SAND used in the stability analysis for this site is conservative. Stability analysis with a cohesion of 10kPa in the silty/clayey SAND (indurated) would provide a minimum FOS of over 1.5. Given the sandy nature of the exposed material, shallow surface erosion and ravelling can be expected as well as creep movements. The depth of these failures is unlikely to be more than 2.0 metres.
