Re: P13/2073: 14 – 16 Viewpoint Road, Mc Crae

Please see below an assessment of the proposal of Clause 54 and DD03.

54.01-1: The site is an extremely steep parcel of land that runs between Viewpoint Road on the Southern side of the property and Penny Lane on the North side of the property. The site is 1205m2 with approximately 20m of fall between Viewpoint Road boundary and Penny Lane boundary.

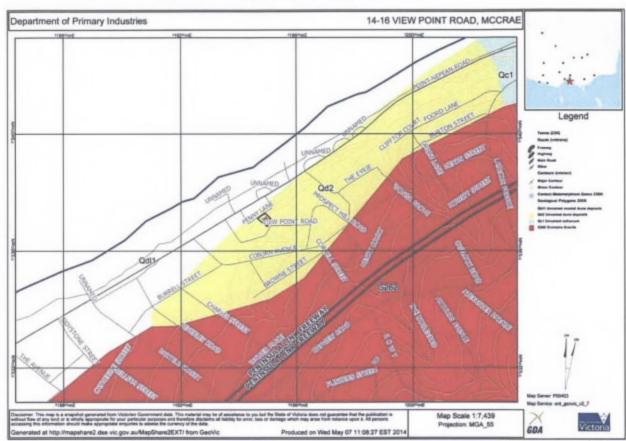
Figure 1: Site Geology from GeoVic

Geological maps of the area suggest that the site is in an area of Devonian Granodiorite & Granite overlain by Quaternary Aeolian. The site investigation confirmed this. A copy of the site geology is shown in Figure 1 below.

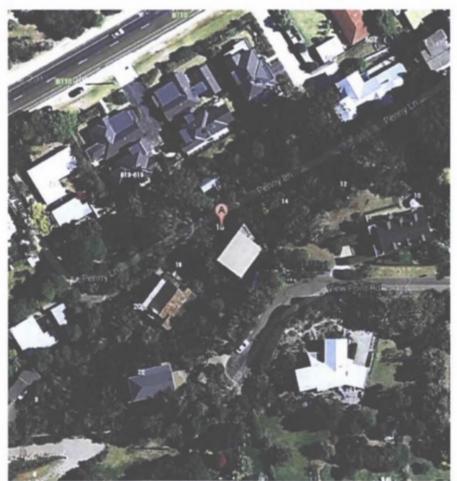
Figure 2: Google Aerial View Of 14-16 View Point Road, MCCRAE

There is an existing single storey timber and fibro sheet clad dwelling near the upper slope end of the allotment and a timber cottage at the downslope end of the allotment – see Figure 2. The existing dwelling is on steel H columns that are founded on what appears to be shallow concrete piles. It is understood the existing structures will be demolished to give way to the construction of the proposed building. No visible defects were observed on the existing dwelling.

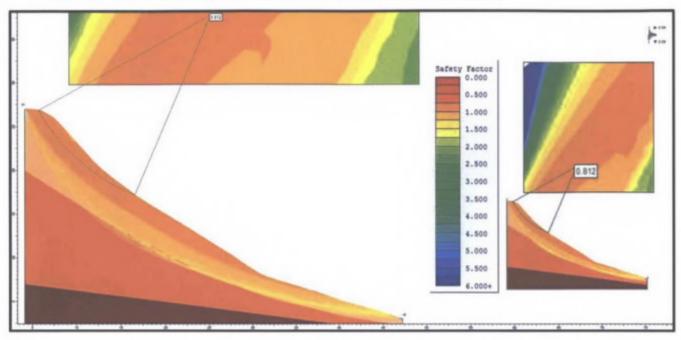
Model 6.2 shows the present soil stratigraphy based on the site investigation and contour map provided. This model considers the effects of earthquake loading. It shows a minimum Factor of Safety (FOS) equalling 0.812 for failure surface on the steepest section of the slope located towards View Point road. This would indicate that the slope section as shown in green would have already failed. However, the model does not consider the effect of vegetation. The roots of existing vegetation over the site are most likely holding the upper SAND soils in place.

All possible failure circles with a FOS of less than 1.5 are also shown in the above model. These failure circles are within the loose colluvium materials and the upper silty SAND layers to a depth of up to 5.0 metres from the existing surface level.

The failure surfaces (circles) with a minimum FOS of 0.812 indicated in both models at the steepest section of the slope reflect that without good vegetation cover, the surface material could have already failed. It is highly recommended that a good cover of vegetation should always be maintained at this site.

Model 6.2 indicates that under existing conditions, the possible failure surfaces with FOS less than 1.5, could extend to a depth of up to 5.0 metres from the existing ground surface.

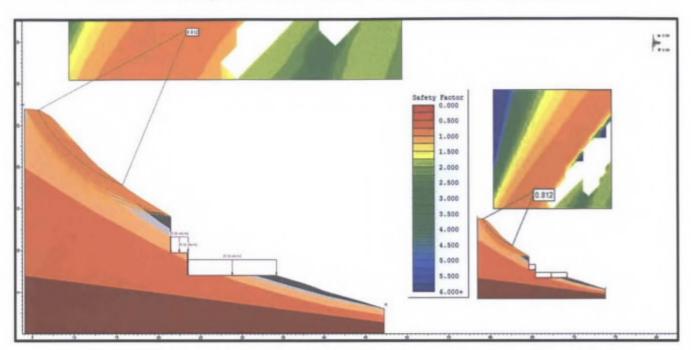
6.3 Model - Loadings from the Proposed New Dwelling Superimposed

Model 6.3 demonstrates the effect of the proposed new dwelling taking into consideration the proposed building's earthworks and architectural elevations and proposed retaining wall at the upslope side of the building. The minimum FOS remains unchanged and the corresponding failure surface is at a similar location to that shown in Model 6.2.

The retaining wall, assumed to be steel and concrete, was added to the model at the vertical cut locations. It has been assumed that the retaining walls will be structurally engineered and have sufficient strength to resist the lateral earth pressures, as well as static and dynamic design actions.

Model 6.3 indicates that if the retaining walls at the proposed cuts are engineered and constructed properly, the stability of slope in general could be improved. However, it should be emphasised that the existing slope itself is still at risk of failure and this will make the construction process difficult since the stability of the upper SAND soils are very sensitive to any changes made in topography. It is recommended that the upper slope (the steep sections) are stabilised before any construction procedures commence and an engineered retaining wall system constructed **before** any cut is made. Overflow from the roadside kerb should be captured and diverted to the street drainage system such that there is minimal water cascading over the steep slope surface.

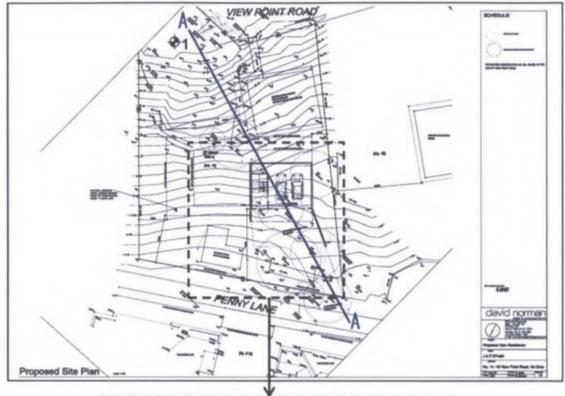
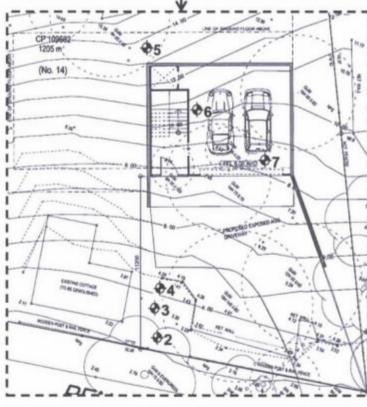
SITE PLAN - LOCATION OF TEST SITES

Note:
Bore Hole 1
is on the plan
above,
Bore Holes
2-7 are on the
plan at left

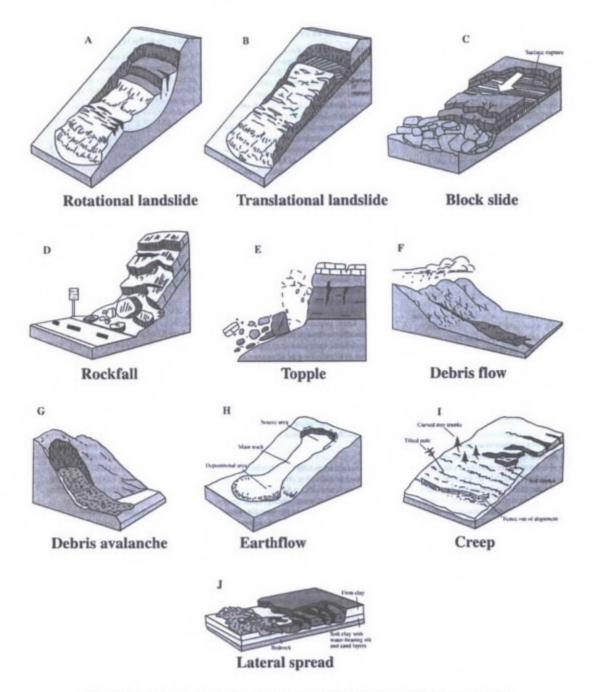
Figure B1: These schematics illustrate the major types of landslide movement. (From US Geological Survey Fact Sheet 2004-3072, July 2004, with kind permission for reproduction.)

Figure B1 gives schematics to illustrate the major types of landslide movement. Further information and photographs of landslides are available on the USGS website at http://landslides.usgs.gov.

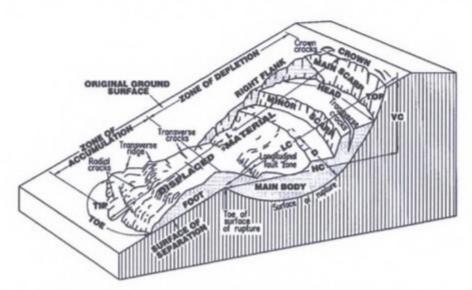
Figure B2: Block of Idealised Complex Earth Slide – Earth Flow

Varnes (1978, Figure 2.1t) provided an idealised diagram showing the features for a *complex earth slide* – *earth flow*, which has been reproduced here as Figure B2. Definitions of landslide dimensions are given in Cruden & Varnes (1996).
