# Significant Incident Notification

| <b>Re:</b> | Landslip and Structural Damage - 3 Penny Lane and 10-12 View Point Road McCrae |
| <b>Address:</b> | 3 Penny Lane and 10-12 View Point Road McCrae |

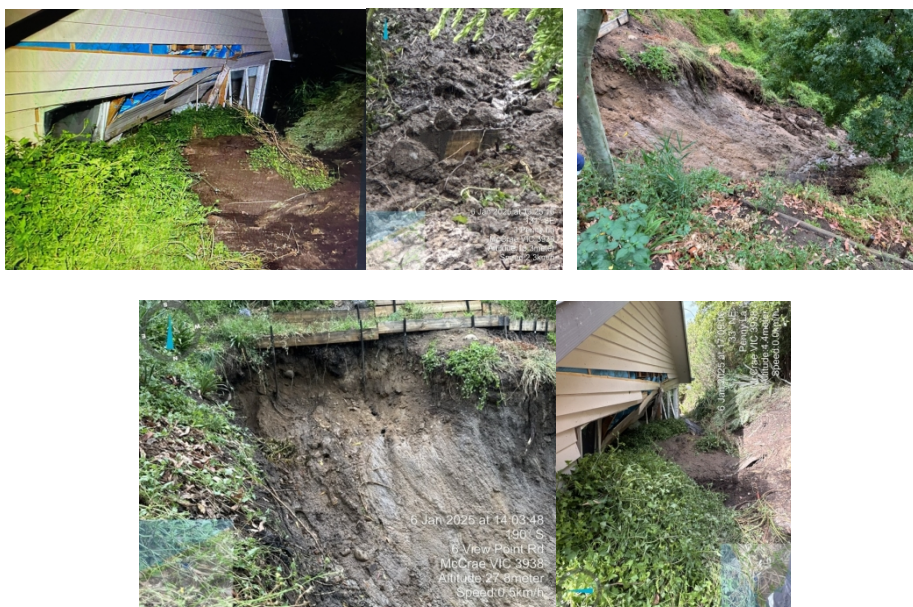
### Photos

The affected premises (3 Penny Lane) are holiday residences that have sustained structural damage to the rear of the 3-storey dwelling, which is benched into the slope. Between 20 and 25 tonnes of material has struck the dwelling, causing moderate damage to external walls and structural piers.

- PSM consulting engineers (Geologists, geotechnical, hydrogeologists, and hydrogeologists engineers) have been engaged in assisting the MBS.
- Structural Damage to the rear of the dwelling has occurred, including movement of piers in a concentrated area.

- The rear external wall of the centre of the dwelling is unsafe and unstable.
- An underfloor inspection indicates the water problem has been an ongoing matter for some time.

- No access to the dwelling for residential occupation.
- Water tracing is occurring by the MBS.
- Ongoing investigations by the MBS Office are occurring.
- Both owners (3 Penny Lane and 10-12 View Points) continually communicate with the MBS.
- PSM is providing a preliminary report regarding the possibility of the dwelling (3 Penny Lane) being dislodged from its piers from further impacts, causing the dwelling to collapse and affecting property along Point-Nepean Road (607 and 605).
- The site has been taped off.
