PSM5665 - McCrae Landslide Monitoring - Information and request for access

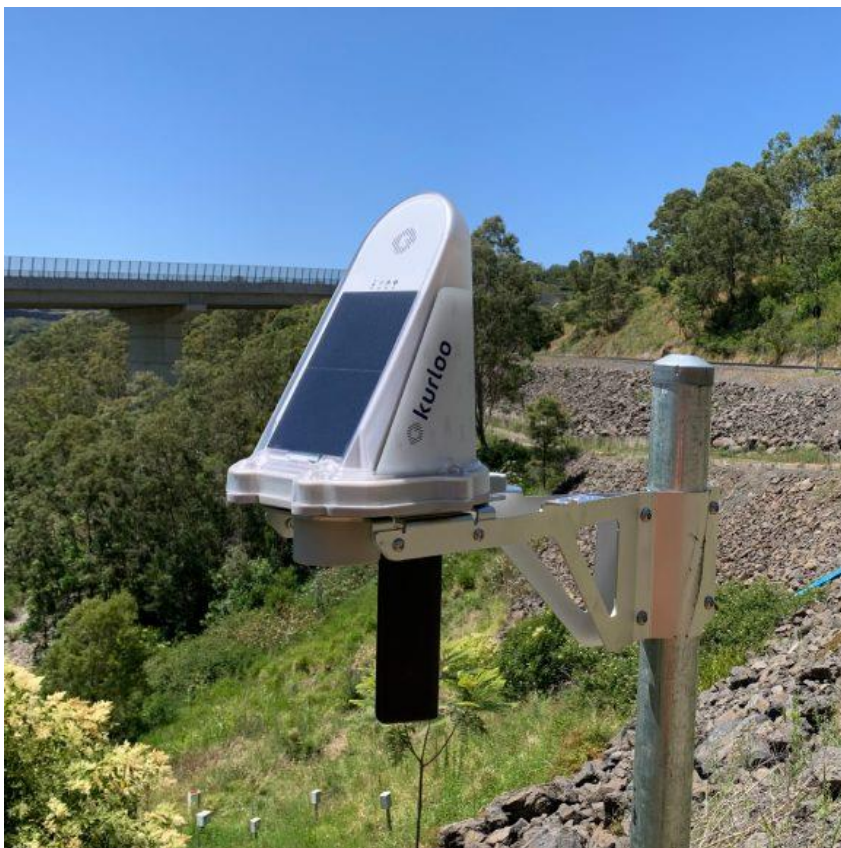
Figure 1: Example of GNSS Sensor installed on steel post

1. GNSS (i.e. GPS, refer Figure 1)
2. Tilt Sensors (refer Figure 2)
3. Manual Survey Prisms (refer Figure 3).

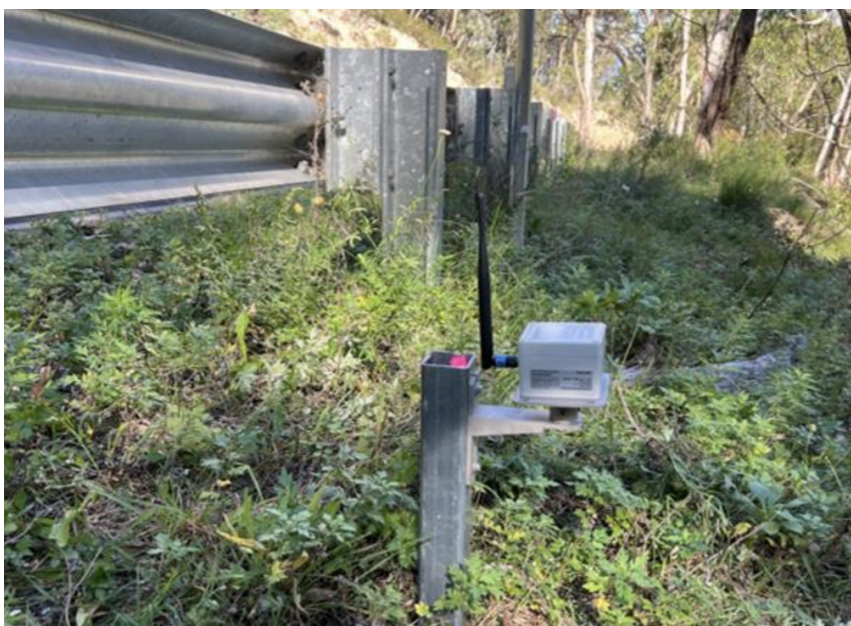
Figure 2: Example of tilt sensor installed on steel post

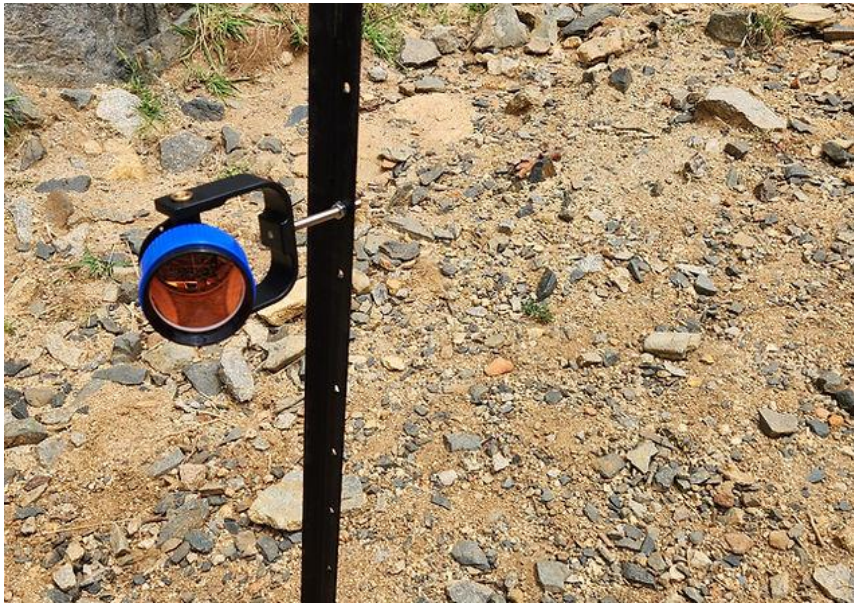
Figure 3: Typical example of survey prism on star picket
