Leak Report

4 Waller Place McCrae Victoria 3938 Australia

Leak Address	4 Waller Place McCrae Victoria 3938 Australia
Zone	South East Water ► Reactive Leaks
Leak Asset Type	No Leaks Found
Has the leak been called in by DS Technician?	Yes
Job Ref	1295094/003
Leak Visible	No

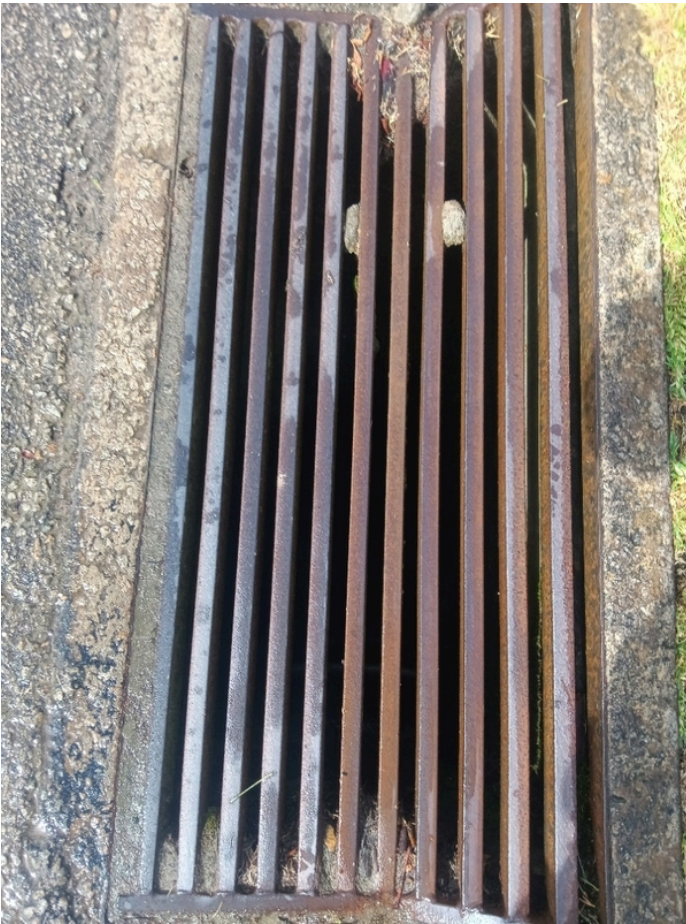
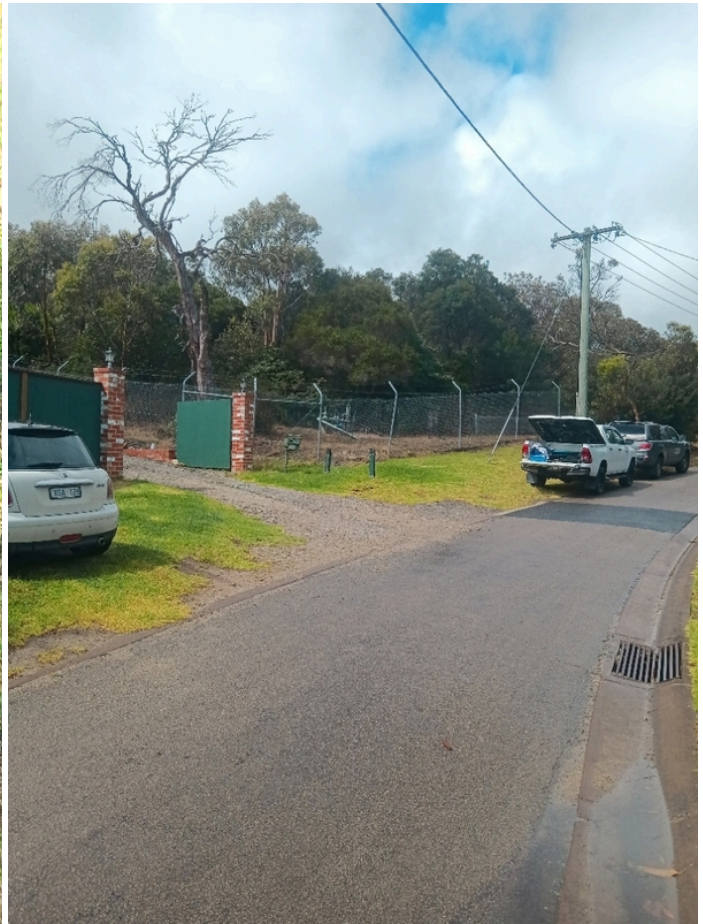
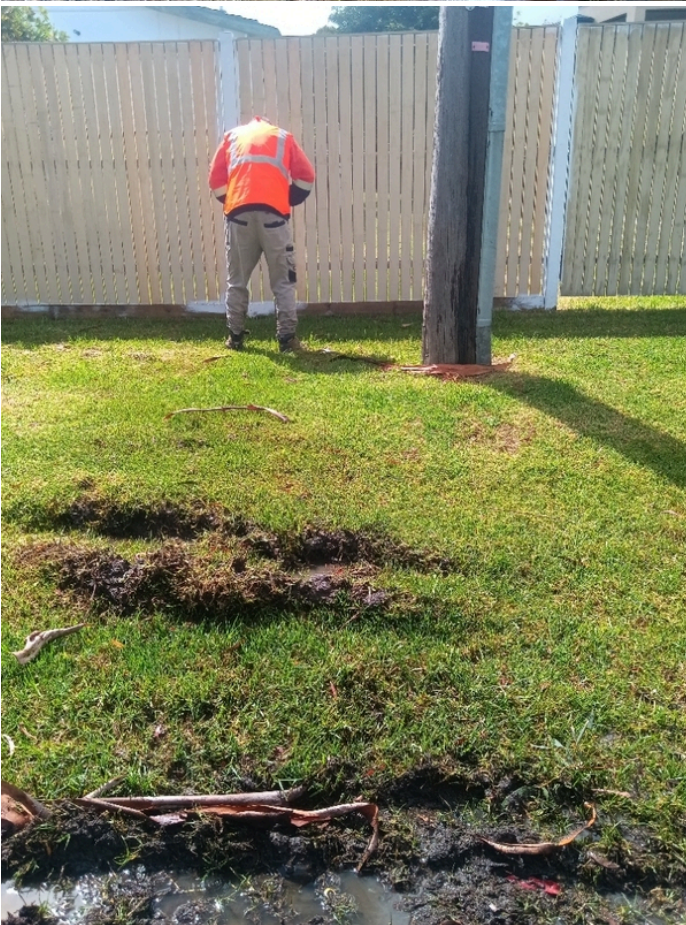
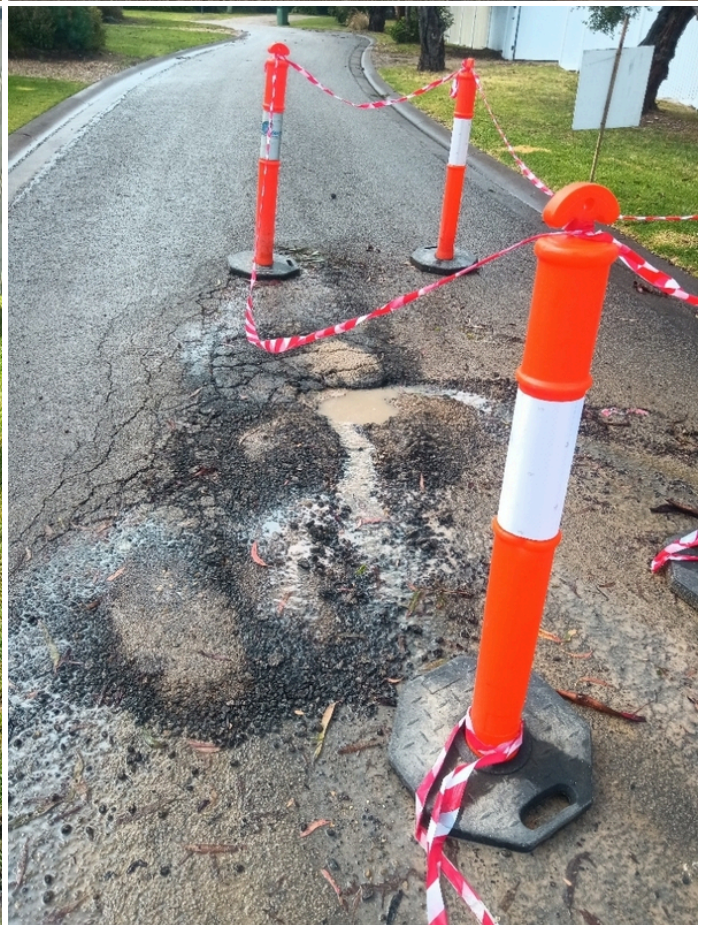
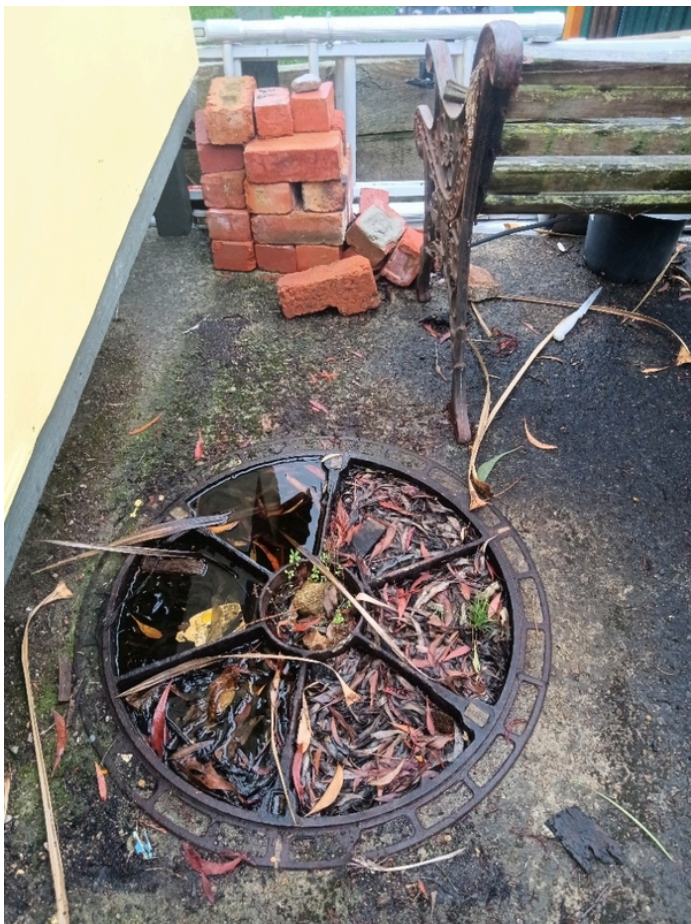
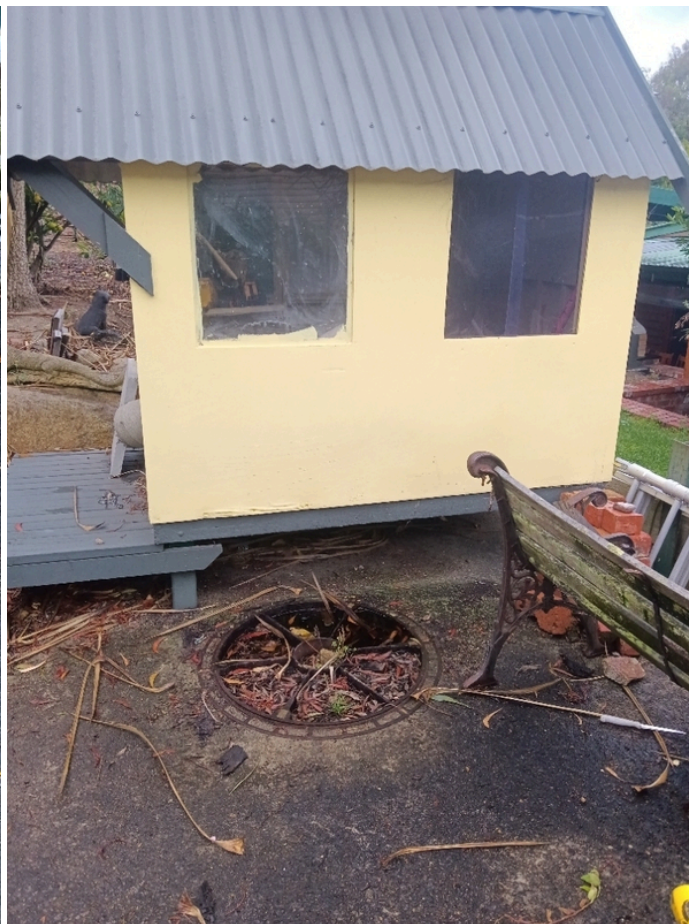
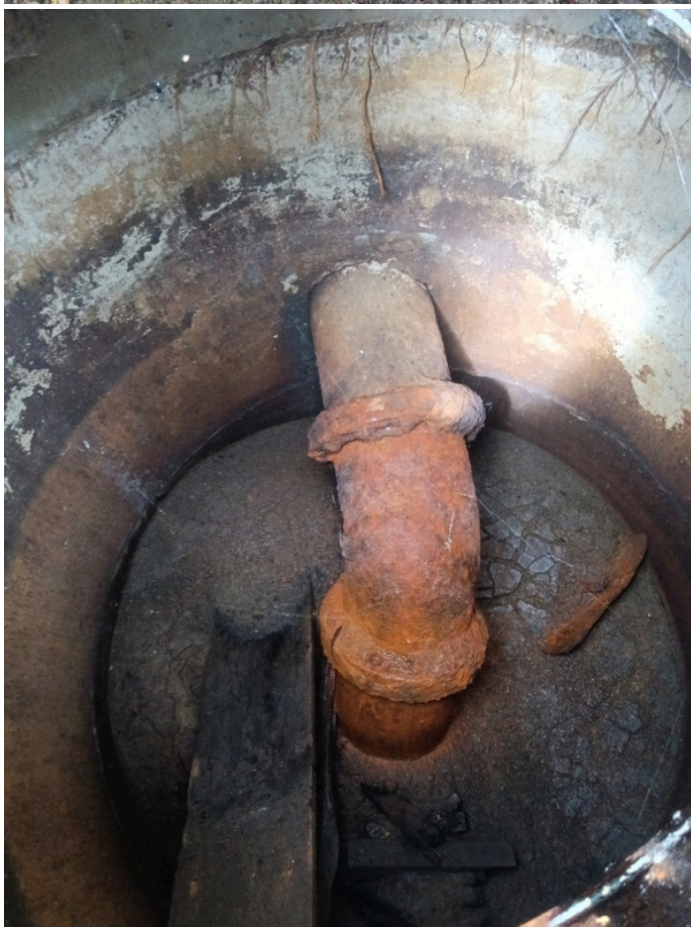
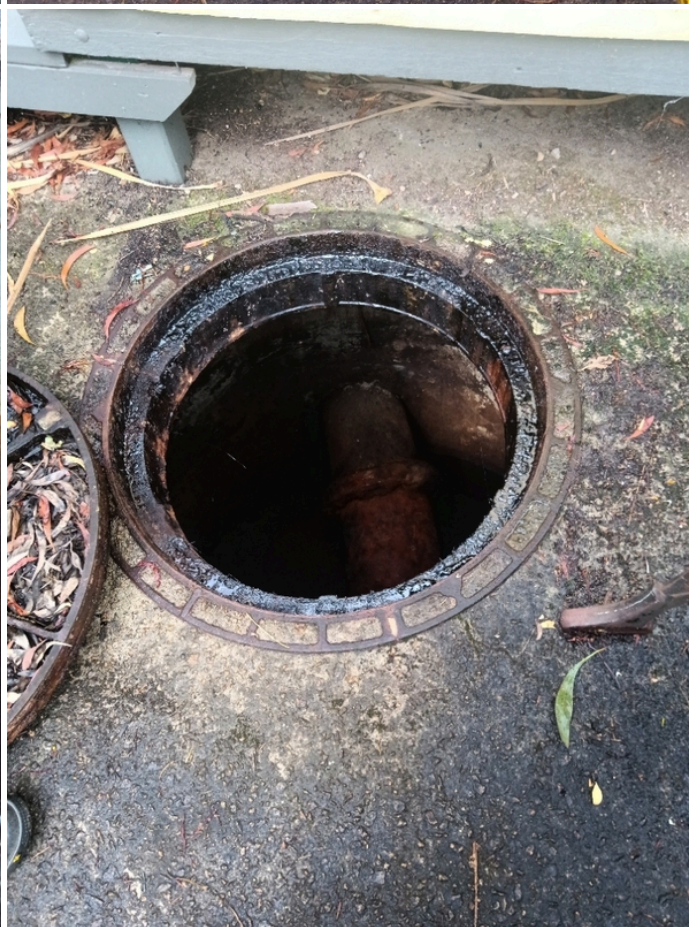
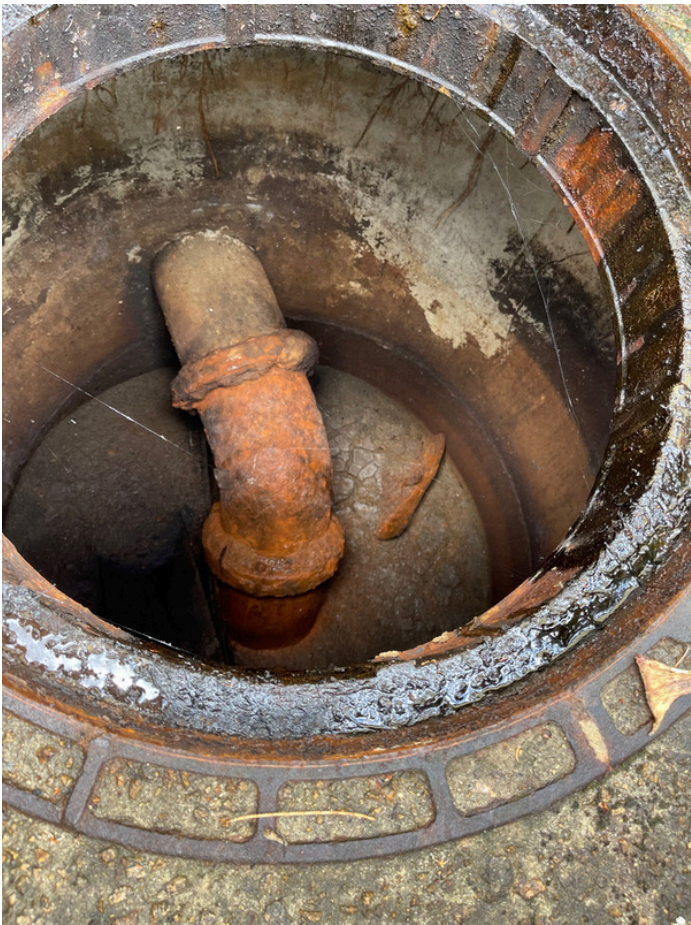
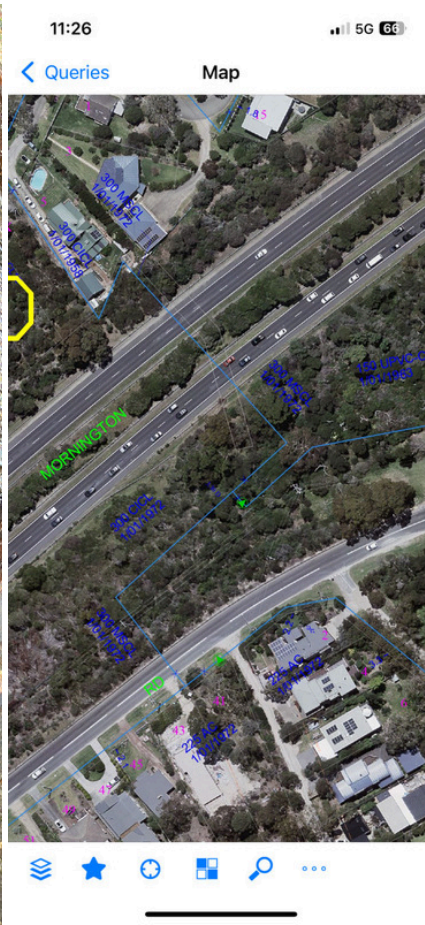
Identified Leaks

Sounded all assets in the area, followed suspect 300mm main and no leaks were detected. Chlorine sample needs to be taken when rain stops.

The new owners at 4 Waller and the owner Bret of number 5 (has lived here for the past 20 years) has let us at the back of his block where he has an old Water style lid cover (see attached photos) it houses the 14" main elbow it's very deep 4m is actually not on his property, although it's fencing inside his property, we just popped the and sounded it directly, no noise at all. Apparently the drains run all year round, but the water has got a lot worse and it's affected on the roadways and two locations bubbling up and damaging the road. It been partially barricaded of.

We also surveyed Bayview Rd above the Highway with no leak noises detected.

I don't believe there's any leaks on the mains but still some of the smaller pipes really haven't checked out. Jason Marsh will return take samples when it's not raining for a few days.
