**From:** Peter Johnson Irrelevant & Sensitive  
**Sent:** Fri 4/18/2025 12:59:55 PM (UTC+10:00)  
**To:** Submissions (McCrae Inquiry)[submissions@mccraeinquiry.vic.gov.au]  
**Cc:** Richard Irrelevant & Sensitive Bronwyn  
Borghesi Irrelevant & Sensitive  
**Subject:** View Point Road - My photos over the years

**What was the water flow like in the northern gutter?**

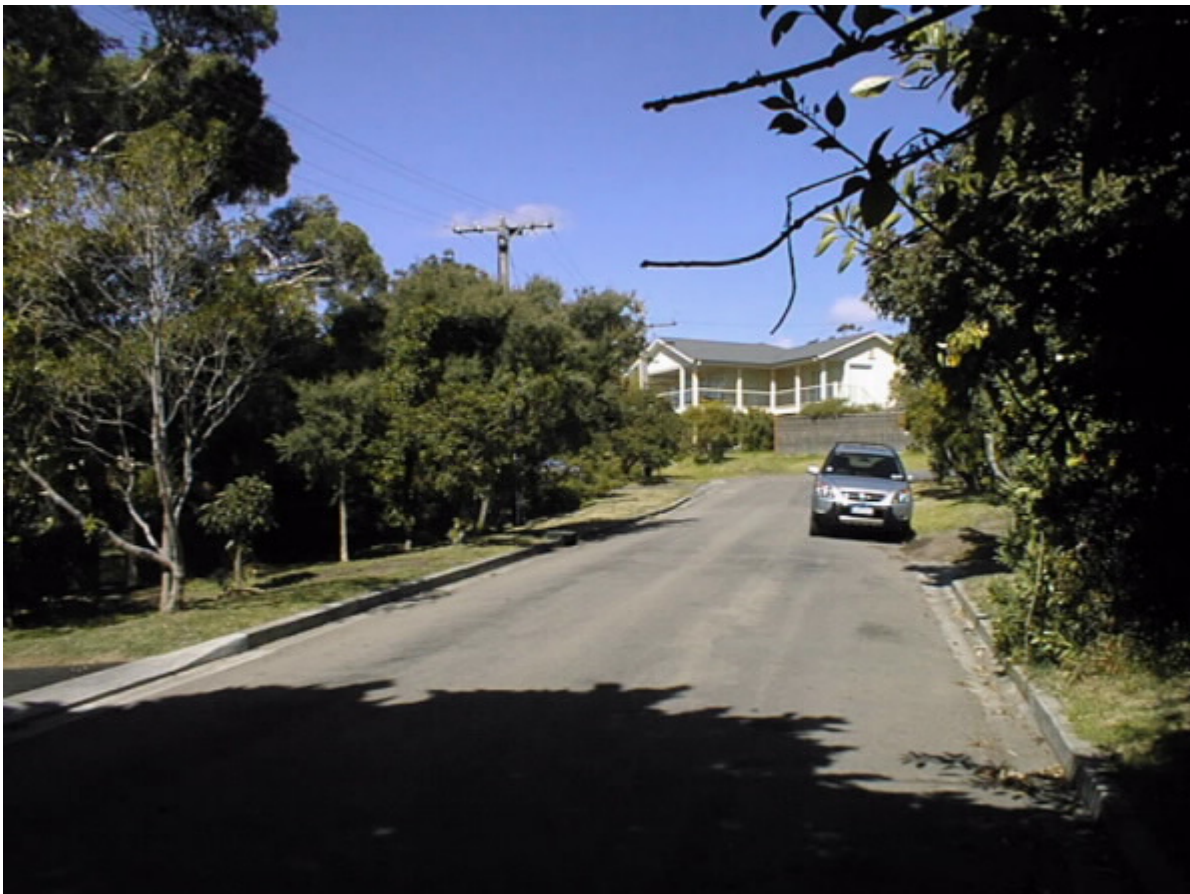
Before 2004, the flows were fairly minimal, often drying up entirely during the summer months.

*View outside no.4, 29th January 2004. The northern gutter is dry.*

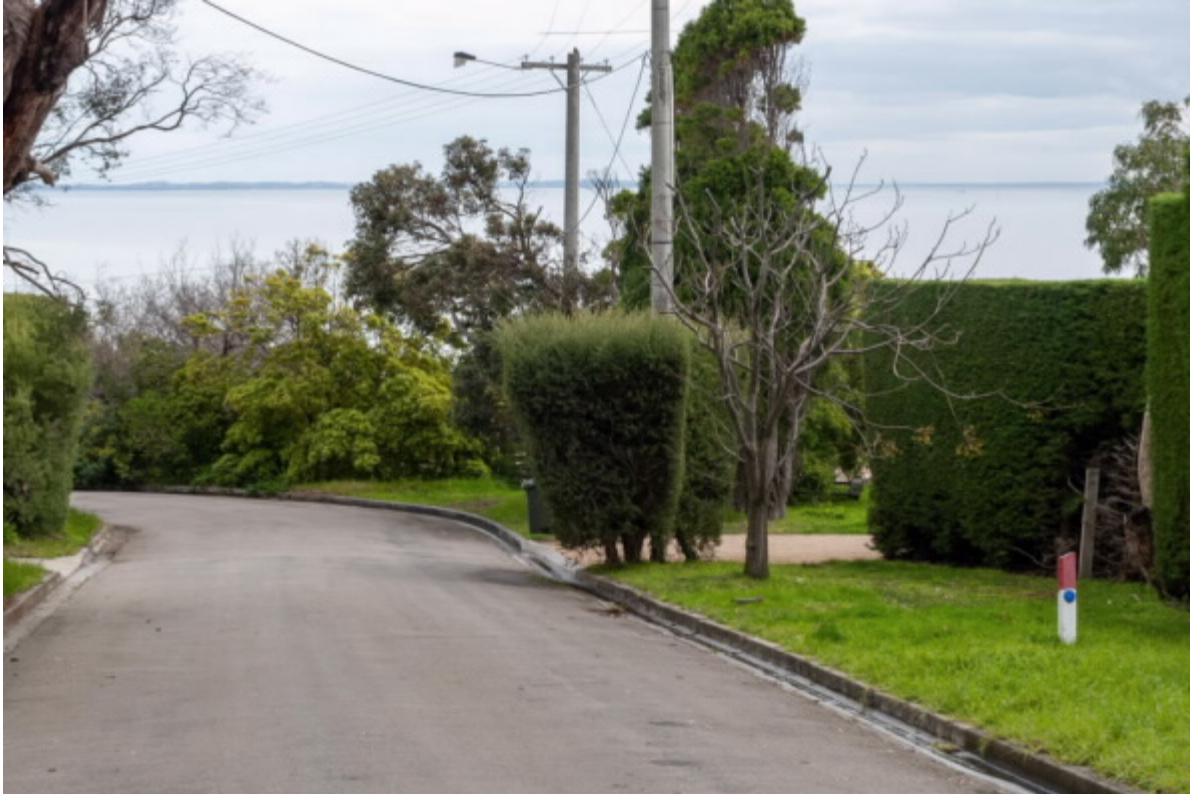
In the years that followed this changed. The water flow gradually grew larger and larger, and lasted throughout the summer. Eventually a big problem developed with algae growth along the gutter adjacent to nos.6 & 10, running about 200mm wide all down its length. The Shire was forced to clean it out several times due to local complaints. They should have records of these complaints somewhere in their system.

*View outside no.10 in 2008 before the hump was installed, note the poor gutter condition.*

About 5 years ago the council put a hump across the road before the curve in the above image, in order to transfer the water across to the other side of the road in order to reduce any overflow impact to the cliff-edge residences during heavy rainstorms. The related complaints and subsequent action should also appear in Shire records.

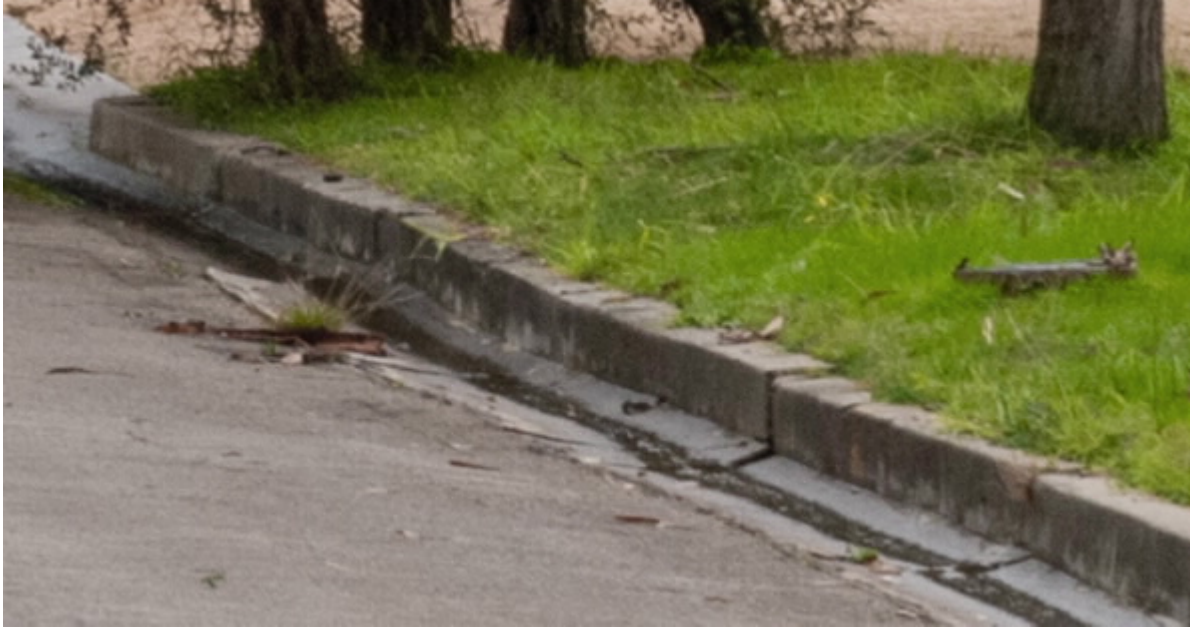
*Zoomed view of previous image showing the poor state of the gutter.*

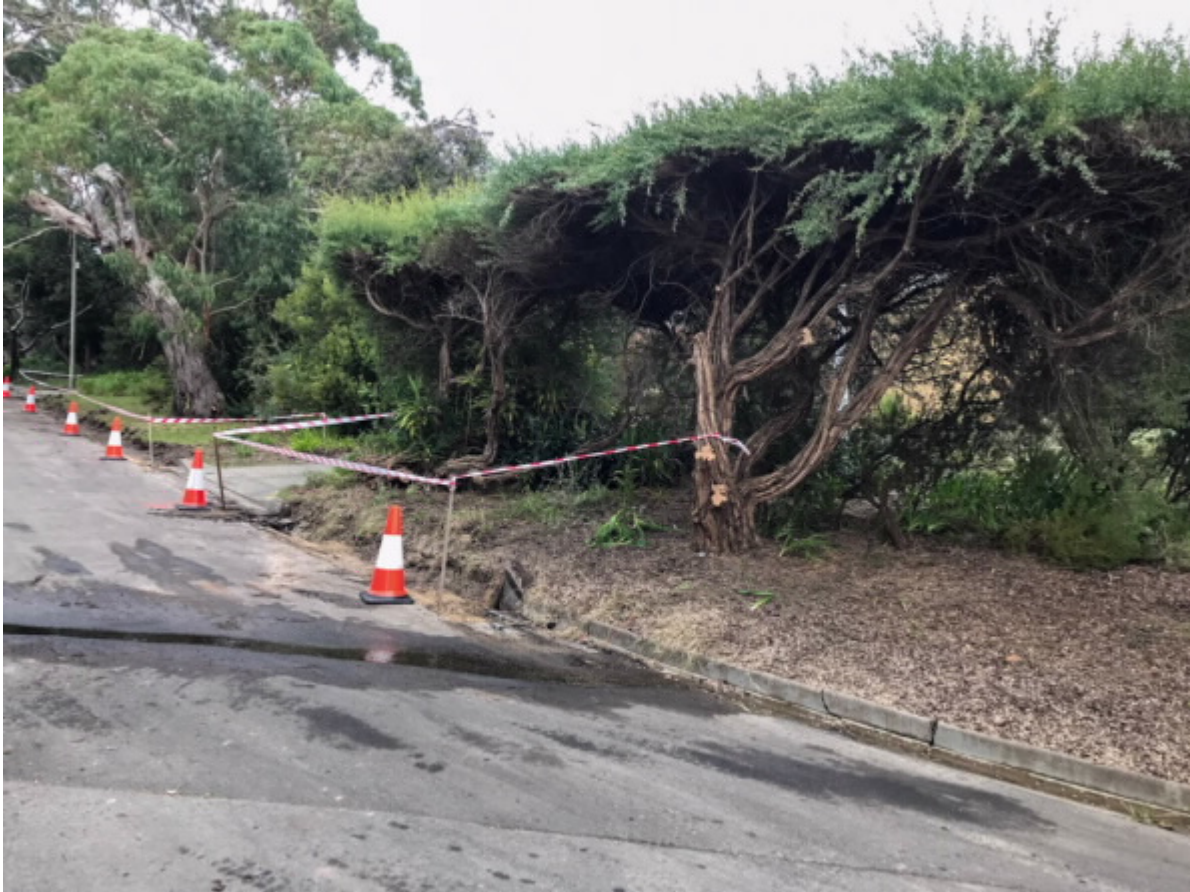
*View in 5 May 2023. Shows hump across road to divert water. Note the cracked kerb.*

Following the first landslide about 2 years ago, the gutters were finally replaced in May 2023.

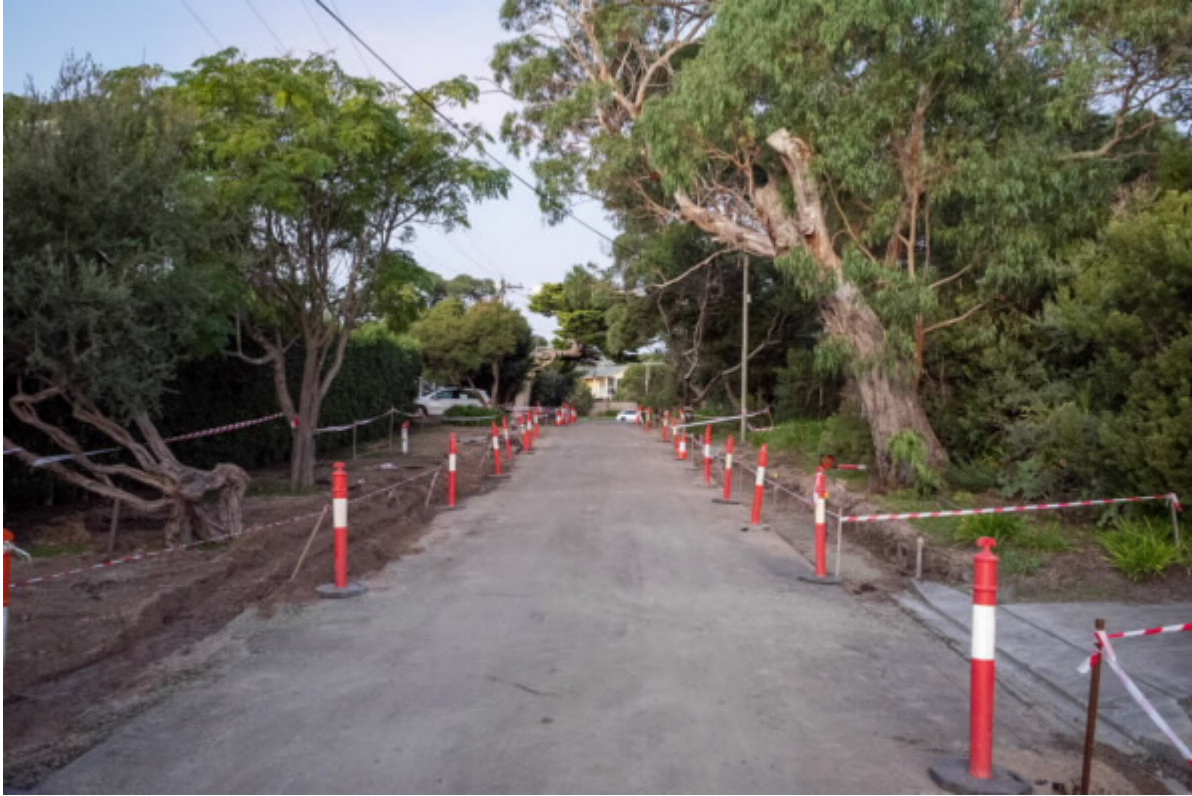
*Looking east 13 May 2023, showing work in progress replacing gutters.*

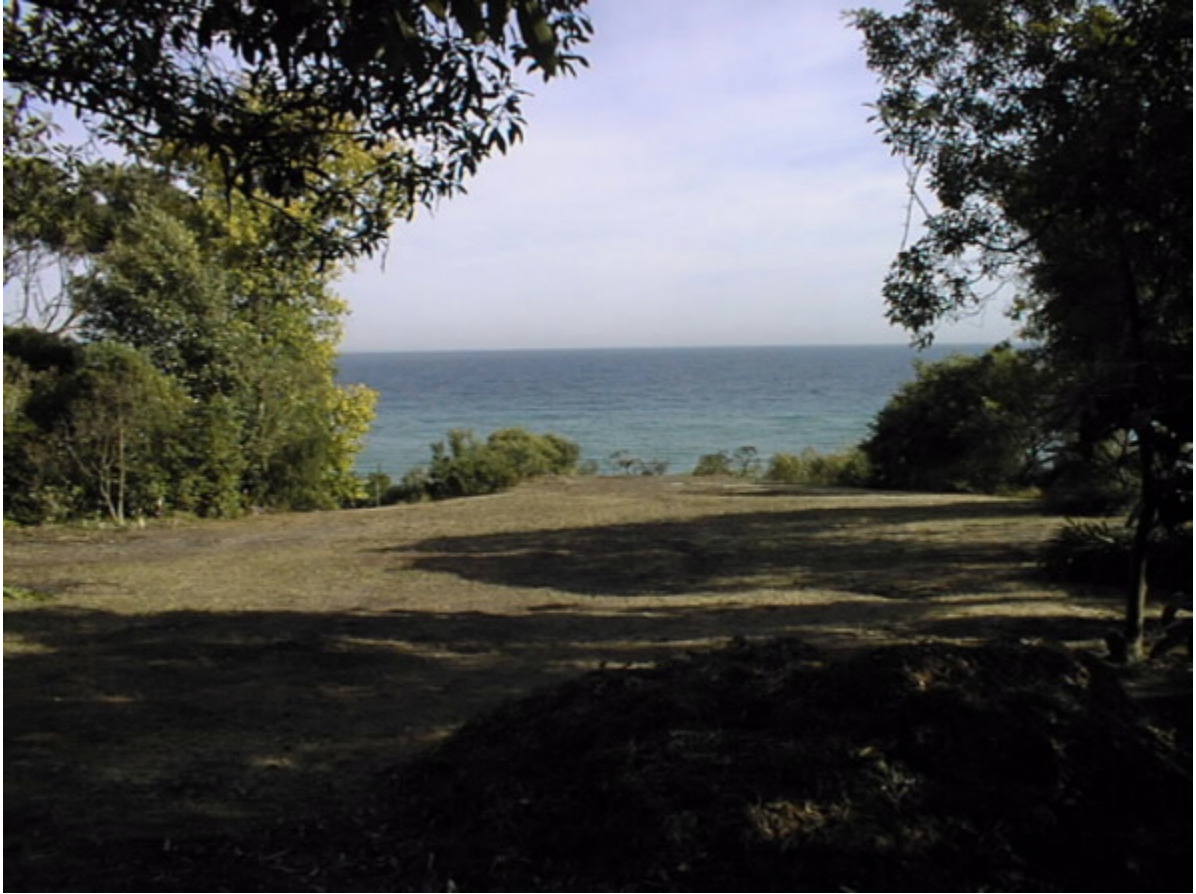
*Site at no. 6 looking north from the front gate, 18 March 2002. Note the site had been graded before sale in about 2000.*

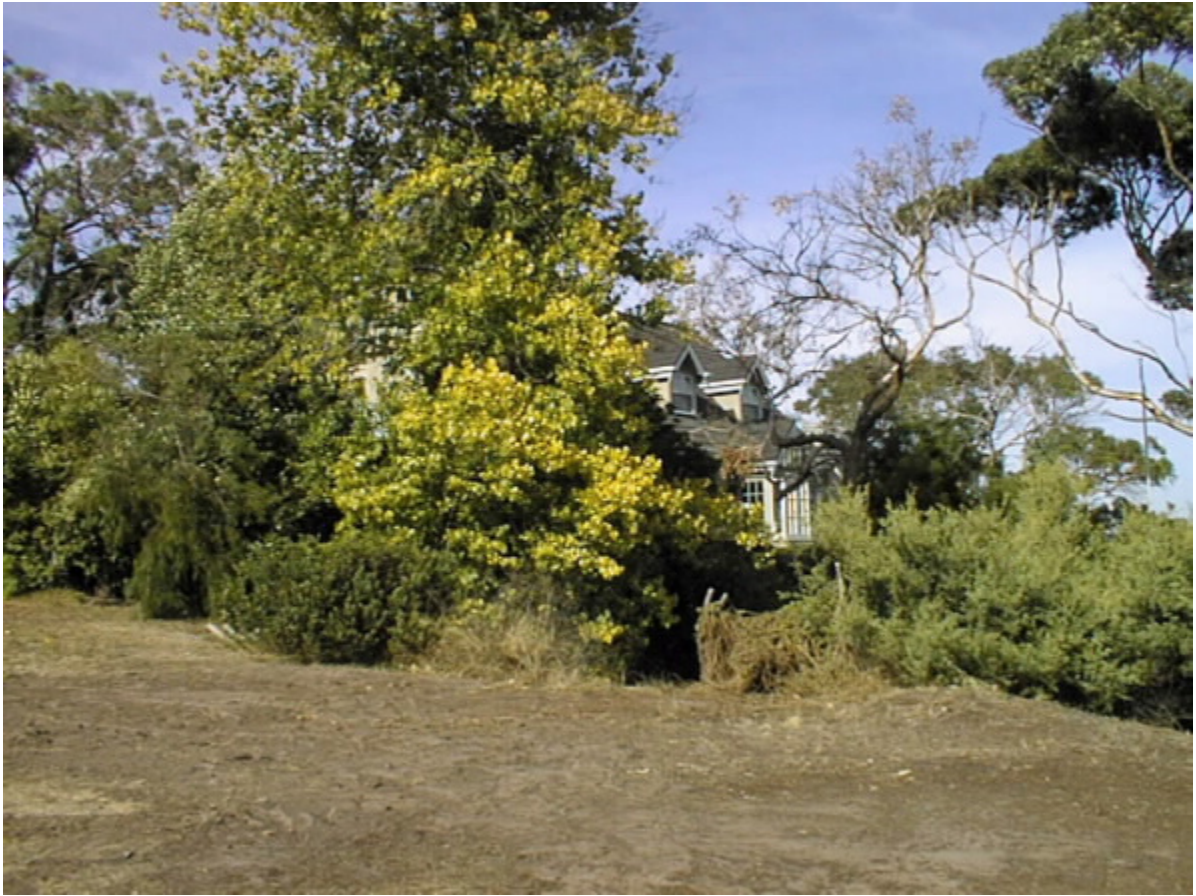
*View from no.6 towards no.10, 18 March 2002. Shows extensive vegetation between the respective sites.*

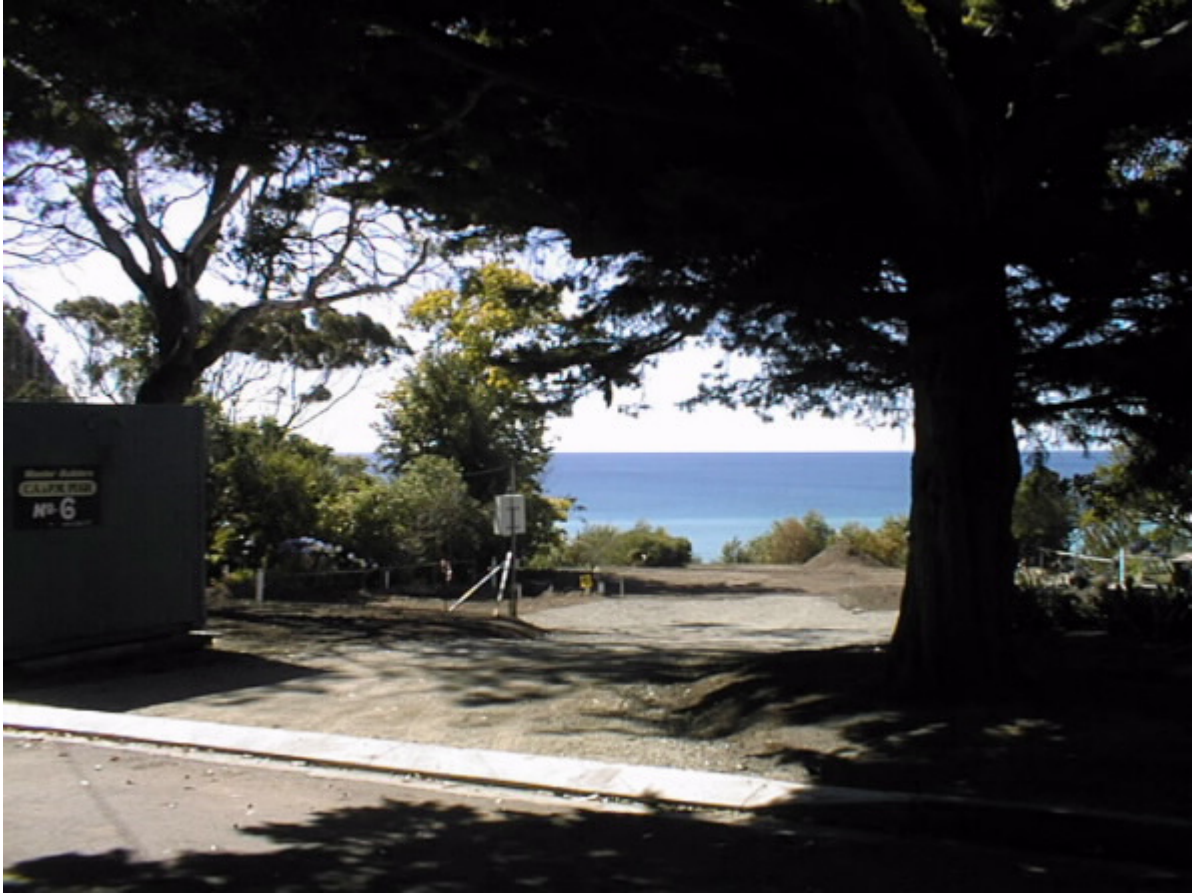
*No.6 just before construction, 29th January 2004. Note the gutter is dry.*
