**Task Number:**1337352/001**Task Address:**27 COBURN AVENUE, MCCRAE VIC 3938**Program Name:**ServiceStream - FY2425 - CCTV Retic 3 (Apr25)**Task Work Type:**Scheduled Maintenance - CCTV Inspection**Source Of Work:****Facility:****Permit Not Required:**No**Permit Pre Approved:**No**Permit Reason:**Other**Permit Other Reason:**

**Request Details:**Clean + CCTV Inspection Program McCrae Package: 1. All lines to be cleaned PRIOR to CCTV Inspection 2. CCTV Inspection using WSA 05 2020 Codes 3. Any manhole alterations required to complete works, action request to be raised and Sewer Maintenance Technician to be contacted SI's to be completed: 1. Sewer Clean 2. Sewer CCTV 3. Sewer Manhole Fault and Inspection

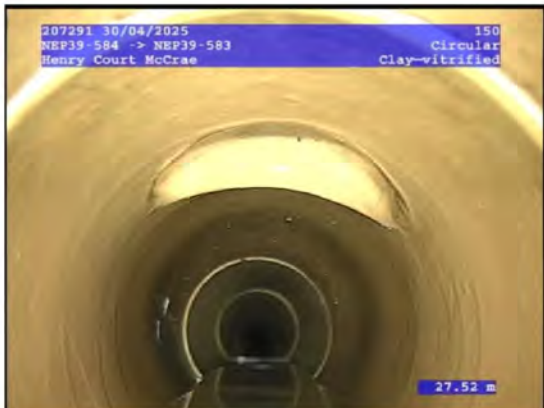
7, 00:12:24, 27.52  
Junction, unlined, open, Height/Diameter (mm): 100 at 12 o'clock

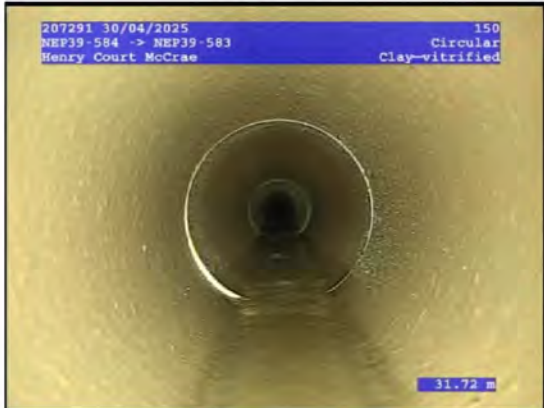
9, 00:15:32, 31.72  
Water flow at constant depth, turbid or discoloured water, <5%

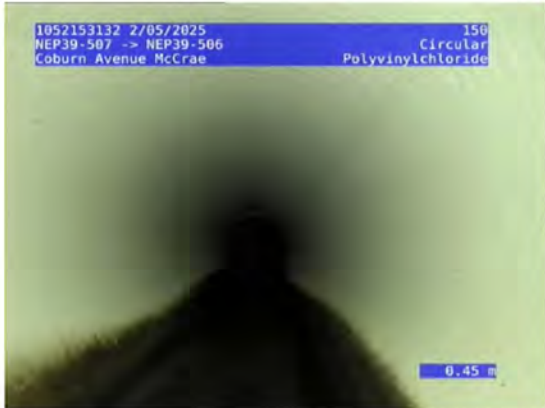
1, 00:00:23, 0.45  
Water flow at constant depth, turbid or discoloured water, <5%

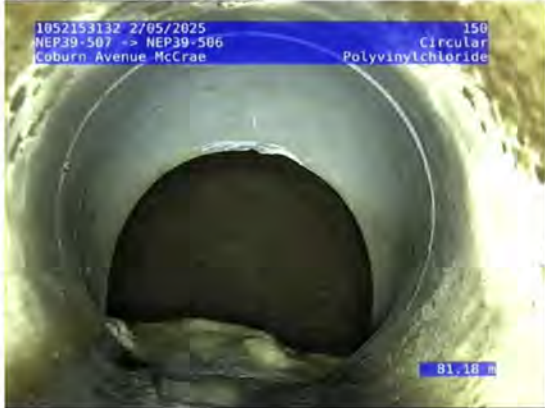
9, 00:19:40, 81.18  
Finish node, maintenance hole, Nodename:, NEP39-506,  
reference: drop pipe

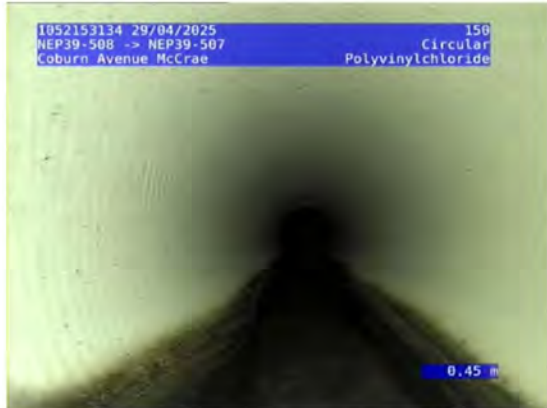
1, 00:00:30, 0.45  
Water flow at constant depth, turbid or discoloured water, <5%

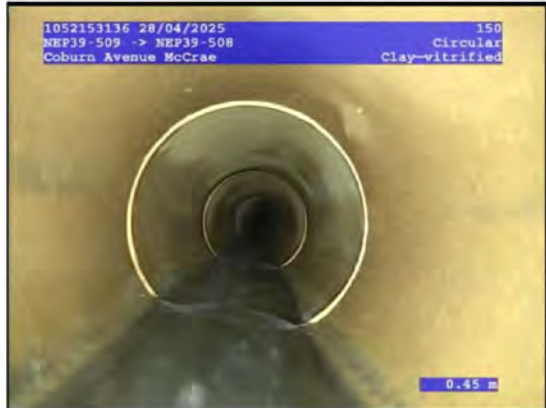
1, 00:00:22, 0.45  
Water flow at constant depth, turbid or discoloured water, 5-10%

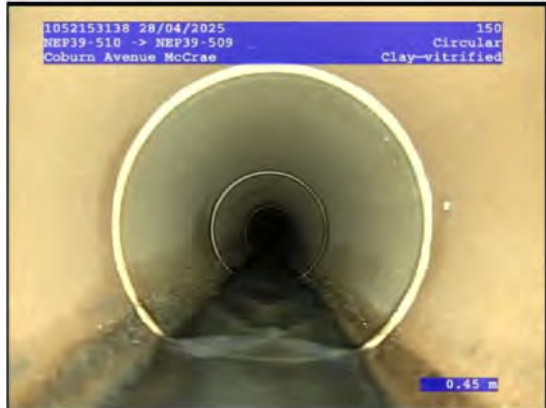
1, 00:00:00, 0.45  
Water flow at constant depth, turbid or discoloured water, <5%

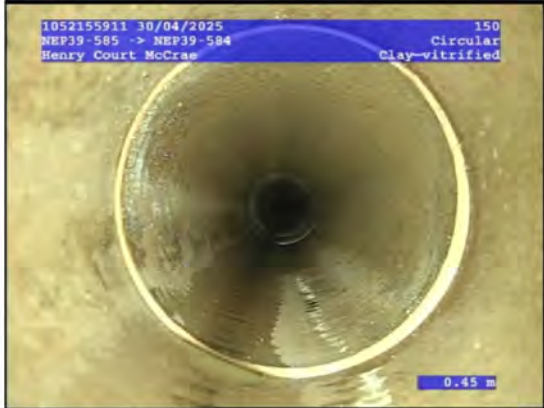
1, 00:00:00, 0.45  
Water flow at constant depth, turbid or discoloured water, <5%

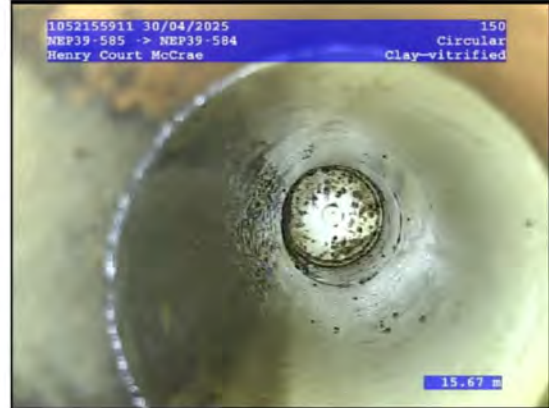
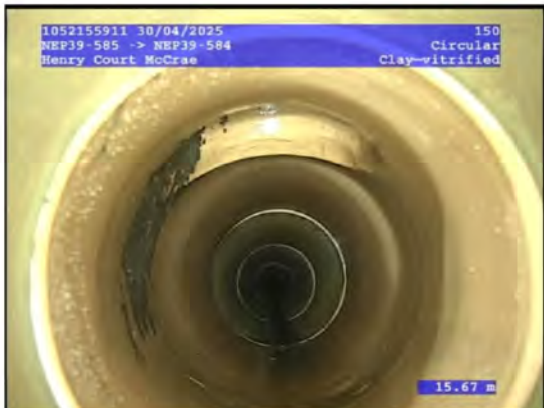
2, 00:06:57, 15.67  
Junction, unlined, open, Height/Diameter (mm): 100 at 12 o'clock

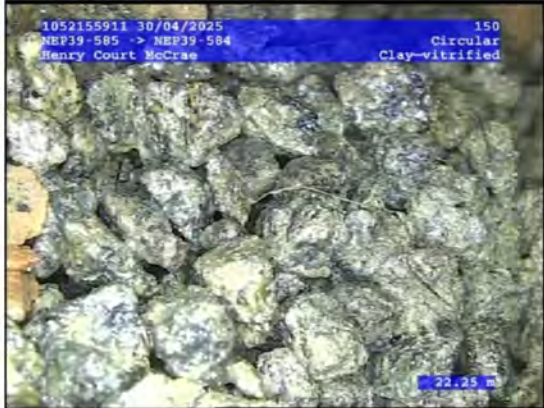
9, 00:10:56, 22.25

The material deposited is coarse sediments-gravel or rubble from 4 o'clock to 8 o'clock, Obstruction: 10%

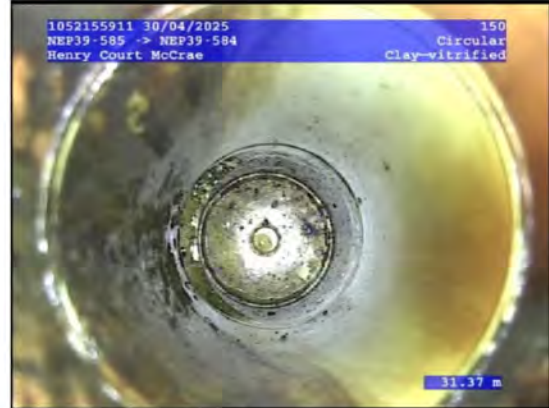
14, 00:15:38, 31.37  
Junction, unlined, open, Height/Diameter (mm): 100 at 12 o'clock

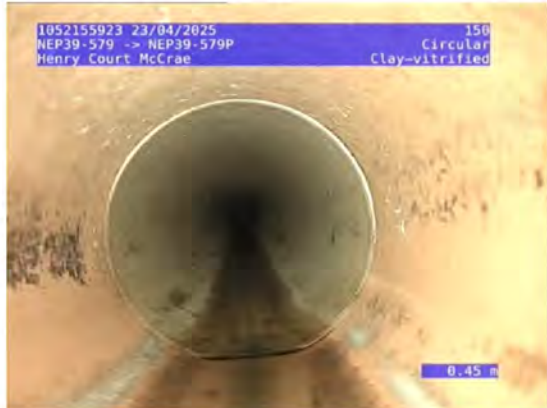
1, 00:00:23, 0.45  
Water flow at constant depth, turbid or discoloured water, <5%

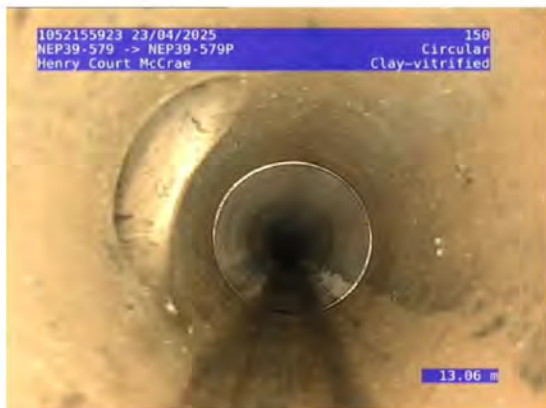
6, 00:06:53, 13.06  
Junction, unlined, open, Height/Diameter (mm): 100 at 9 o'clock

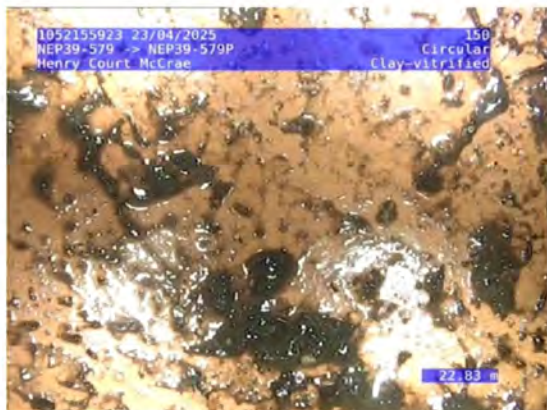
10, 00:10:32, 22.48  
Junction, unlined, open, Height/Diameter (mm): 100 at 10 o'clock

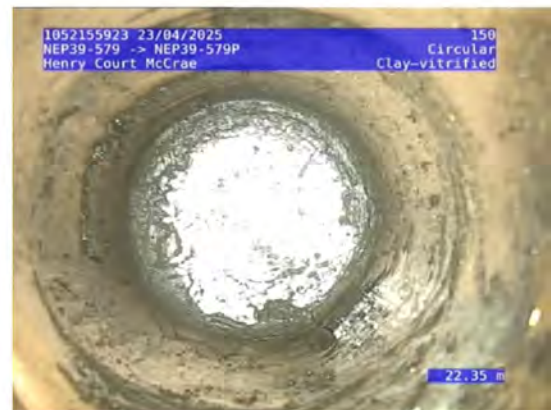
11, 00:11:22, 22.83  
Finish node, dead end, Nodename:., NEP39-579P

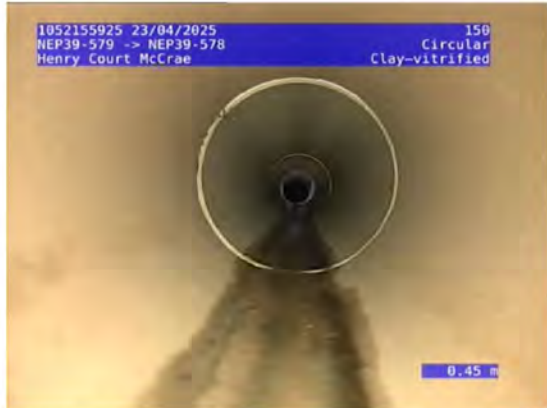
1, 00:00:22, 0.45  
Water flow at constant depth, turbid or discoloured water, <5%

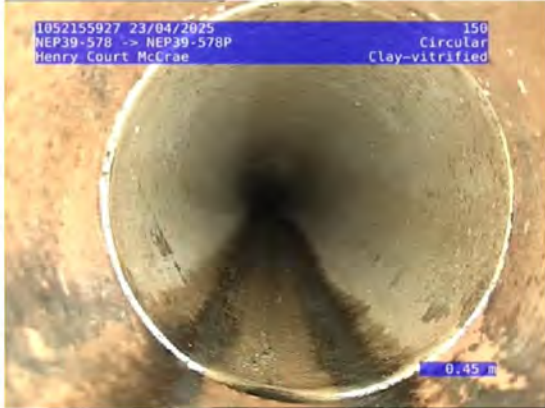
1, 00:00:42, 0.45  
Water flow at constant depth, turbid or discoloured water, <5%

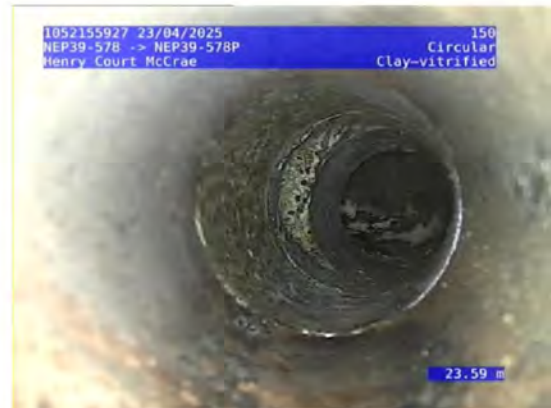
4, 00:08:21, 23.59  
Junction, unlined, open, Height/Diameter (mm): 100 at 2 o'clock

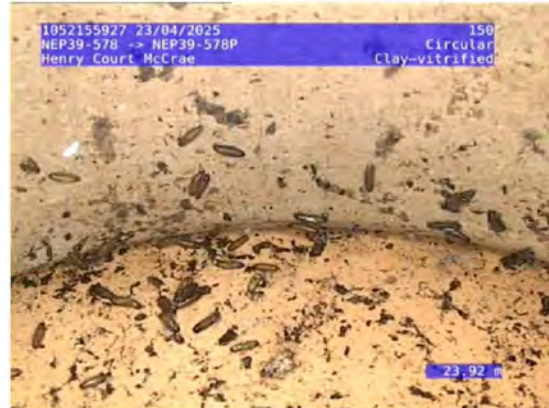
6, 00:09:02, 23.92  
Finish node, dead end, Nodename:, NEP39-578P

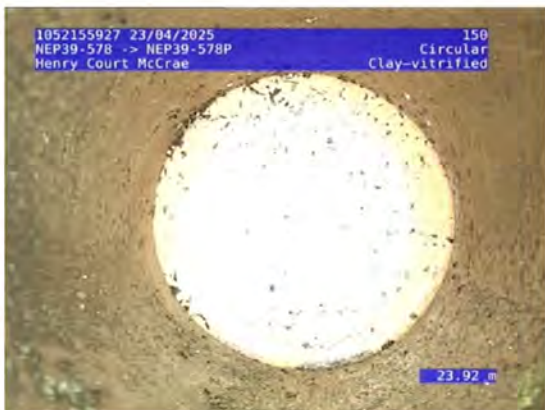
7, 00:09:02, 23.92  
Finish node, dead end, Nodename:, NEP39-578P

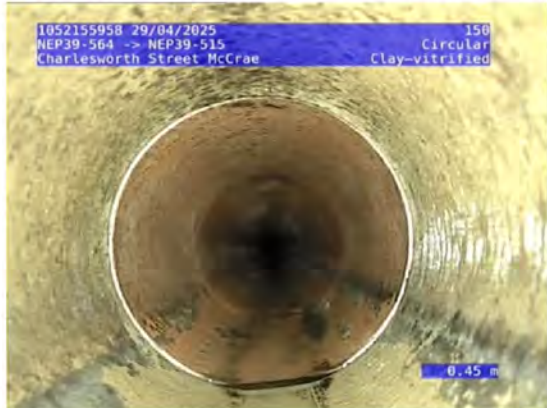
1, 00:00:24, 0.45  
Water flow at constant depth, turbid or discoloured water, <5%

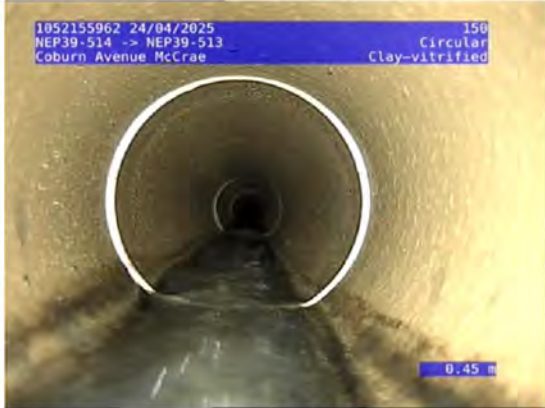
1, 00:00:26, 0.45  
Water flow at constant depth, turbid or discoloured water, <5%

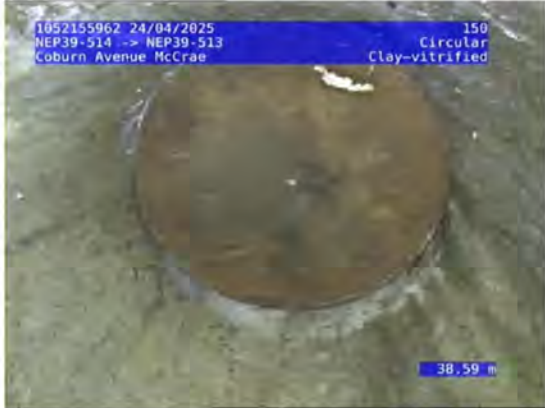
5, 00:14:22, 38.59

Finish node, maintenance hole, Nodename:, NEP39-513

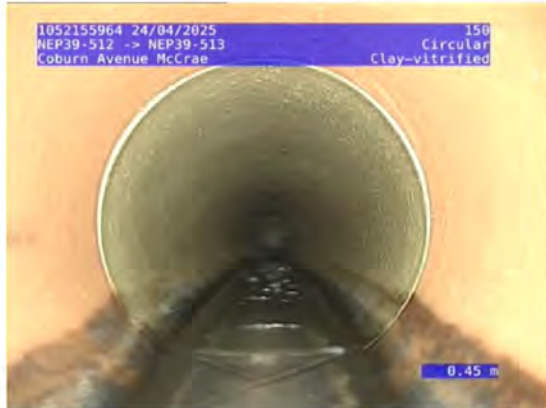
1, 00:00:23, 0.45  
Water flow at constant depth, turbid or discoloured water,  
5-10%

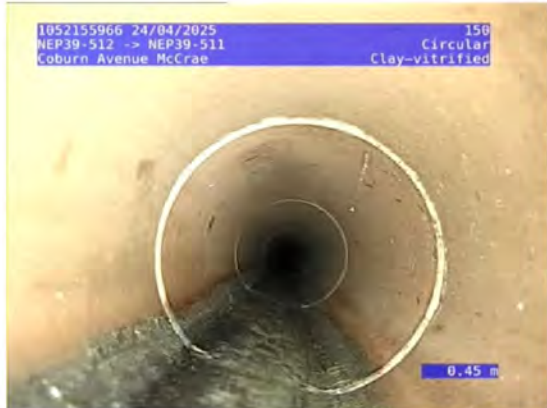
1, 00:00:21, 0.45  
Water flow at constant depth, turbid or discoloured water, <5%

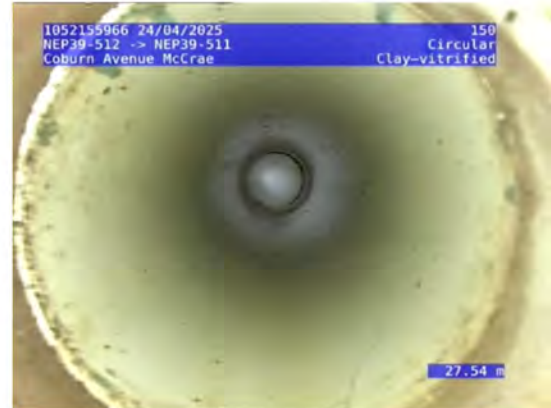
2, 00:09:04, 27.54  
Junction, unlined, open, Height/Diameter (mm): 100 at 12 o'clock

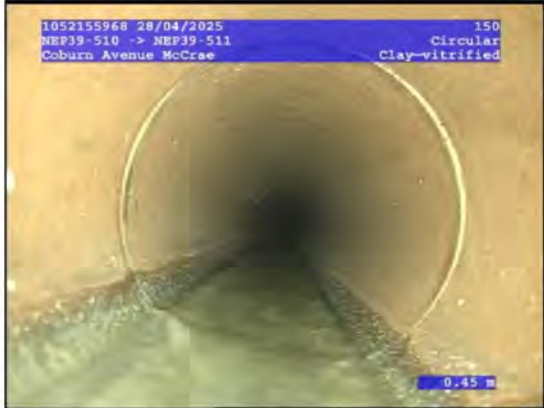
1, 00:00:23, 0.45  
Water flow at constant depth, turbid or discoloured water, <5%

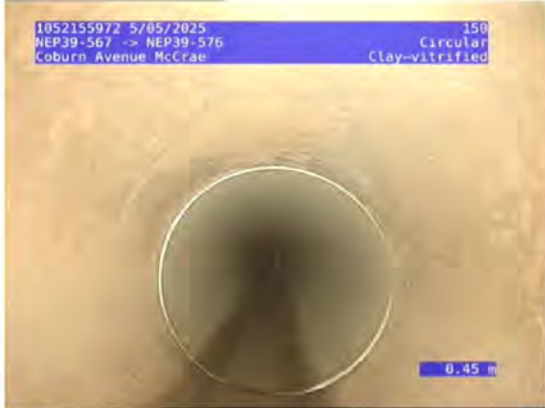
1, 00:00:22, 0.45  
Water flow at constant depth, turbid or discoloured water, <5%

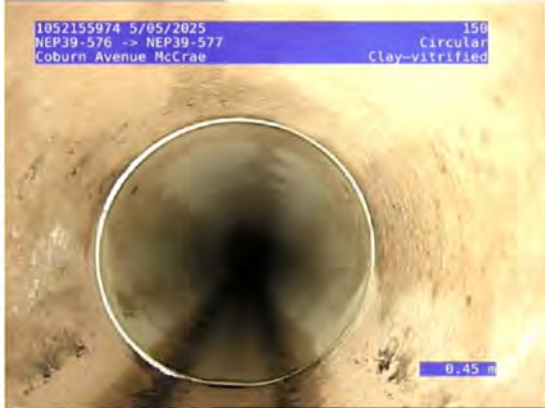
1, 00:00:24, 0.45  
Water flow at constant depth, turbid or discoloured water, <5%

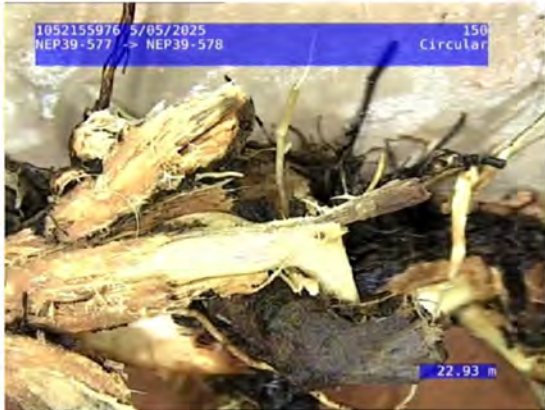
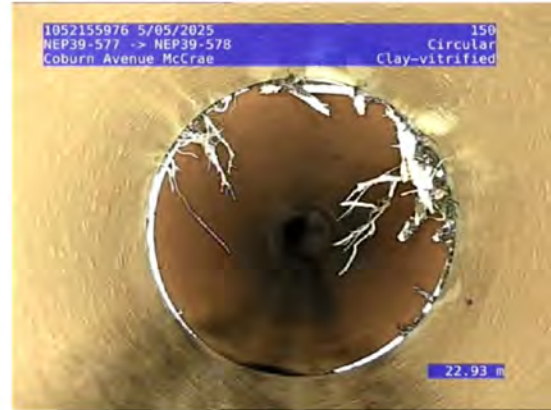
5, 00:08:21, 22.93  
Recently cut interwoven mass of mostly fine roots leaving a beard of roots, Obstruction: 10%, at joint from 12 o'clock to 12 o'clock

6, 00:08:21, 22.93  
Recently cut interwoven mass of mostly fine roots leaving a beard of roots, Obstruction: 10%, at joint from 12 o'clock to 12 o'clock

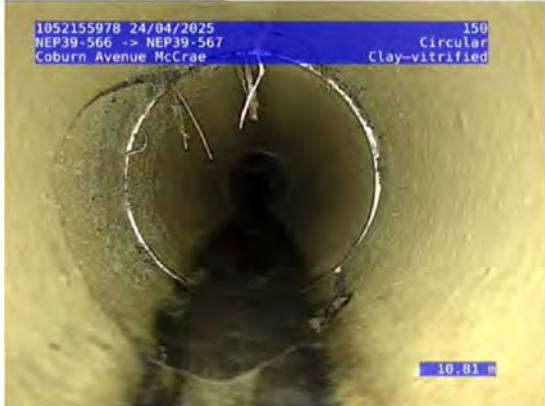
4, 00:04:09, 10.81  
Breaking, all pieces are present but some of them are visibly displaced from position, length of break: 200mm from 4 o'clock to 11 o'clock

Breaking, all pieces are present but some of them are visibly displaced from position, length of break: 200mm from 4 o'clock to 11 o'clock

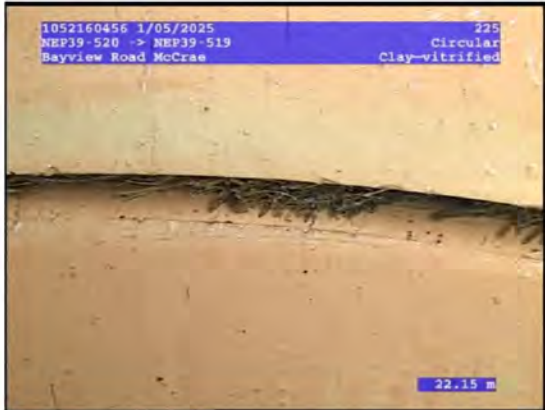
5, 00:07:12, 22.15

Recently cut interwoven mass of mostly fine roots leaving a beard of roots, at joint from 12 o'clock to 12 o'clock

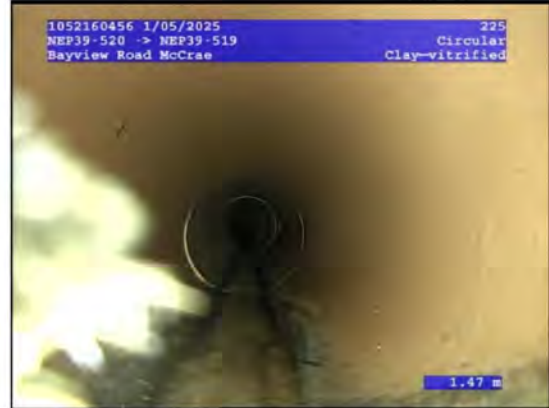
6, 00:02:59, 1.47

Inspection (survey) abandoned, roots / Unable to cut due to no access to DS manhole

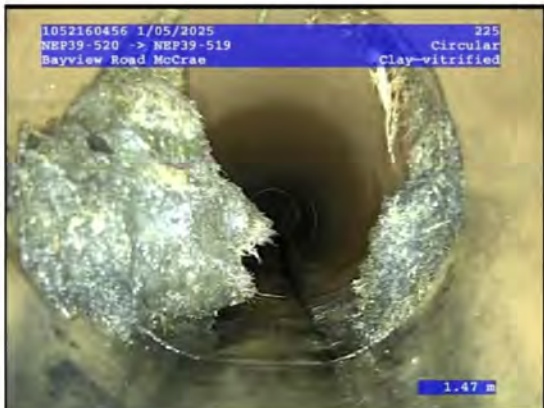
7, 00:02:59, 1.47

Inspection (survey) abandoned, roots / Unable to cut due to no access to DS manhole

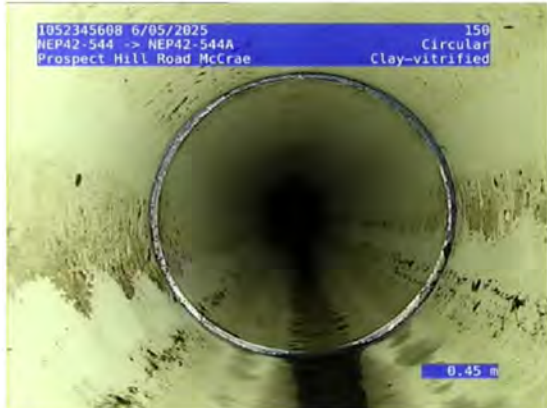
1, 00:00:22, 0.45  
Water flow at constant depth, turbid or discoloured water, <5%
